FIELD INSPECTION REPORT

Project Name:	Mountain Valley Pipeline	Inspector:	Marshall Willis
Inspection Date:	Thursday, August 12, 2021	Project Contact:	Brian Clauto, Cory Chalmers
Spread H: Franklin County	STA 13140+00 – 13185+00 MVP-FR-292/292.01	Weather:	Dry

FIELD INSPECTION PHOTO LOG

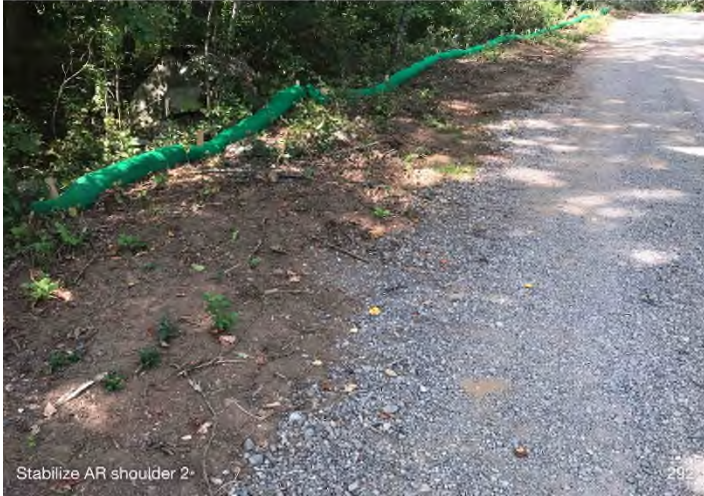
- MVP-FR-292: Stabilize disturbed shoulders of access road.
- STA 13146+40: Stabilization needed.

Figure 1: MVP-FR-292 – Stabilization needed along the shoulder of access road FR-292.

Recommended Corrective Action: Maintain and install all controls per the approved PSS&S.

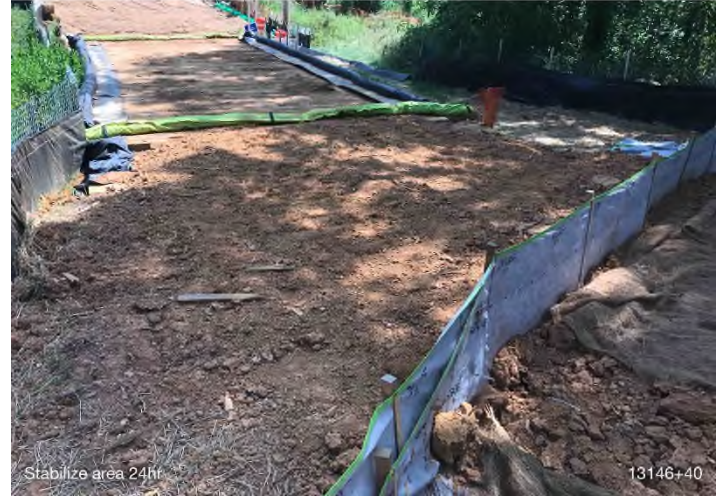
Figure 2: STA 13146+40 – Stabilization needed.

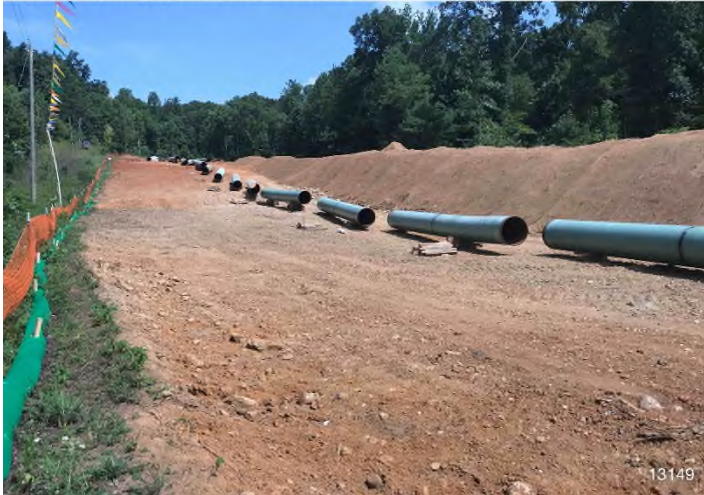
Figure 3: STA 13149+00 – Controls in place and functioning properly.

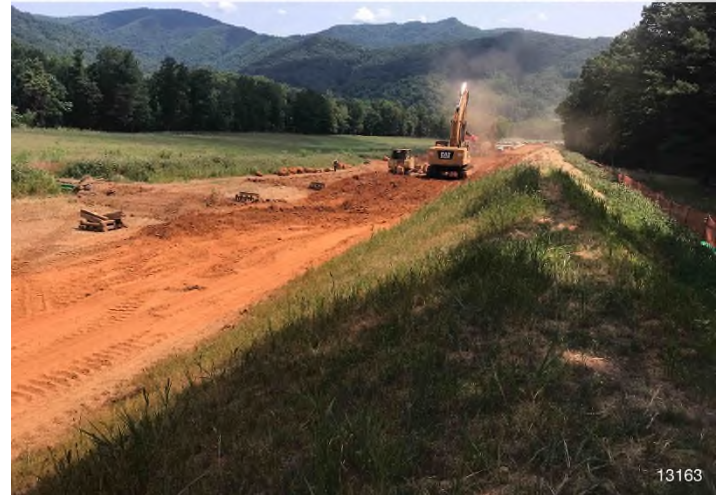
Figure 4: STA 13163+00 – Controls in place and functioning properly.
