FIELD INSPECTION REPORT

Project Name:	Mountain Valley Pipeline	Inspector:	Marshall Willis
Inspection Date:	Wednesday, August 11, 2021	Project Contact:	Brian Clauto, Cory Chalmers
Spread H: Roanoke County	STA 12776+03 – 12780+00 STA 12866+36 – 12915+25 MVP-RO-282/286	Weather:	Dry

FIELD INSPECTION PHOTO LOG

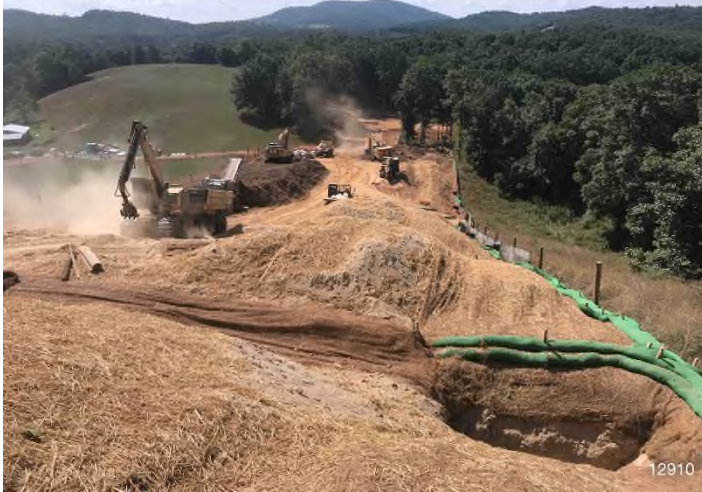
Figure 1: STA 12910+00 – Controls in place and functioning properly.
BRG: 158°S (T) LAT: 37.122314 LON: -80.131357 ±40246ft ALT: 2650ft

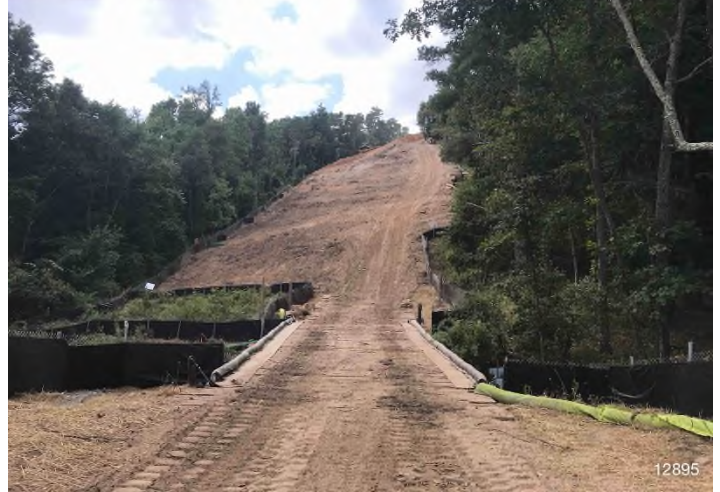
Figure 2: STA 12895+00 – Controls in place and functioning properly.
BRG: 205°SW (T) LAT: 37.156564 LON: -80.116440 ±8727ft ALT: 2615ft

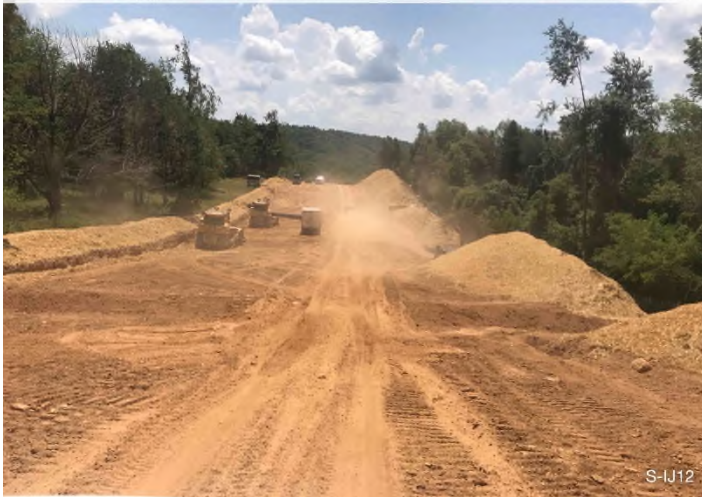
Figure 3: STA 12775+00 – Controls in place and functioning properly.
BRG: 69°E (T) LAT: 37.175690 LON: -80.139315 ±16ft ALT: 2823ft

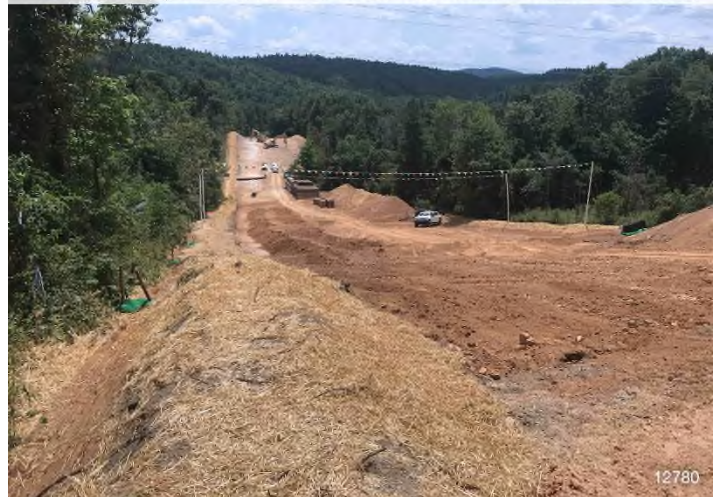
Figure 4: STA 12780+00 – Controls in place and functioning properly.
BRG: 177°S (T) LAT: 37.174147 LON: -80.139134 ±16ft ALT: 2828ft
