FIELD INSPECTION REPORT

| Project Name: | Mountain Valley Pipeline | Inspector: | Marshall Willis |
| Spread H: Roanoke County | STA 12910+76 – 12923+66 MVP-RO-286 | Weather: | Dry |

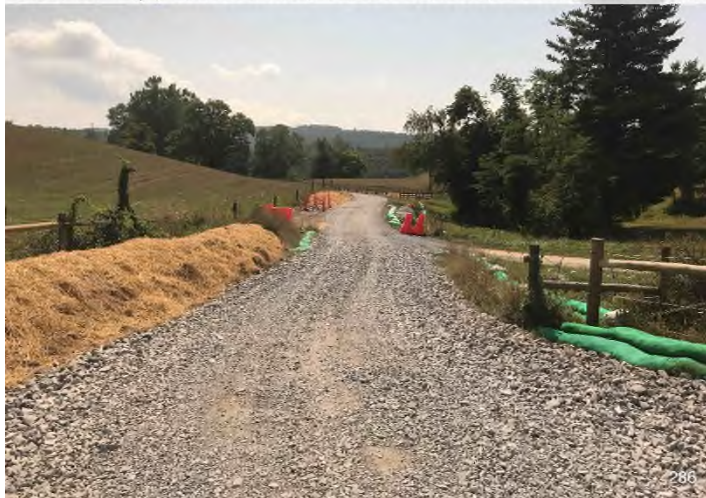
Figure 1: MVP-RO-286 – Controls in place and functioning properly.

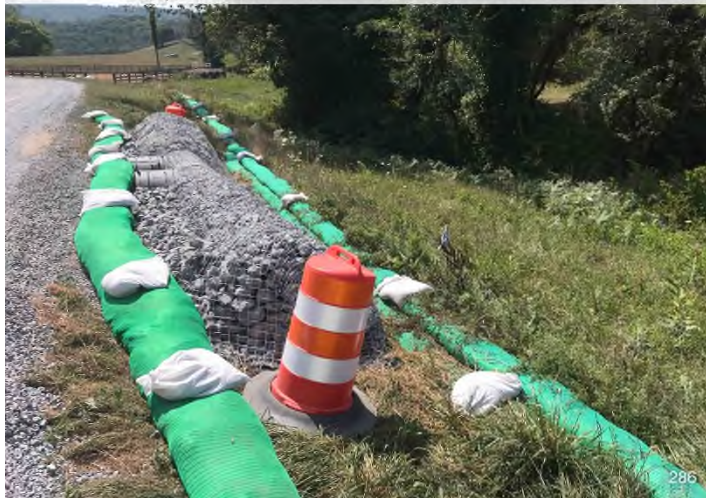
Figure 2: MVP-RO-286 – Controls in place and functioning properly.

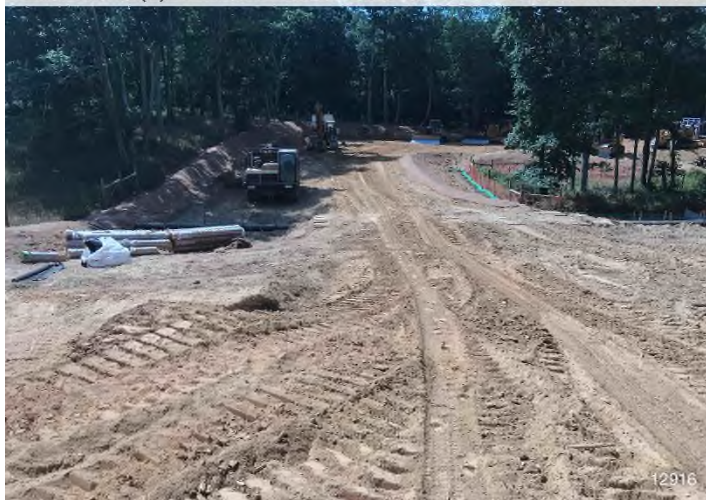
Figure 3: STA 12916+00 – Controls in place and functioning properly.

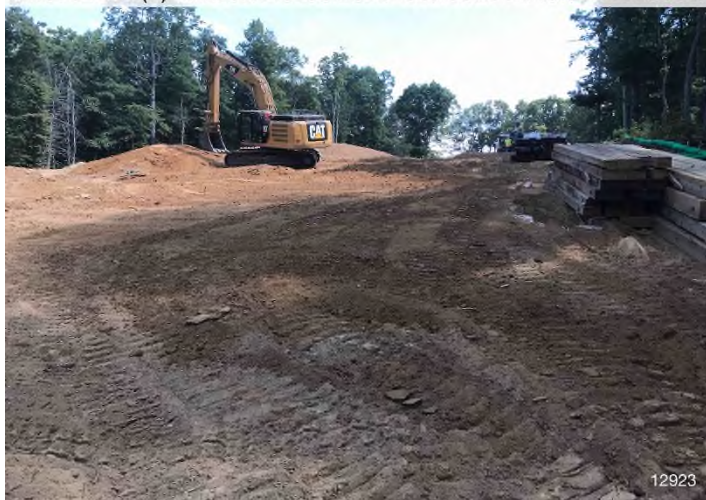
Figure 4: STA 12923+00 – Controls in place and functioning properly.
