## FIELD INSPECTION REPORT

| <b>Project Name:</b> | Mountain Valley Pipeline | <b>Inspector:</b> | Marshall Willis |
| <b>Inspection Date:</b> | Monday, August 9, 2021 | <b>Project Contact:</b> | Brian Clauto, Cory Chalmers |
| <b>Spread H:<br/>Roanoke County</b> | STA 12776+03 – 12796+50<br>STA 12690+43 – 12703+08<br>MVP-RO-282/280 | <b>Weather:</b> | Dry |

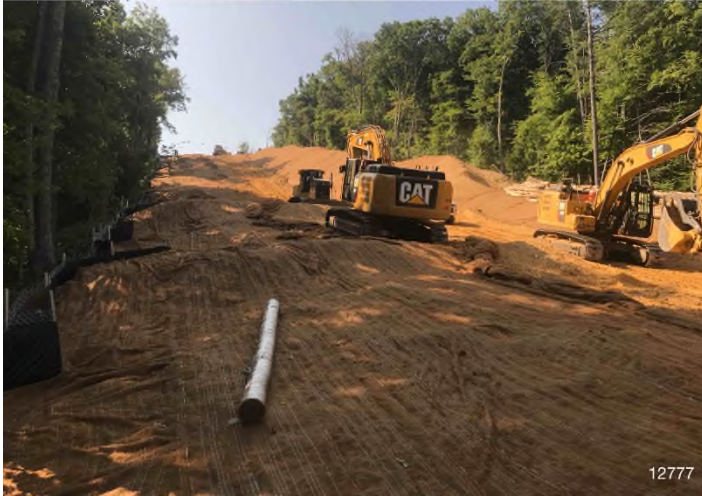
**Figure 1: STA 12777+00** – Controls in place and functioning properly.

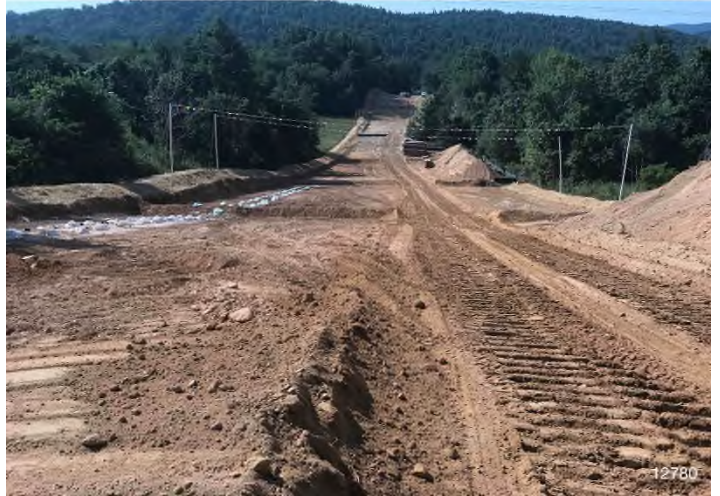
**Figure 2: STA 12780+00** – Controls in place and functioning properly.

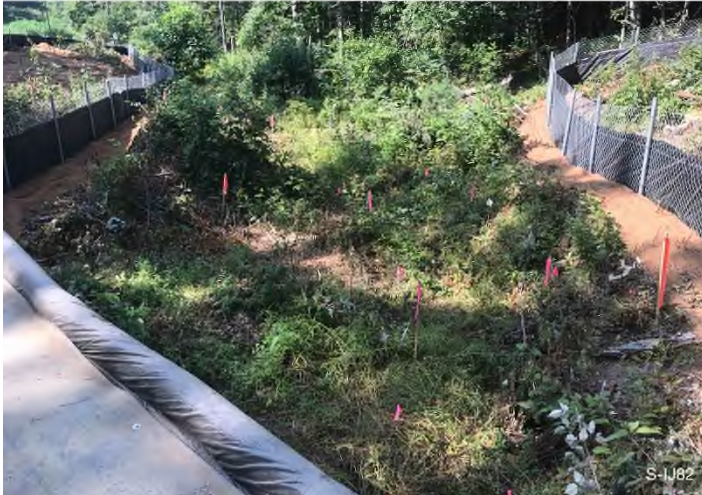
**Figure 3: Stream S-IJ82** – Controls in place and functioning properly around stream S-IJ82.

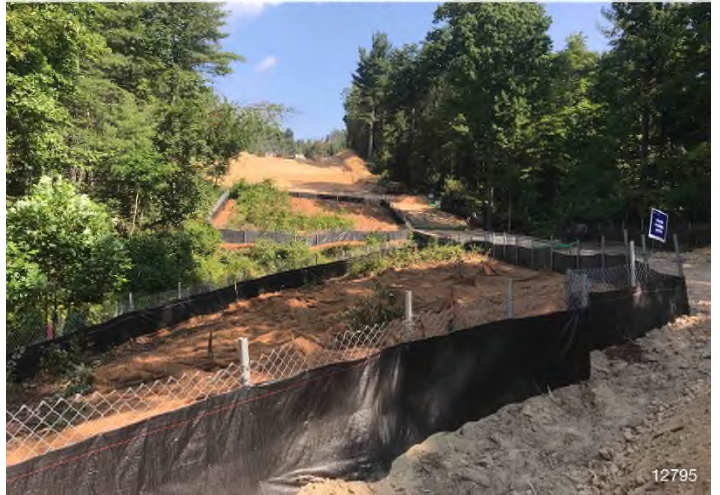
**Figure 4: STA 12795+00** – Controls in place and functioning properly. Buffer established around S-IJ82.
