## FIELD INSPECTION REPORT

| Project Name: | Mountain Valley Pipeline | Inspector: | Marshall Willis |
| Spread I:<br>Franklin County | STA 14454+22 – 14546+75 | Weather: | Dry |

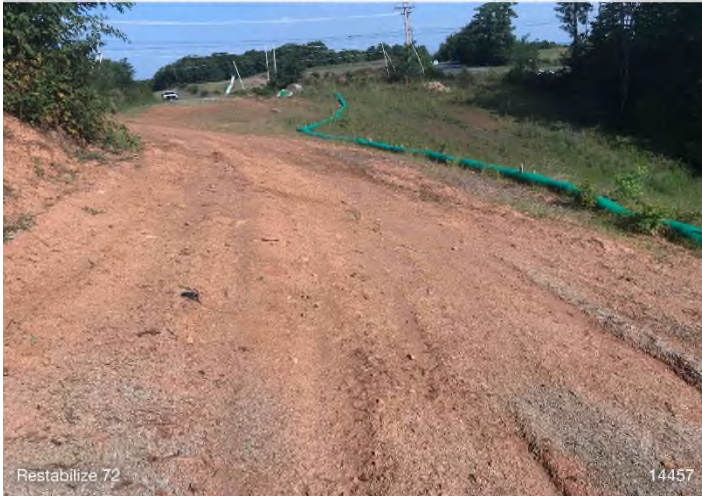
- STA 14455+00 to 14460+00: Re-stabilize ROW in travel lane.
- STA 14532+00: Triple stack CFS maintenance needed.

**Figure 1: STA 14455+00 to 14460+00 – Re-stabilization needed.**

**Recommended Corrective Action:** Maintain and install all controls per the approved PSS&S.

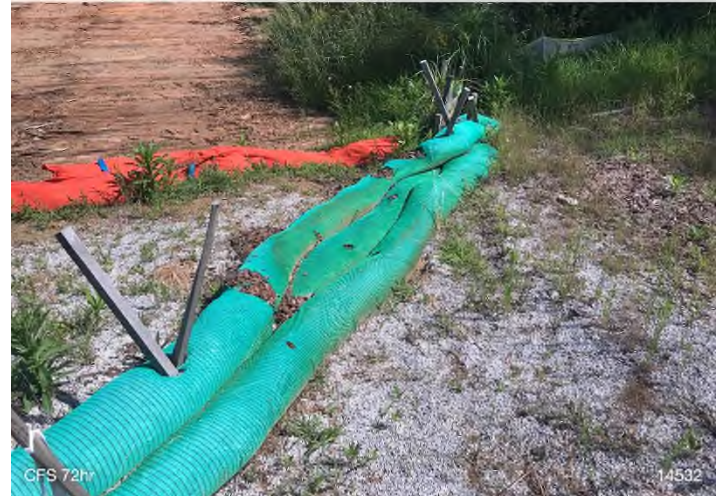
**Figure 2: STA 14532+00 – Triple stack CFS maintenance needed.**

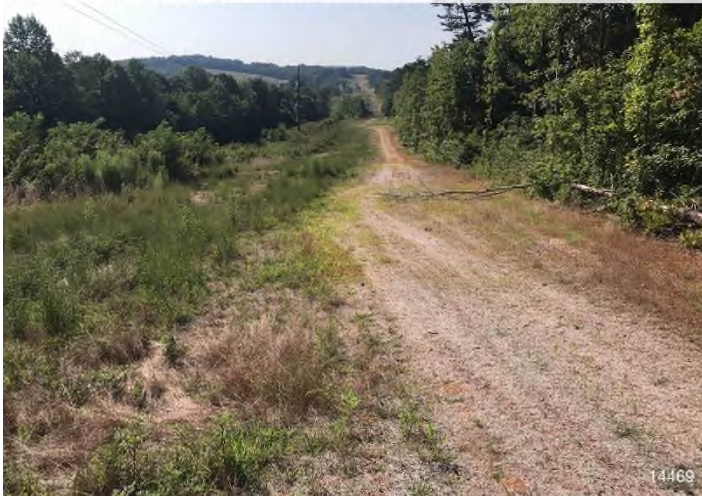
**Figure 3: STA 14469+00 – Controls in place and functioning properly.**

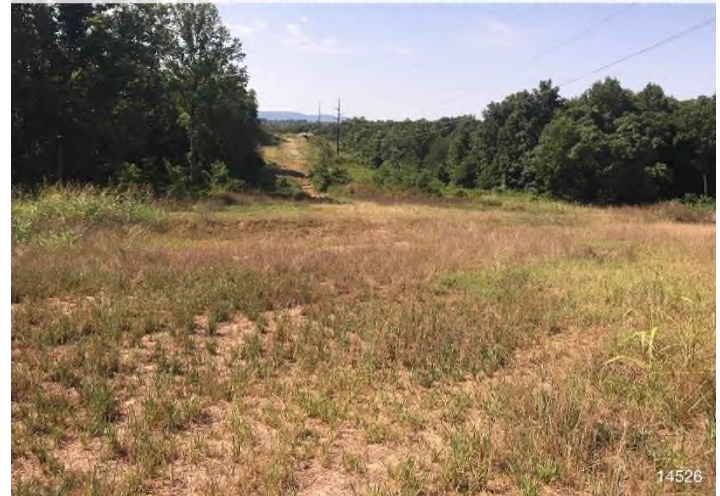
**Figure 4: STA 14526+00 – Controls in place and functioning properly.**
