## FIELD INSPECTION REPORT

| <b>Project Name:</b> | Mountain Valley Pipeline | <b>Inspector:</b> | Marshall Willis |
| <b>Inspection Date:</b> | Wednesday, August 4, 2021 | <b>Project Contact:</b> | Brian Clauto, Cory Chalmers |
| <b>Spread I:<br/>Franklin County</b> | STA 13996+00 – 14009+81<br>MVP-FR-306.03/.02<br>MVP-MLV-AR-32<br>STA-14233+12 – 14250+00 | <b>Weather:</b> | Dry |

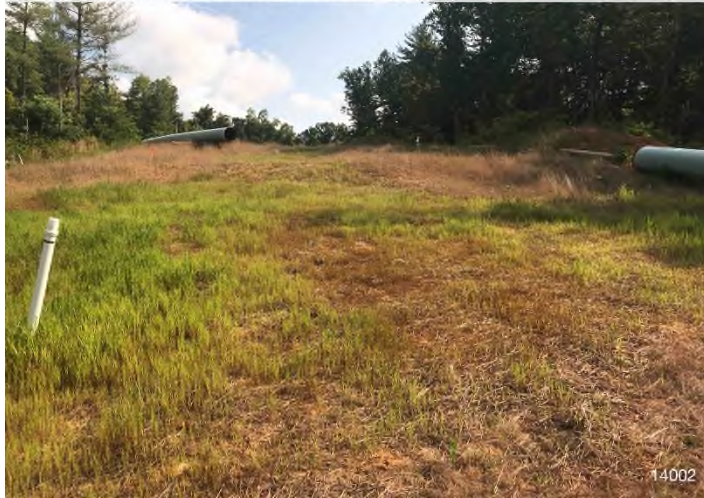
14002

**Figure 1: STA 14002+00** – Controls in place and functioning properly.

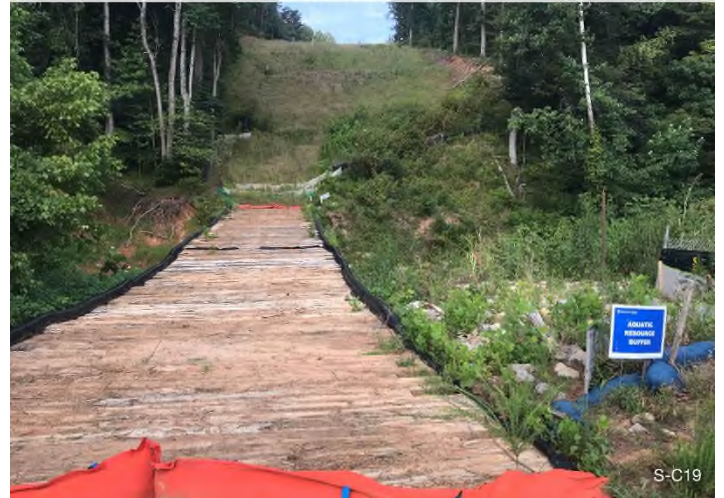
S-C19

**Figure 2: Stream S-C19** – Controls in place and functioning properly around Magodee Creek crossing.

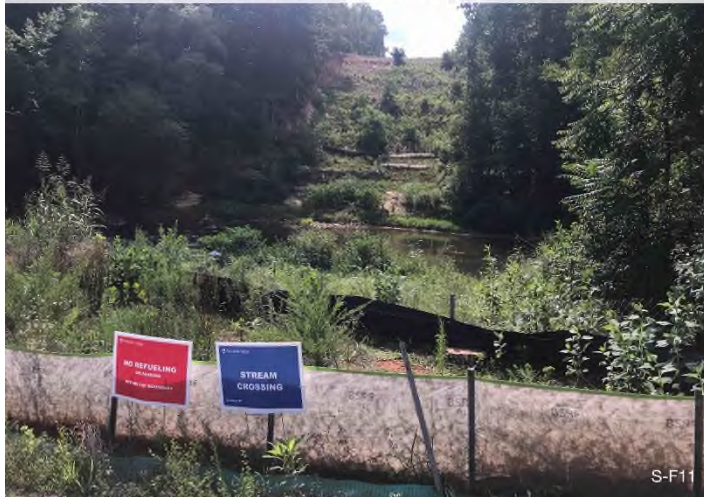
S-F11

**Figure 3: Stream S-F11** – Controls in place and functioning properly around Blackwater River crossing.

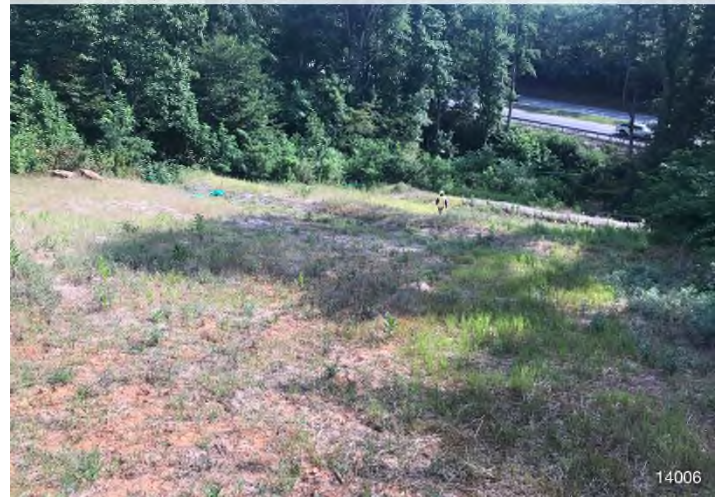
14006

**Figure 4: STA 14006+00** – Controls in place and functioning properly.
