## FIELD INSPECTION REPORT

<b>Project Name:</b>	Mountain Valley Pipeline	<b>Inspector:</b>	Marshall Willis
<b>Inspection Date:</b>	Monday, August 2, 2021	<b>Project Contact:</b>	Brian Clauto, Cory Chalmers
<b>Spread H: Roanoke County</b>	STA 12905+00 – 12912+00 STA 12729+12 – 12799+00 MVP-RO-286/280/281	<b>Weather:</b>	Dry

## FIELD INSPECTION PHOTO LOG

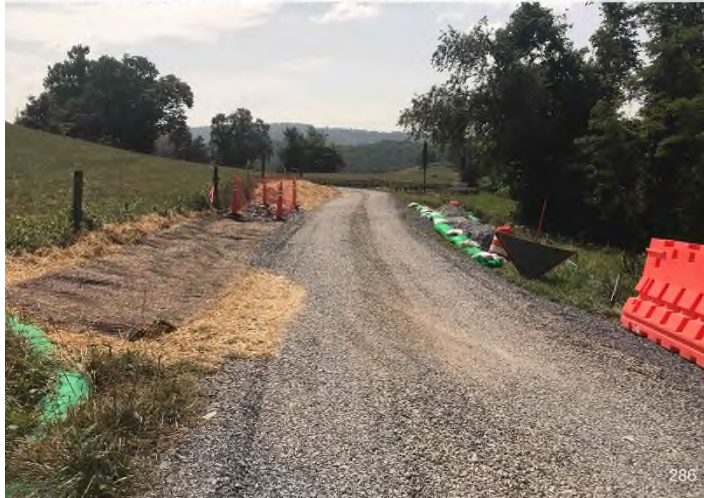
**Figure 1: MVP-RO-286** – Controls in place and functioning properly.

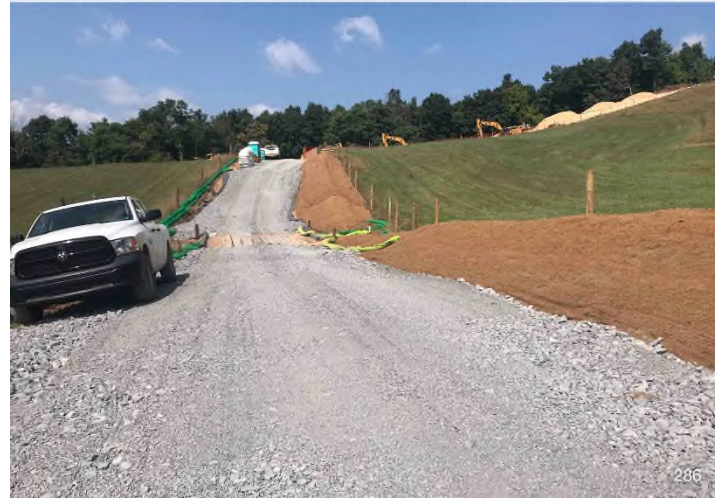
**Figure 2: MVP-RO-286** – Controls in place and functioning properly.

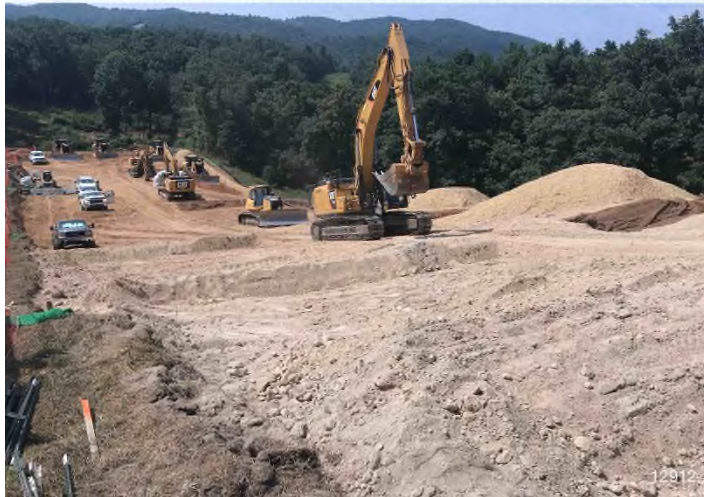
**Figure 3: STA 12912+00** – Controls in place and functioning properly.

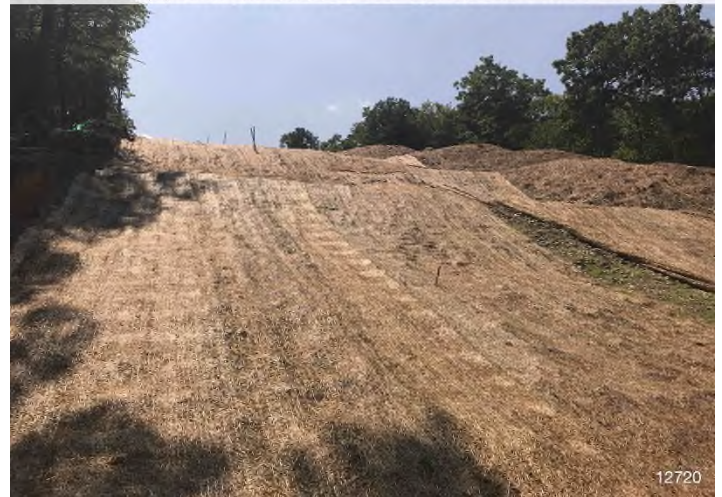
**Figure 4: STA 12720+00** – Controls in place and functioning properly. Area stabilized with erosion control matting.
