FIELD INSPECTION REPORT

Project Name:	Mountain Valley Pipeline	Inspector:	Marshall Willis
Inspection Date:	Thursday, July 29, 2021	Project Contact:	Brian Clauto, Cory Chalmers
Spread H: Franklin County	STA 13342+40 – 13415+51	Weather:	Dry

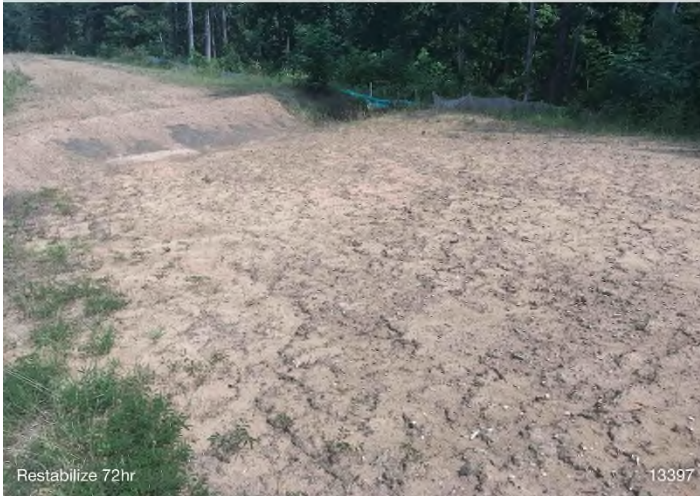
Figure 1: STA 13404+00 to 13387+64 – Re-stabilization needed.

Restabilize 72hr

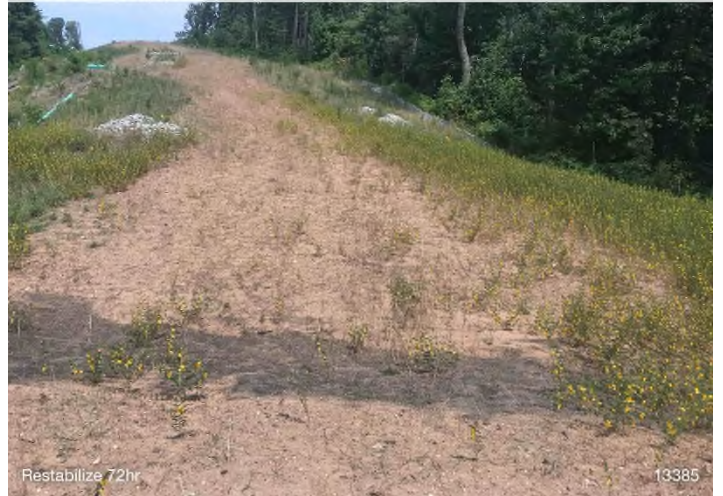
Figure 2: STA 13383+00 to 13379+00 – Re-stabilization needed.

Restabilize 72hr

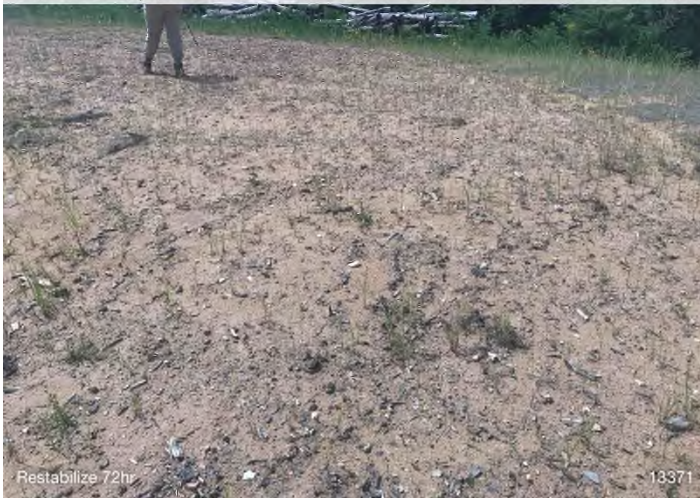
Figure 3: STA 13373+00 to 13371+00 – Re-stabilization needed.

Restabilize 72hr

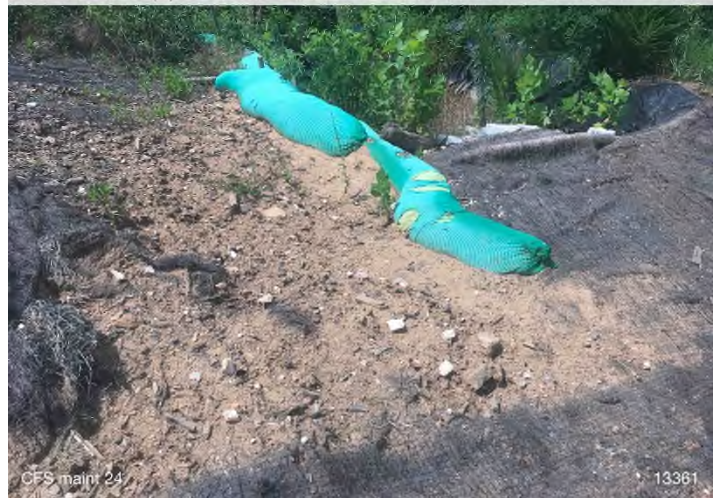
- STA 13361+00: CFS clean out needed.

Figure 4: STA 13361+00 – CFS clean out needed.

CFS maint 24

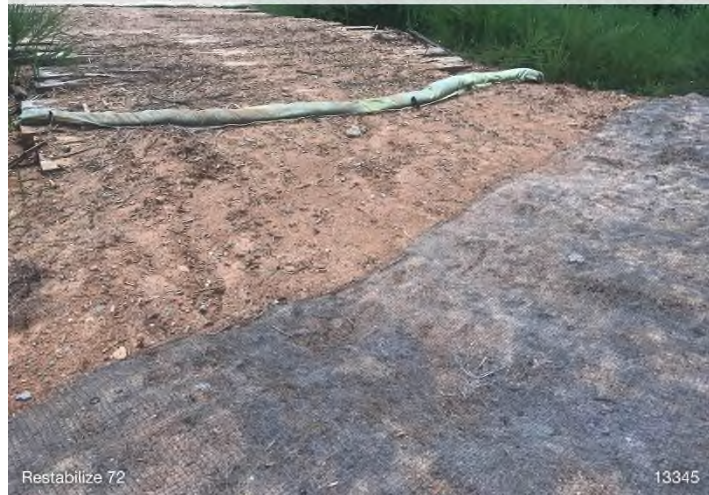
Figure 5: STA 13345+00 – Re-stabilization needed.

Restabilize 72

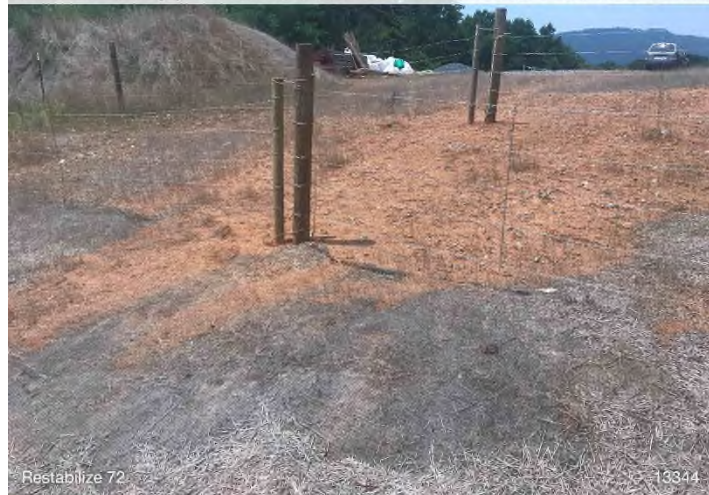
Figure 6: STA 13344+00 – Re-stabilization needed.

Restabilize 72
