FIELD INSPECTION REPORT

Project Name:	Mountain Valley Pipeline	Inspector:	Marshall Willis
Inspection Date:	Wednesday, July 28, 2021	Project Contact:	Brian Clauto, Cory Chalmers
Spread H: Roanoke County	STA 12912+00 – 12917+00 STA 12773+00 – 12761+27 MVP-RO-286/282	Weather:	Dry

FIELD INSPECTION PHOTO LOG

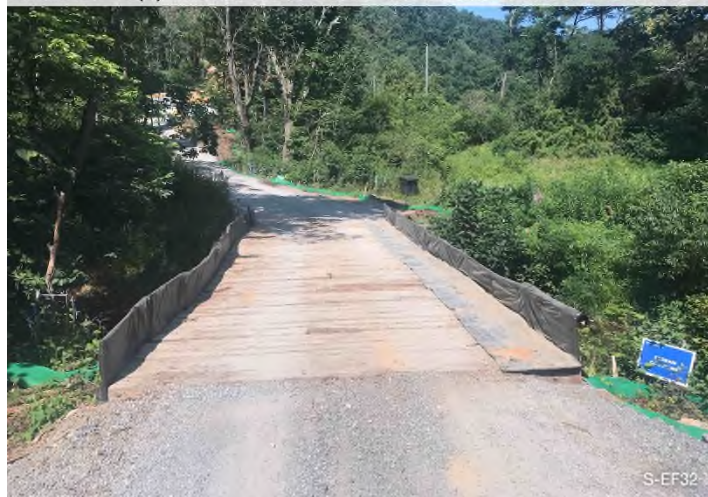
Figure 1: Stream S-EF32 – Controls in place and functioning properly along stream crossing.

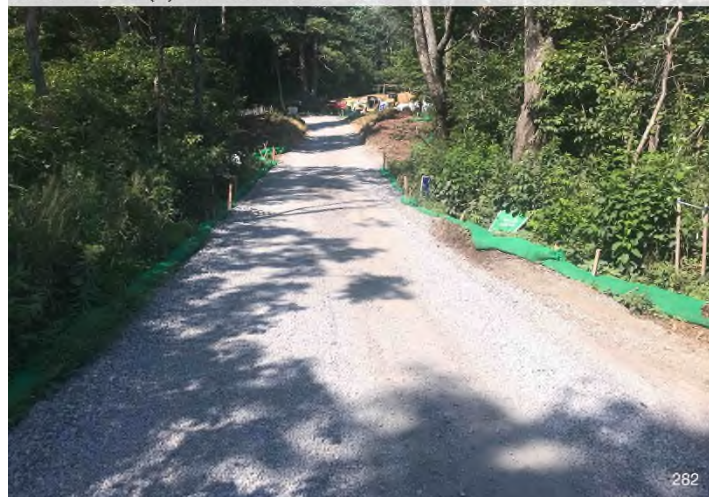
Figure 2: MVP-RO-282 – Controls in place and functioning properly along access road.

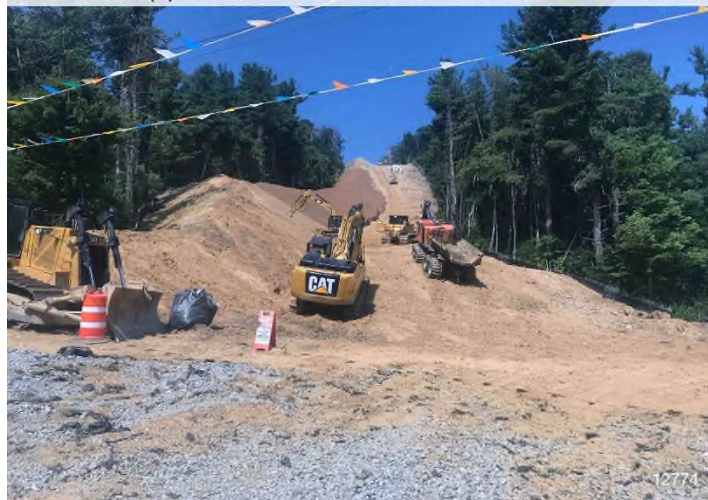
Figure 3: STA 12774+00 – Controls in place and functioning properly.

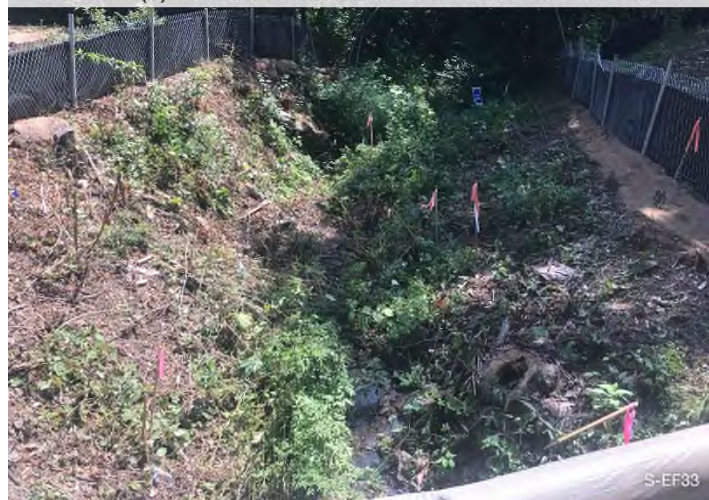
Figure 4: Stream S-EF33 – Controls in place and functioning properly along stream crossing.
