## FIELD INSPECTION REPORT

<b>Project Name:</b>	Mountain Valley Pipeline	<b>Inspector:</b>	Marshall Willis
<b>Inspection Date:</b>	Friday, July 23, 2021	<b>Project Contact:</b>	Brian Clauto, Cory Chalmers
<b>Spread H: Roanoke County</b>	STA 12964+64 – 12980+00 STA 12945+00 – 12958+54 MVP-RO-288/287/286	<b>Weather:</b>	Dry

## FIELD INSPECTION PHOTO LOG

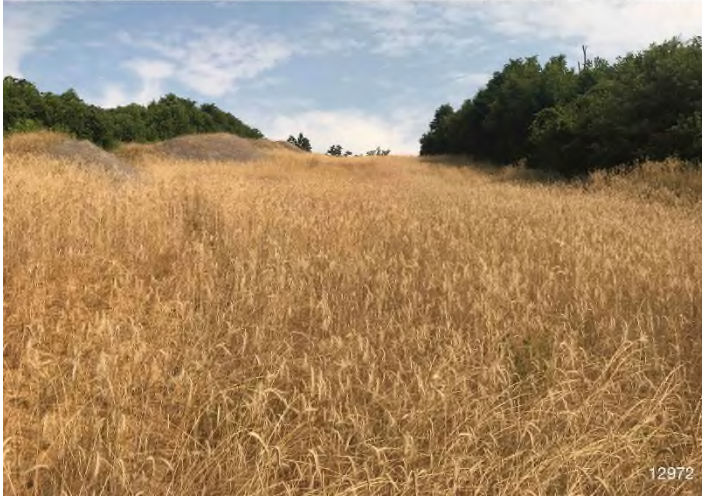
**Figure 1: STA 12972+00** – Controls in place and functioning properly.  
BRG: 337°NW (T) LAT: 37.130631 LON: -80.137332 ±98ft ALT: 2709ft

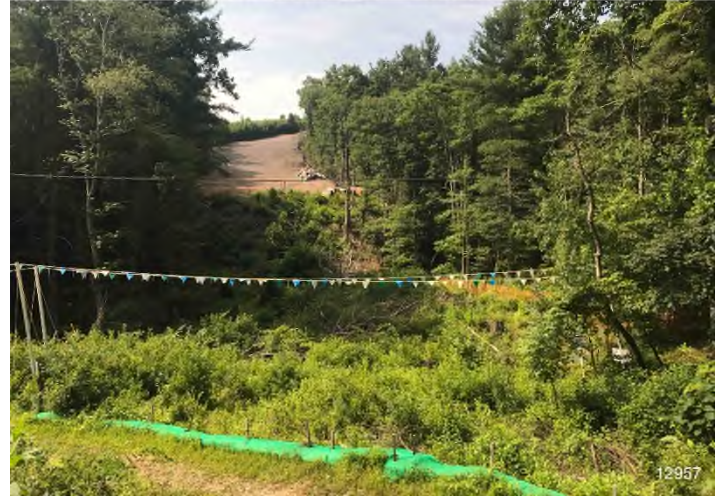
**Figure 2: STA 12957+00** – Controls in place and functioning properly.  
BRG: 185°S (T) LAT: 37.134656 LON: -80.137381 ±32ft ALT: 2636ft

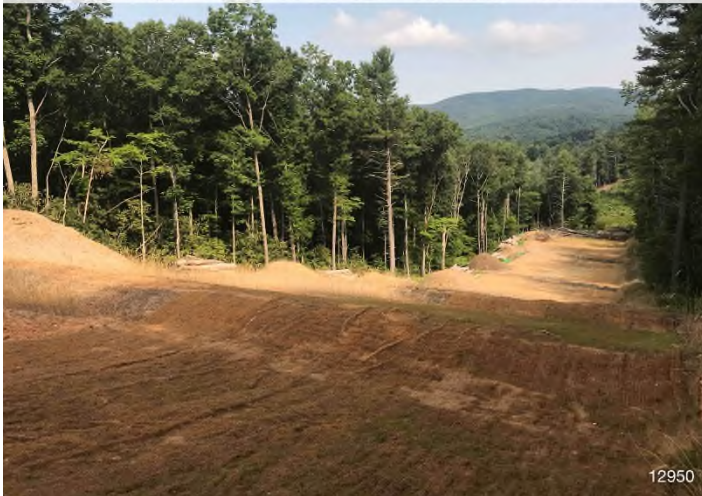
**Figure 3: STA 12950+00** – Controls in place and functioning properly. Area stabilized with straw and erosion control matting.  
BRG: 318°NW (T) LAT: 37.136478 LON: -80.138581 ±32ft ALT: 2726ft

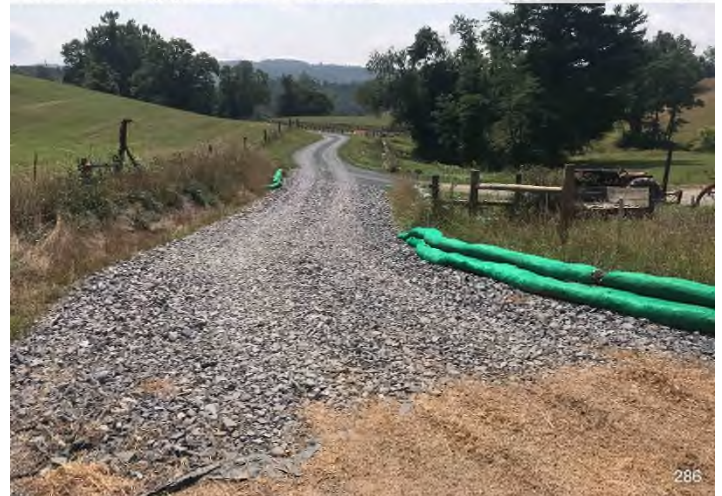
**Figure 4: MVP-RO-286** – Controls in place and functioning properly along MVP-RO-286.  
BRG: 122°SE (T) LAT: 37.144928 LON: -80.135617 ±16ft ALT: 2715ft
