FIELD INSPECTION REPORT

Project Name:	Mountain Valley Pipeline	Inspector:	Marshall Willis
Inspection Date:	Thursday, July 22, 2021	Project Contact:	Brian Clauto, Cory Chalmers
Spread H: Montgomery County Roanoke County	STA 12179+95 – 12200+00 STA 12724+88 – 12743+89 MVP-MN-274 MVP-RO-281/281.02	Weather:	Dry

FIELD INSPECTION PHOTO LOG

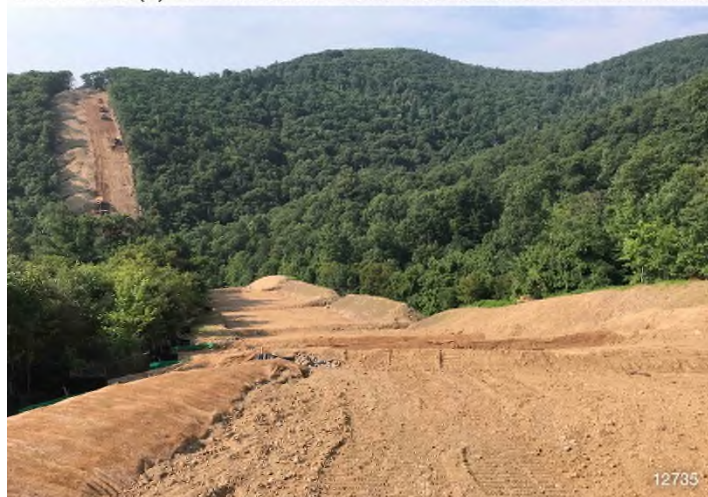
Figure 1: STA 12735+00 – Controls in place and functioning properly.

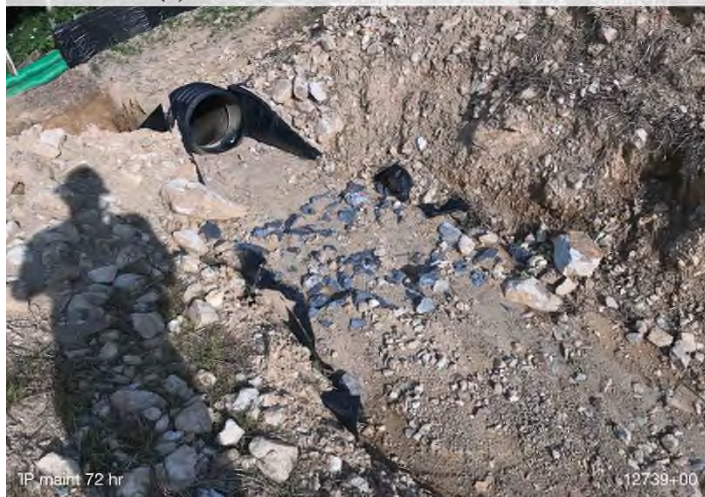
- STA 12739+00: Slope drain inlet protection maintenance needed.

Figure 2: STA 12739+00 – Slope drain inlet protection needs maintenance.

Recommended Corrective Action: Maintain and install all controls per the approved PSS&S.

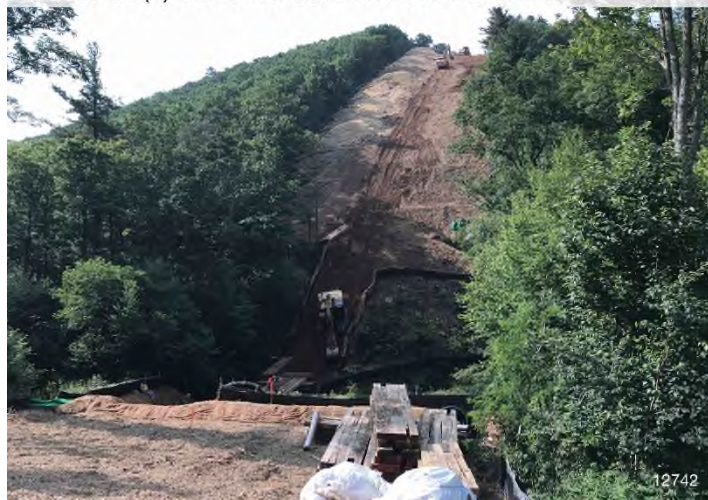
Figure 3: STA 12742+00 – Controls in place and functioning properly.

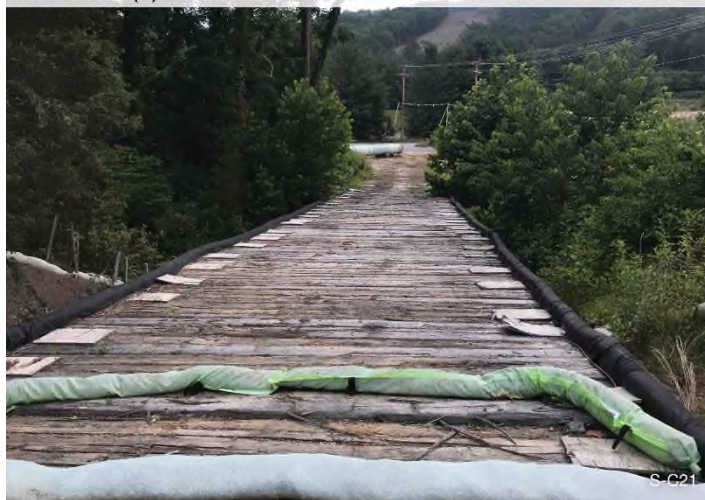
Figure 4: Stream S-C21 – Controls in place and functioning properly along Bradshaw Creek.
