I	
Project Name:	Mountain Valley Pipeline	Inspector:	Matthew Grant
Inspection Date:	Wednesday, July 21, 2021	Project Contact:	Brian Clauto
Spread H: Franklin	AR FR291, FR-292.01 ATWS1482, 1483, 1251, 1248, 1248A, 1410, 1249 St 13118-13194	Weather:	Dry

FIELD INSPECTION PHOTO LOG

Project Name: Mountain Valley Pipeline Date: Wednesday, July 21, 2021

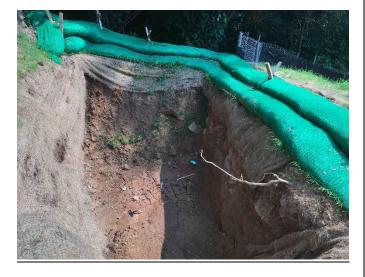
Figure 1: St13120 Uncontained trash
