## FIELD INSPECTION REPORT

| <b>Project Name:</b> | Mountain Valley Pipeline | <b>Inspector:</b> | Marshall Willis |
| <b>Spread H:<br/>Franklin County</b> | STA 13115+97 – 13195+79<br>MVP-FR-291<br>MVP-FR-291.02 | <b>Weather:</b> | Dry |

## FIELD INSPECTION PHOTO LOG

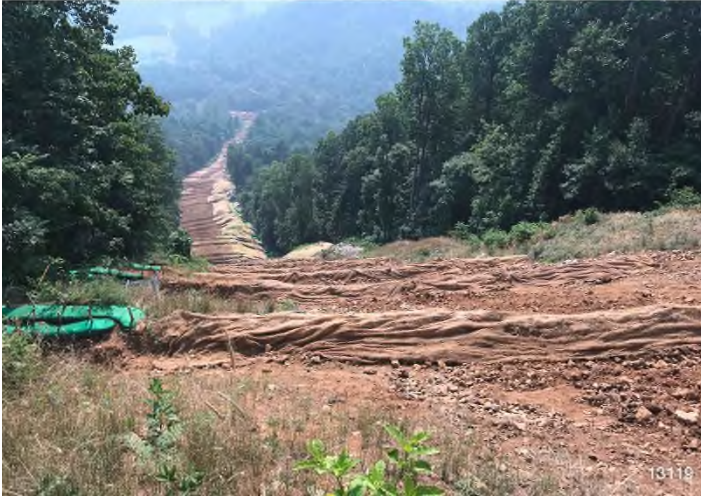
**Figure 1: STA 13119+00** – Controls in place and functioning properly.

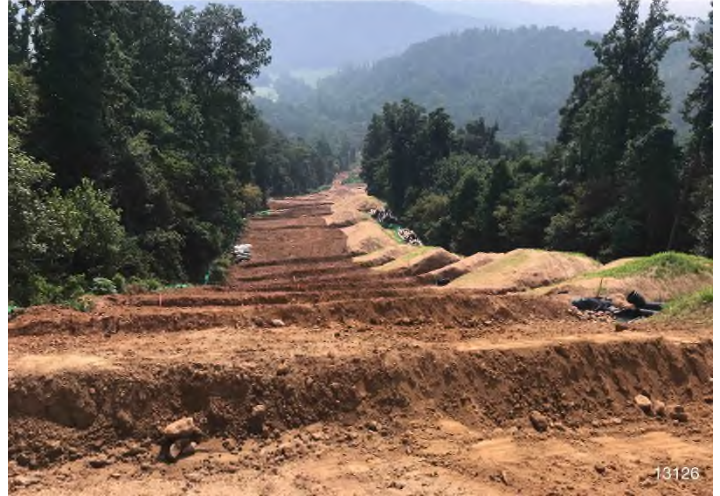
**Figure 2: STA 13126+00** – Controls in place and functioning properly.

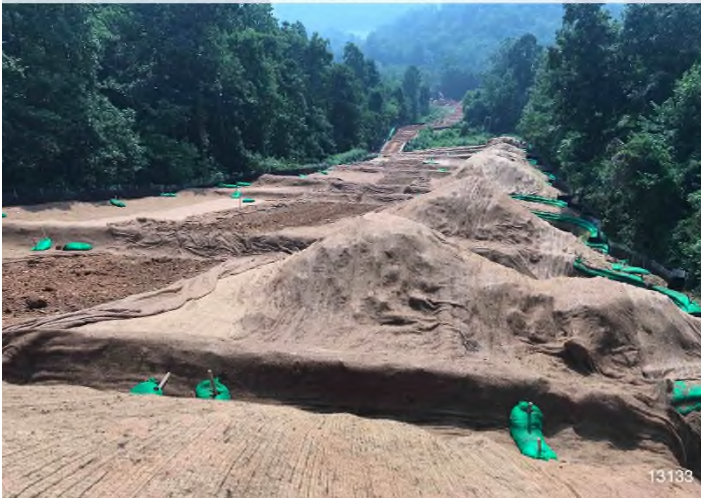
**Figure 3: STA 13133+00** – Controls in place and functioning properly.

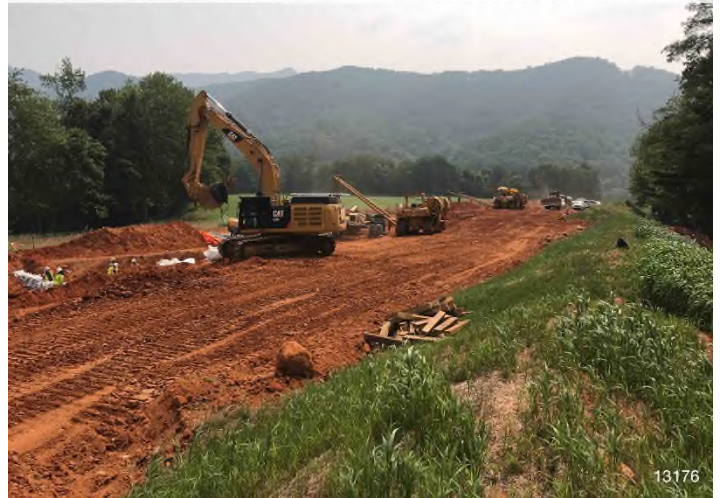
**Figure 4: STA 13176+00** – Controls in place and functioning properly.
