## FIELD INSPECTION REPORT

| Project Name: | Mountain Valley Pipeline | Inspector: | Marshall Willis |
| Spread H:<br>Montgomery County | STA 12119+17 – 12190+85<br>MVP-MN-273/274 | Weather: | Dry |

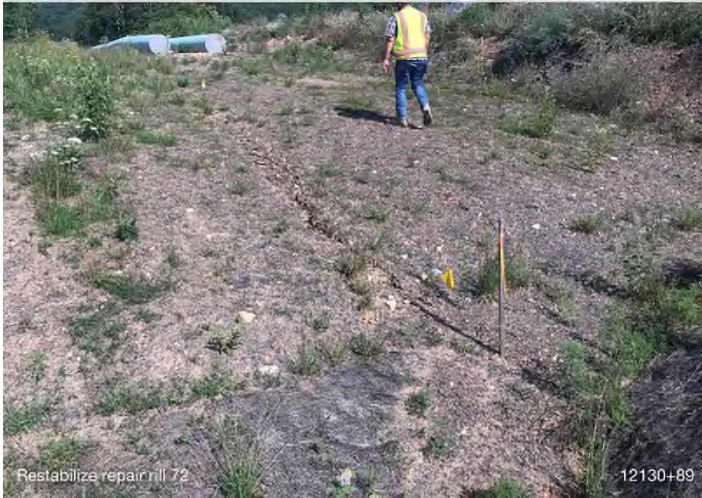
- STA 12130+89: Re-stabilization needed.

**Figure 1: STA 12130+89** – Re-stabilization needed.

**Recommended Corrective Action:** Maintain and install all controls per the approved PSS&S.

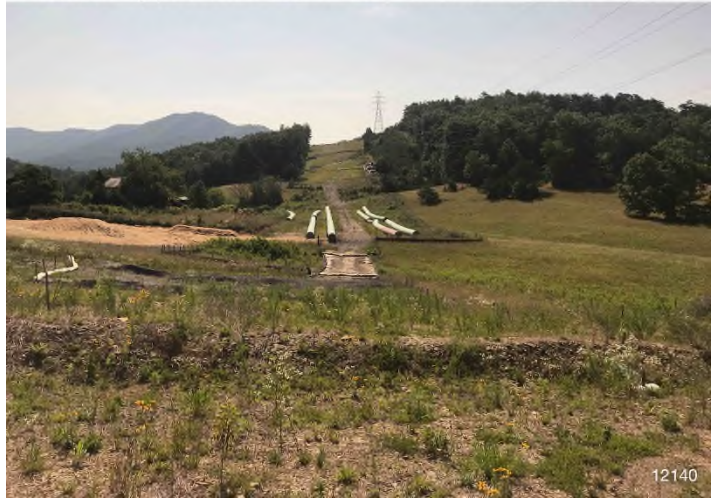
**Figure 2: STA 12140+00** – Controls in place and functioning properly.

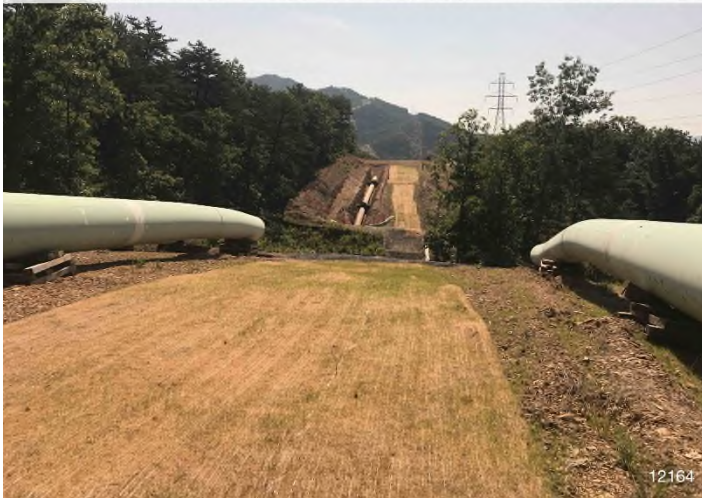
**Figure 3: STA 12164+00** – Controls in place and functioning properly.

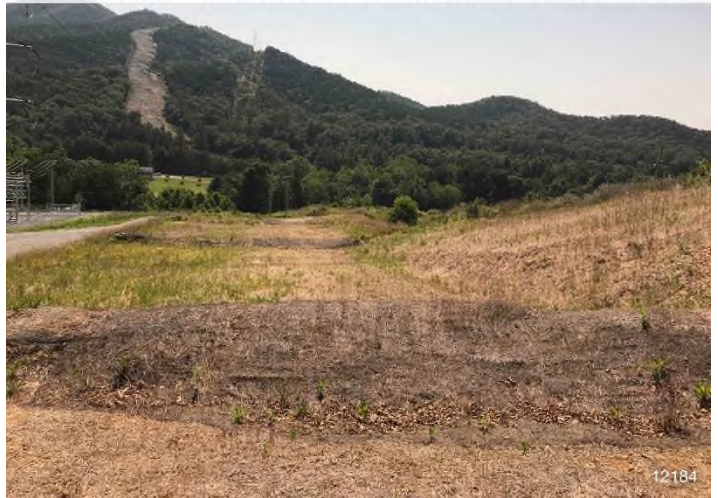
**Figure 4: STA 12184+00** – Controls in place and functioning properly.
