FIELD INSPECTION REPORT

Project Name:	Mountain Valley Pipeline	Inspector:	Marshall Willis
Inspection Date:	Wednesday, July 14, 2021	Project Contact:	Brian Clauto, Cory Chalmers
Spread H: Montgomery County	STA 12071+80 – 12119+17 MVP-MN-270	Weather:	Wet

FIELD INSPECTION PHOTO LOG

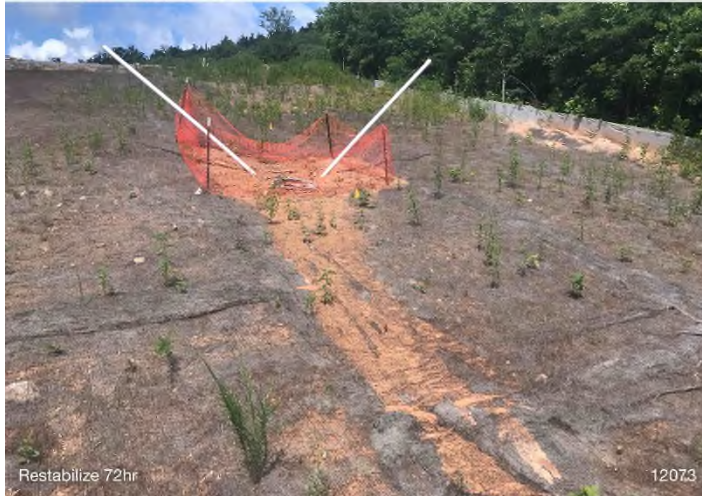
Figure 1: STA 12073+00 – Re-stabilization needed.

Recommended Corrective Action: Maintain and install all controls per the approved PSS&S.

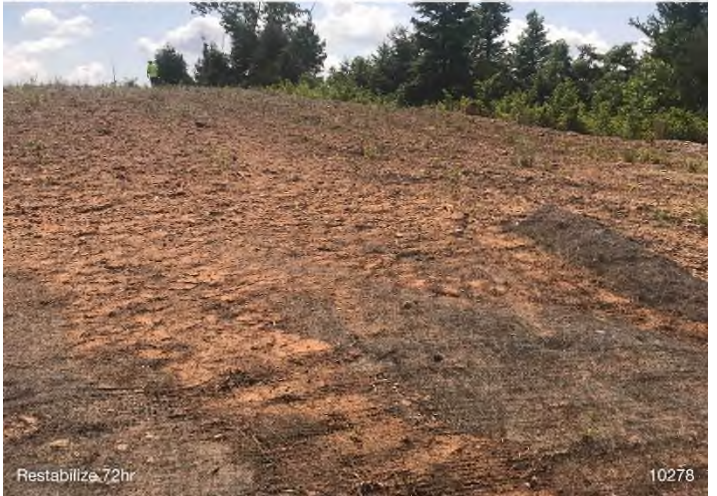
Figure 2: STA 12078+00 – Re-stabilization needed.

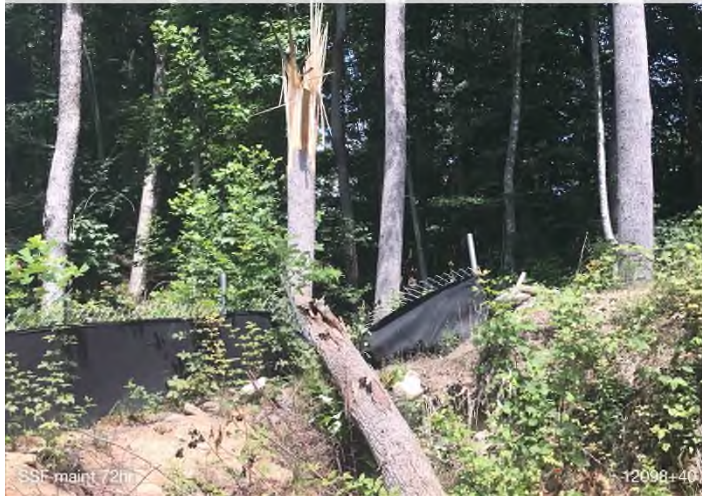
Figure 3: STA 12098+40 – Repair SSF.

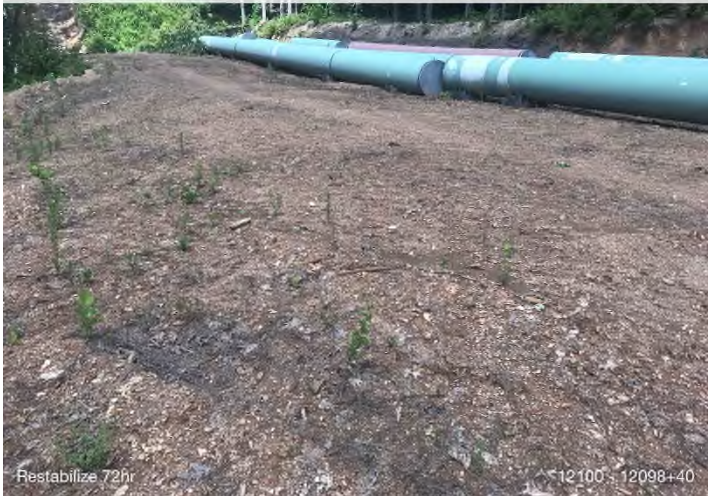
Figure 4: STA 12098+40 to 12100+00 – Re-stabilization needed.

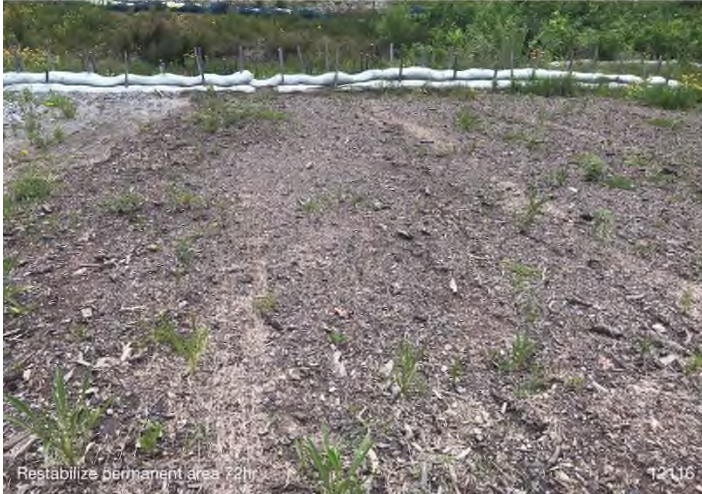
Figure 5: STA 12116+00 – Re-stabilization needed.
