## FIELD INSPECTION REPORT

<b>Project Name:</b>	Mountain Valley Pipeline	<b>Inspector:</b>	Marshall Willis
<b>Inspection Date:</b>	Wednesday, July 7, 2021	<b>Project Contact:</b>	Brian Clauto, Cory Chalmers
<b>Spread H: Franklin County</b>	STA 13140+00 – 13195+50 MVP-FR-292 MVP-FR-292.01	<b>Weather:</b>	Dry

## FIELD INSPECTION PHOTO LOG

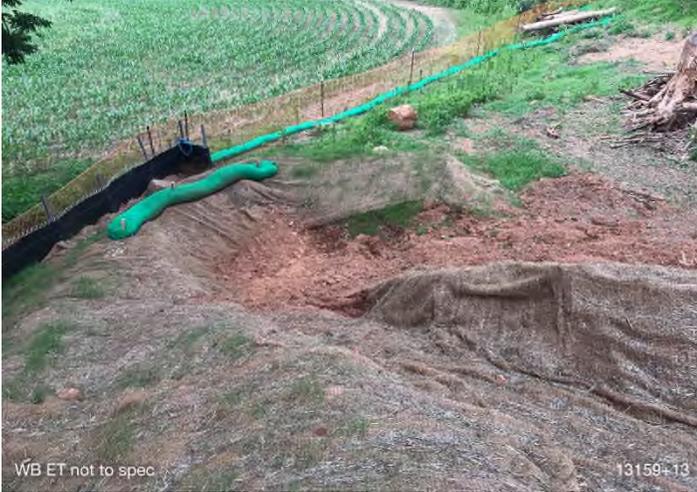
- STA 13159+13: No outlet provided for ROW Diversion (RWD) per VESCH 3.11.
- STA 13187+00: P1 undermined.

**Figure 1: STA 13159+00** – No outlet provided for RWD.

**Recommended Corrective Action:** Provide waterbar outlet with sump and end treatment at RWD at STA 13159+13 and at all of the locations where RWDs cross the ROW.

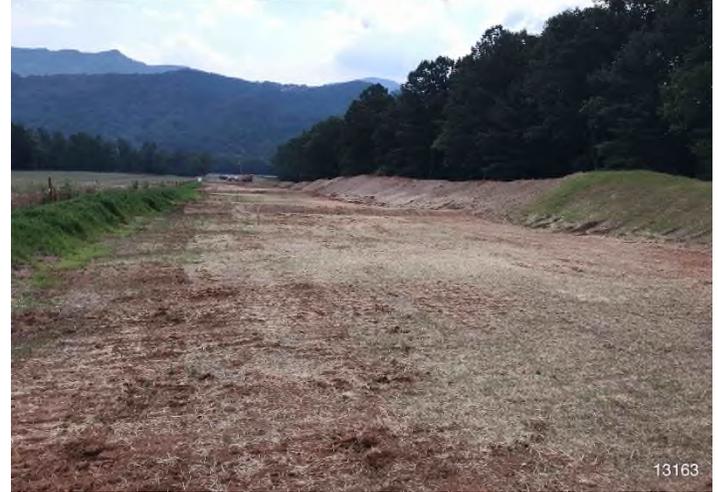
**Figure 2: STA 13163+00** – Controls in place and functioning properly.

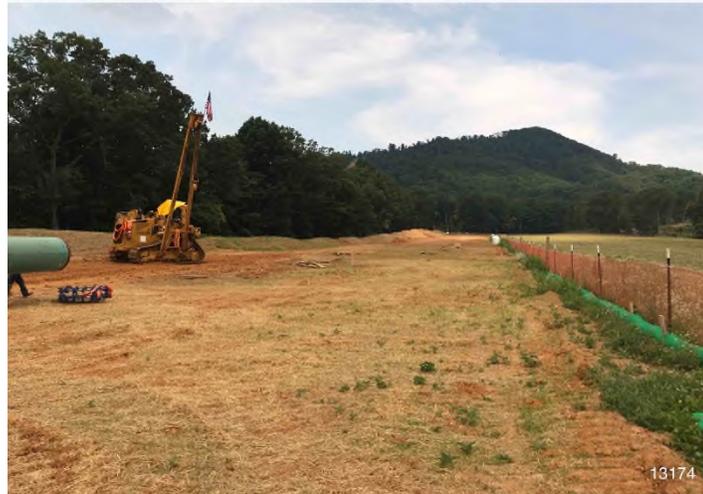
**Figure 3: STA 13174+00** – Controls in place and functioning properly.

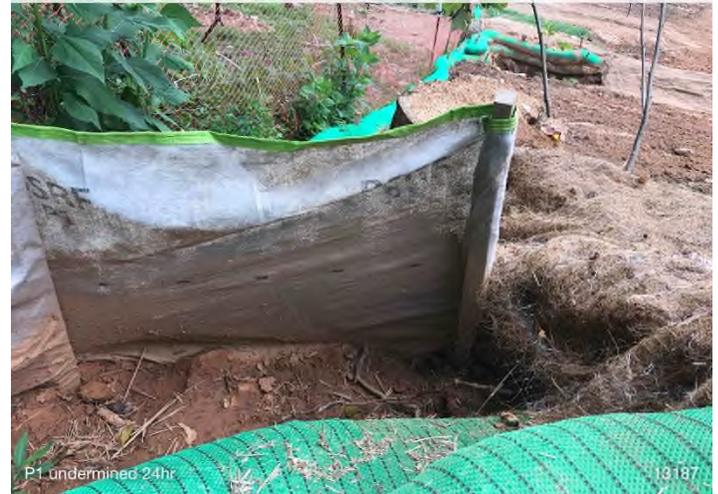
**Figure 4: STA 13187+00** – P1 undermined.
