## FIELD INSPECTION REPORT

<b>Project Name:</b>	Mountain Valley Pipeline	<b>Inspector:</b>	Marshall Willis
<b>Inspection Date:</b>	Friday, July 2, 2021	<b>Project Contact:</b>	Brian Clauto, Cory Chalmers
<b>Spread H: Franklin County</b>	STA 13410+00 – 13415+50 STA 13337+13 – 13348+50 STA 13316+13 – 13306+16 STA 13265+00 – 13263+50	<b>Weather:</b>	Wet

## FIELD INSPECTION PHOTO LOG

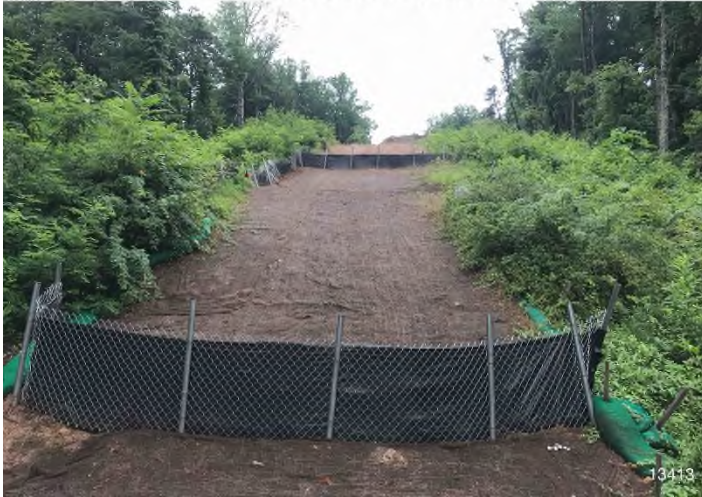
**Figure 1: STA 13413+00** – Controls in place and functioning properly.

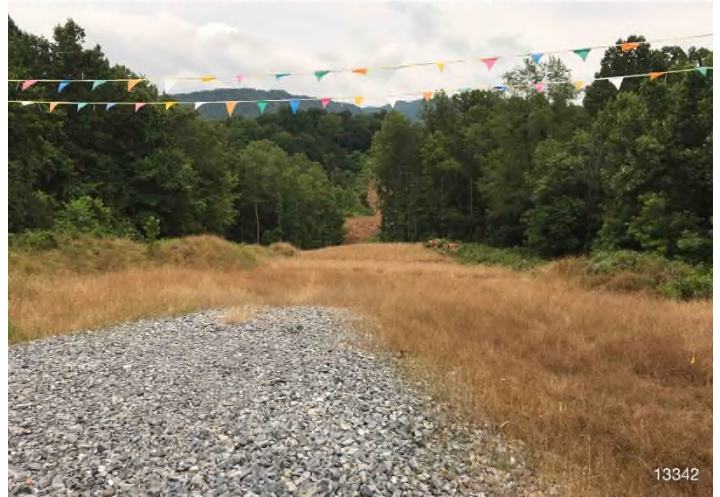
**Figure 2: STA 13342+00** – Controls in place and functioning properly.

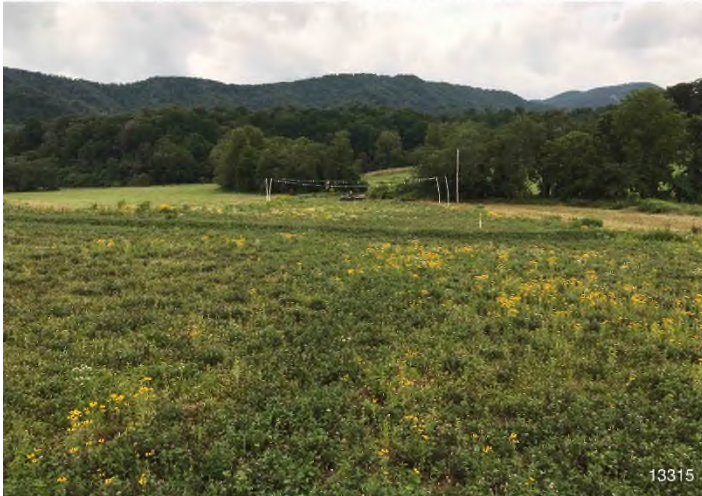
**Figure 3: STA 13315+00** – Controls in place and functioning properly.

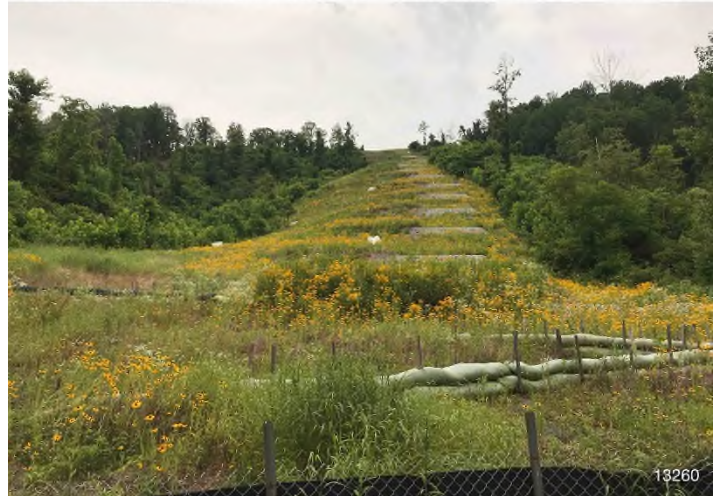
**Figure 4: STA 13260+00** – Controls in place and functioning properly.
