## FIELD INSPECTION REPORT

Project Name:	Mountain Valley Pipeline	Inspector:	Marshall Willis
Inspection Date:	Thursday, July 1, 2021	Project Contact:	Brian Clauto, Cory Chalmers
Spread I: Franklin County	STA 14062+17 – 14132+30 MVP-FR-309.05/309	Weather:	Dry

## FIELD INSPECTION PHOTO LOG

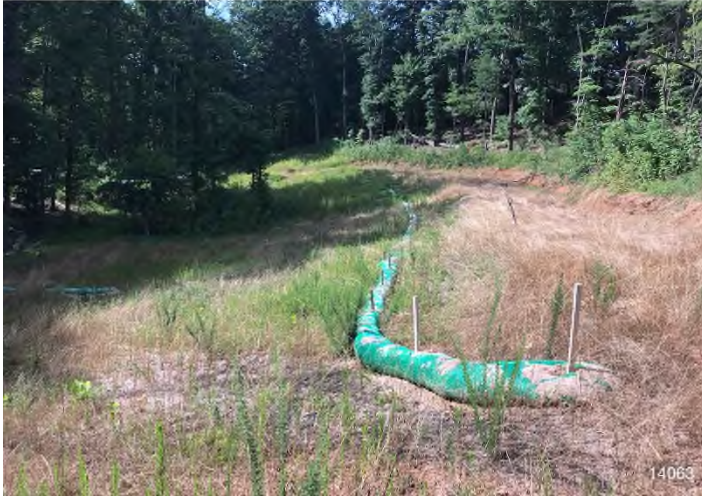
**Figure 1: STA 14063+00** – Controls in place and functioning properly.

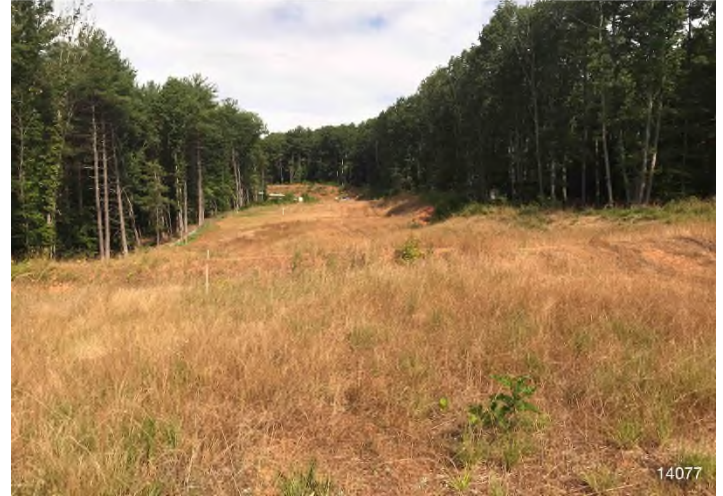
**Figure 2: STA 14077+00** – Controls in place and functioning properly.

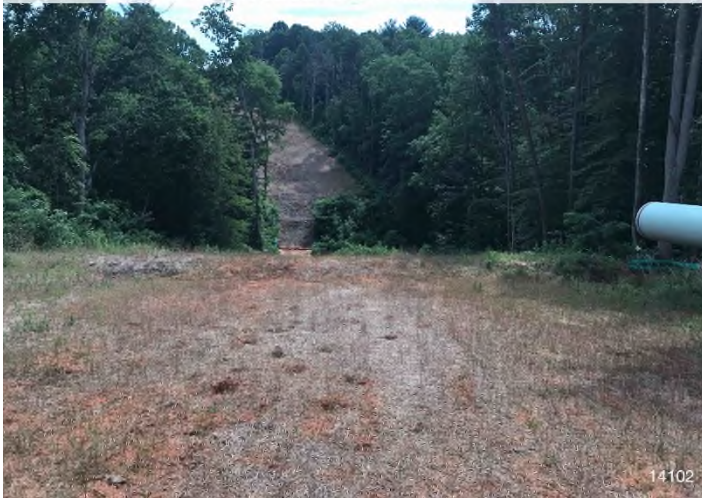
**Figure 3: STA 14102+00** – Controls in place and functioning properly.

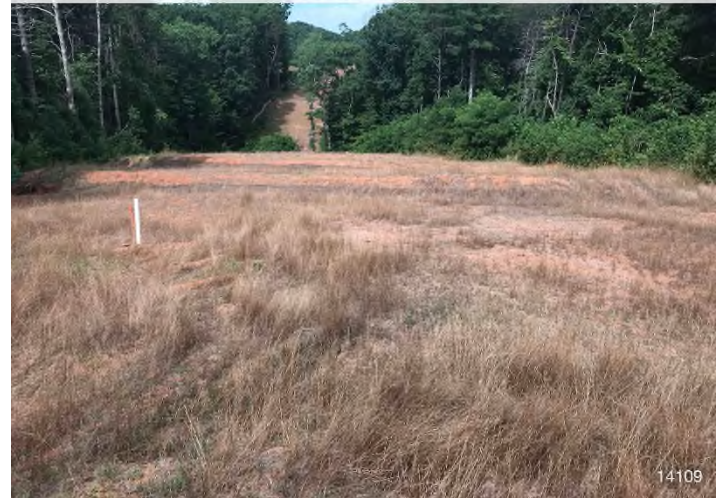
**Figure 4: STA 14109+00** – Controls in place and functioning properly.
