## FIELD INSPECTION REPORT

<b>Project Name:</b>	Mountain Valley Pipeline	<b>Inspector:</b>	Marshall Willis
<b>Inspection Date:</b>	Tuesday, June 29, 2021	<b>Project Contact:</b>	Brian Clauto, Cory Chalmers
<b>Spread H:</b> Roanoke County Franklin County	STA 12724+88 – 12742+00 STA 13138+00 – 13145+00 MVP-RO-281/281.01 MVP-FR-291/292	<b>Weather:</b>	Dry

## FIELD INSPECTION PHOTO LOG

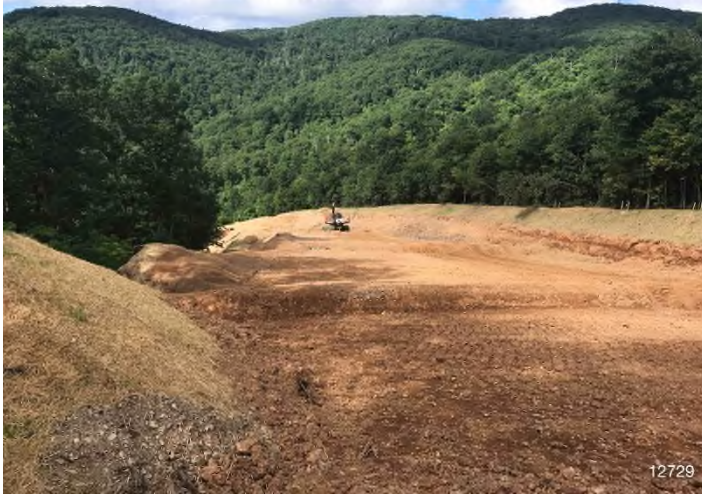
**Figure 1: STA 12729+00** – Controls in place and functioning properly.

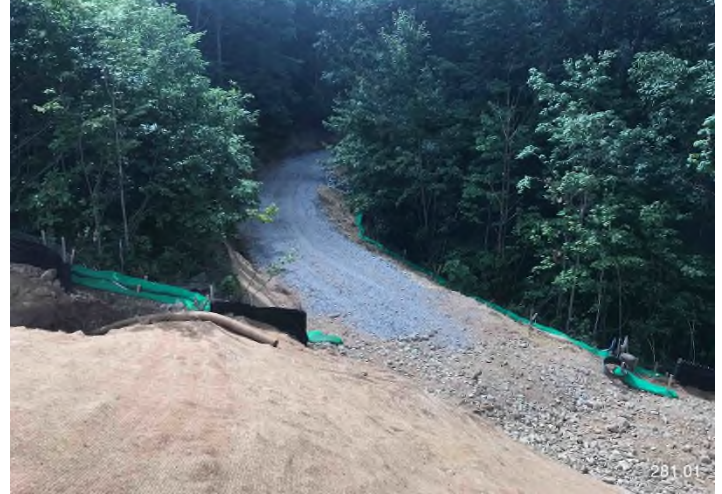
**Figure 2: MVP-RO-281.01** – Controls in place and functioning properly.

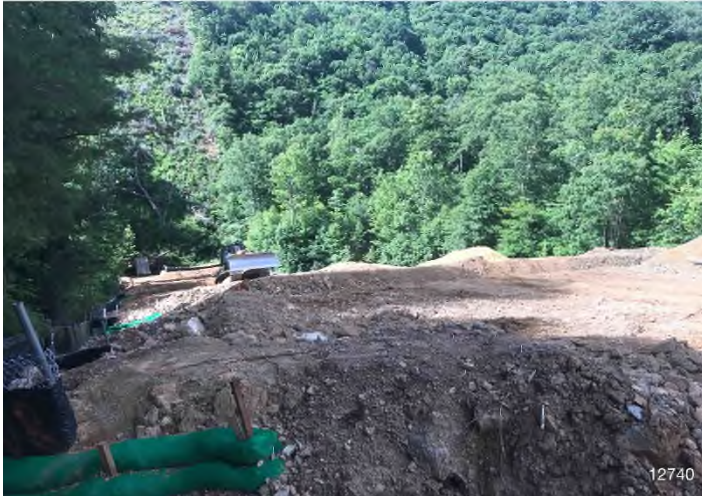
**Figure 3: STA 12740+00** – Controls in place and functioning properly.

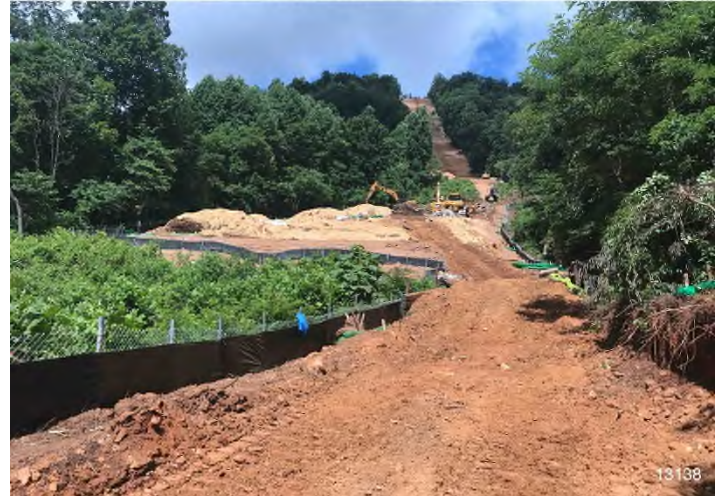
**Figure 4: STA 131378+00** – Controls in place and functioning properly.
