FIELD INSPECTION REPORT

Project Name:	Mountain Valley Pipeline	Inspector:	Matthew Grant
Inspection Date:	Monday, August 2, 2021	Project Contact:	Brian Clauto
Spread H: Roanoke	AR RO 281, 280 St 12727+94-12703	Weather:	Dry

FIELD INSPECTION PHOTO LOG

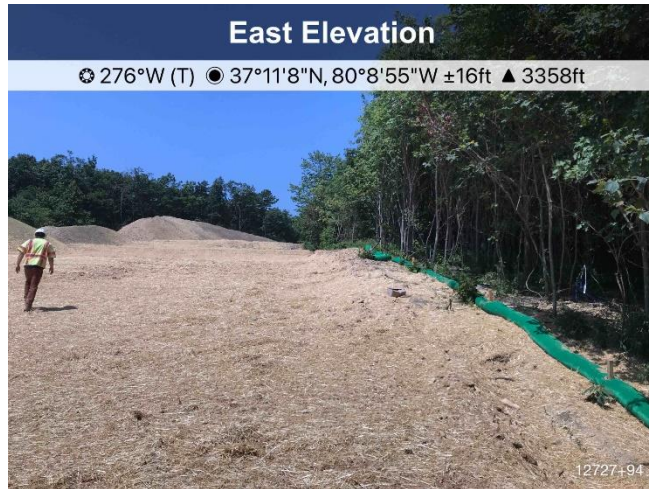
- Figure 1: St12727+94 area has been mulched and seeded.

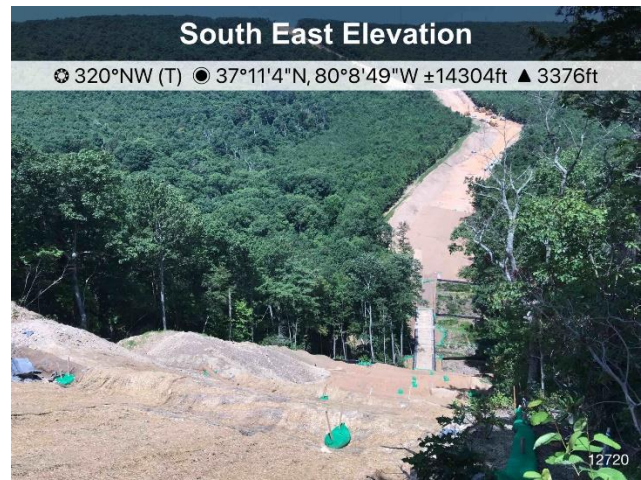
- Figure 2: St12720 temporary waterbars in place and stockpiles have been stabilized.

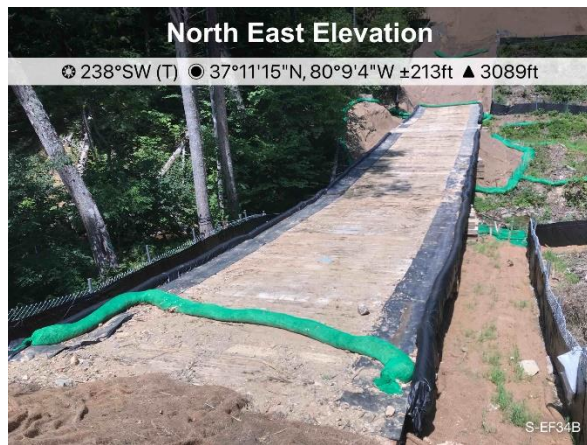
- Comments: Inspected the following resources: S-EF34B
- ECD's that have been installed at the resource appeared to be functioning.

- Figure 3: Designated crossing S-EF34B, ECD's are in place.

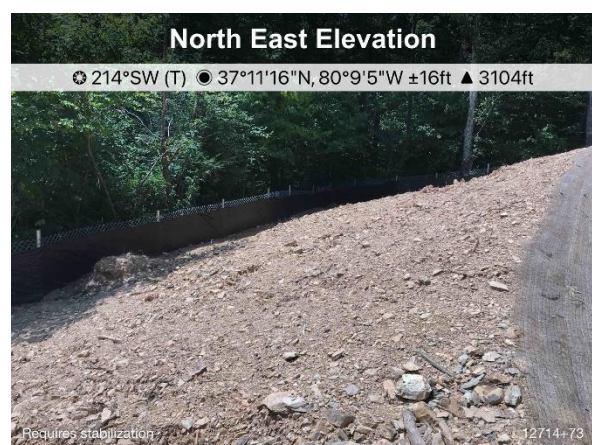
- St12714+73 area lacks stabilization

- Figure 4: St12714+73 area requires stabilization

Recommended Corrective Action: Maintain and install all controls per the approved PSS&S.

Deadline: Within 24-Hour of Notification
