## FIELD INSPECTION REPORT

<b>Project Name:</b>	Mountain Valley Pipeline	<b>Inspector:</b>	Marshall Willis
<b>Inspection Date:</b>	Friday, August 27, 2021	<b>Project Contact:</b>	Brian Clauto, Cory Chalmers
<b>Spread H: Montgomery County</b>	STA 12420+32 – 12443+00 MVP-RO-279 MVP-RO-279.02	<b>Weather:</b>	Dry

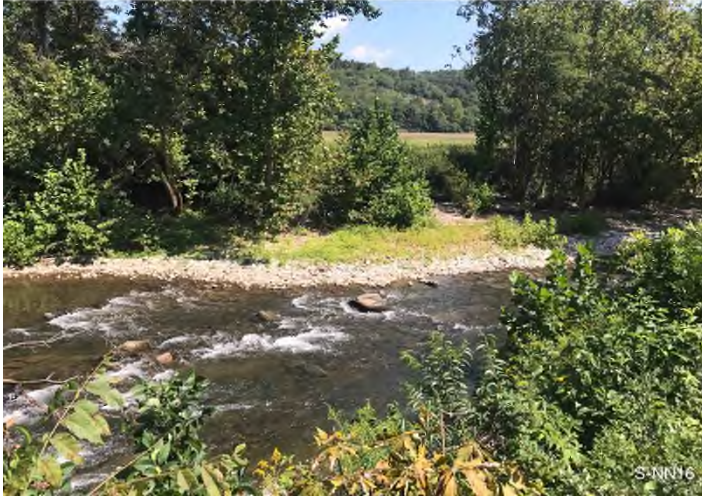
**Figure 1: Stream S-NN16** – Controls in place and functioning properly around Roanoke River.

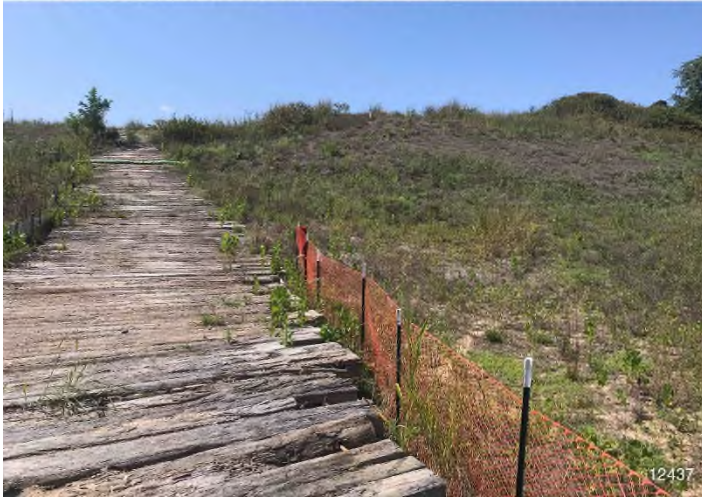
**Figure 3: STA 12437+00** – Controls in place and functioning properly.

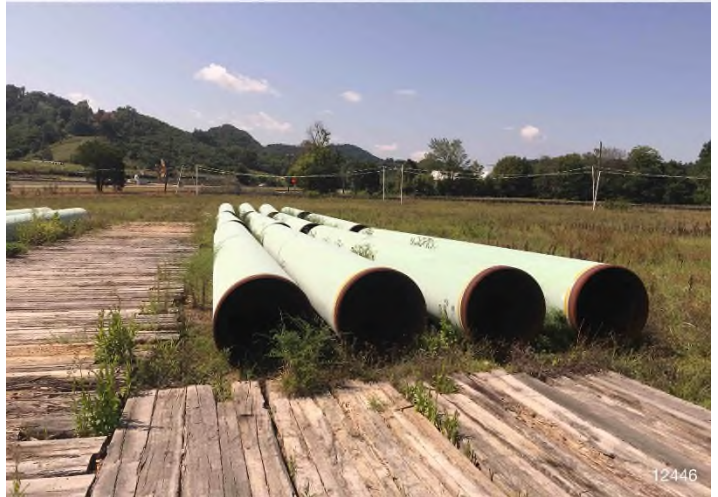
**Figure 4: STA 12446+00** – Controls in place and functioning properly.
