## FIELD INSPECTION REPORT

Project Name:	Mountain Valley Pipeline	Inspector:	Marshall Willis
Inspection Date:	Thursday, August 26, 2021	Project Contact:	Brian Clauto, Cory Chalmers
Spread H: Roanoke County	STA 12888+32 – 12928+00 MVP-RO-286	Weather:	Dry

## FIELD INSPECTION PHOTO LOG

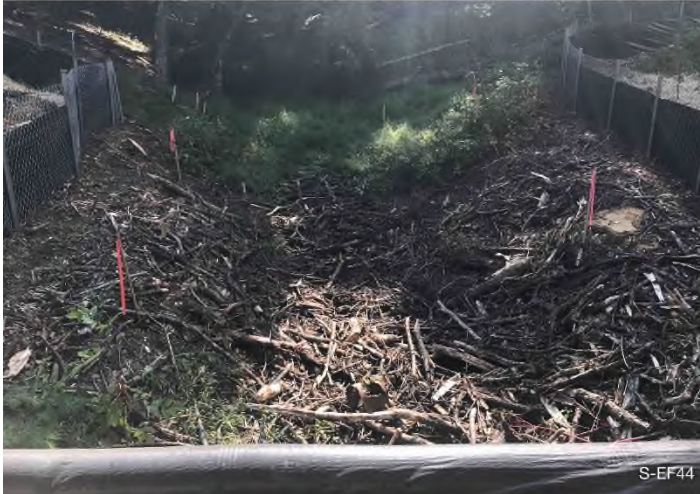
**Figure 1: Stream S-EF44** – Controls in place and functioning properly.

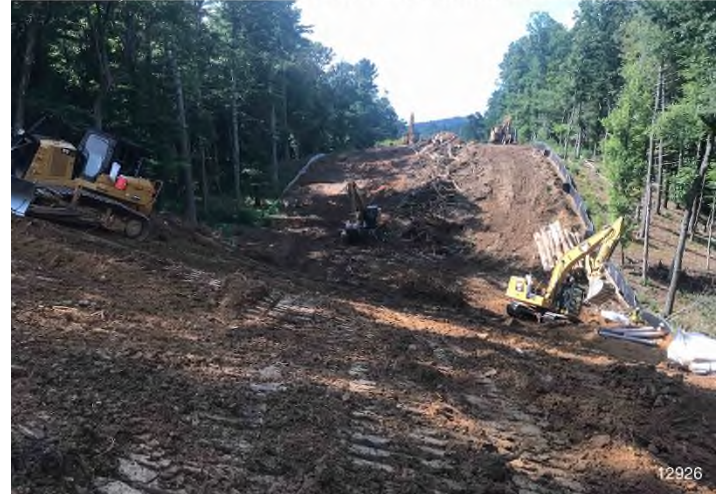
**Figure 2: STA 12926+00** – Controls in place and functioning properly.

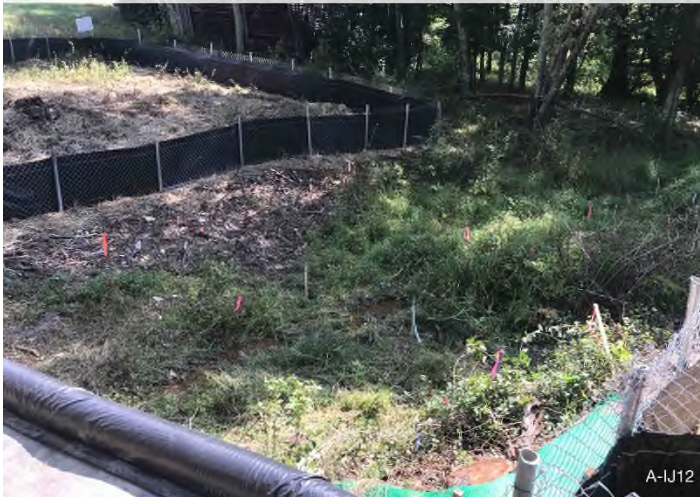
**Figure 3: Stream S-IJ12** – Controls in place and functioning properly.

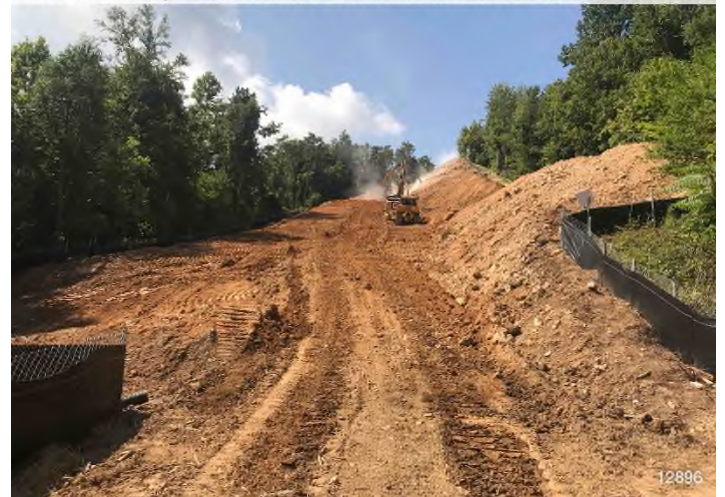
**Figure 4: STA 12896+00** – Controls in place and functioning properly.
