## FIELD INSPECTION REPORT

<b>Project Name:</b>	Mountain Valley Pipeline	<b>Inspector:</b>	Marshall Willis
<b>Inspection Date:</b>	Tuesday, August 17, 2021	<b>Project Contact:</b>	Brian Clauto, Cory Chalmers
<b>Spread H: Roanoke County</b>	STA 12945+00 – 12957+00 STA 12970+00 – 12980+00 MVP-RO-288/287	<b>Weather:</b>	Rainy

## FIELD INSPECTION PHOTO LOG

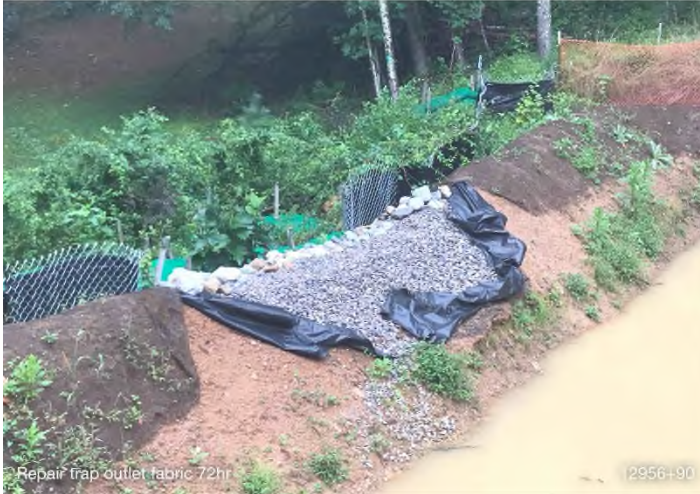
- STA 12956+00: Maintain sediment trap outlet fabric.

**Figure 1: STA 12956+00** – Maintain sediment trap outlet fabric.

**Recommended Corrective Action:** Maintain and install all controls per the approved PSS&S.

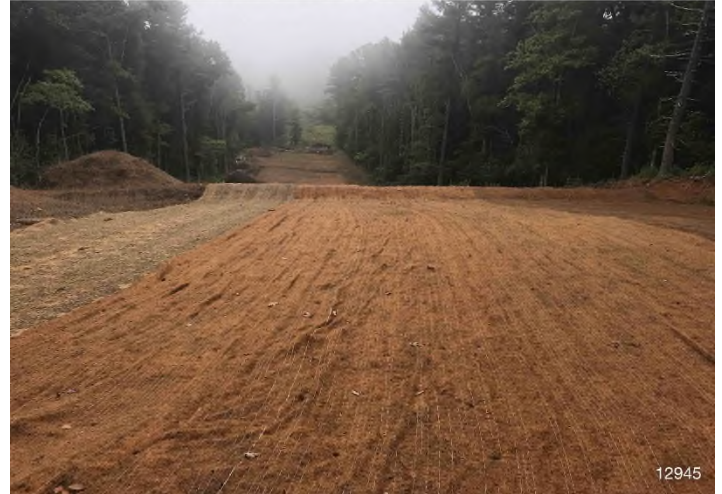
**Figure 2: STA 12945+00** – Controls in place and functioning properly. Area stabilized with erosion matting.

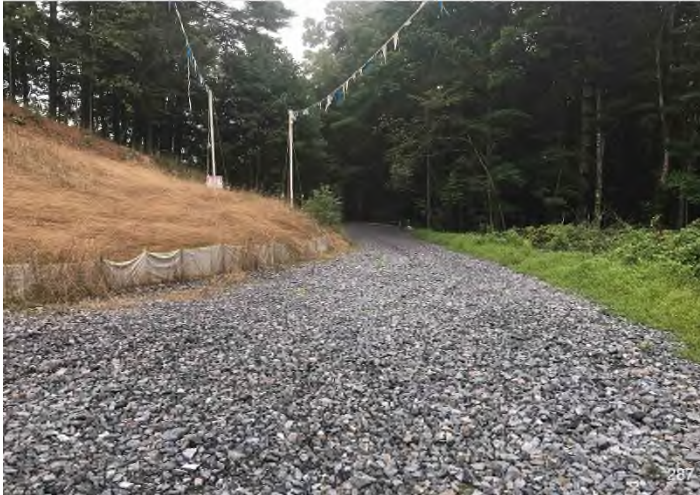
**Figure 3: MVP-RO-287** – Controls in place and functioning properly.

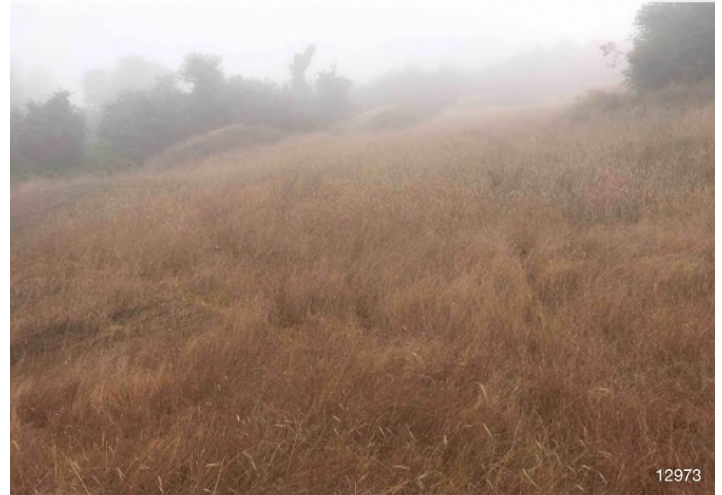
**Figure 4: STA 12973+00** – Controls in place and functioning properly.
