*Living Shoreline  
Sea-Level Resiliency:  
Performance and Adaptive  
Management of Existing Sites*

# Living Shoreline Sea-Level Resiliency: Performance and Adaptive Management of Existing Sites Summary Report

Shoreline Studies Program  
Virginia Institute of Marine Science  
William & Mary

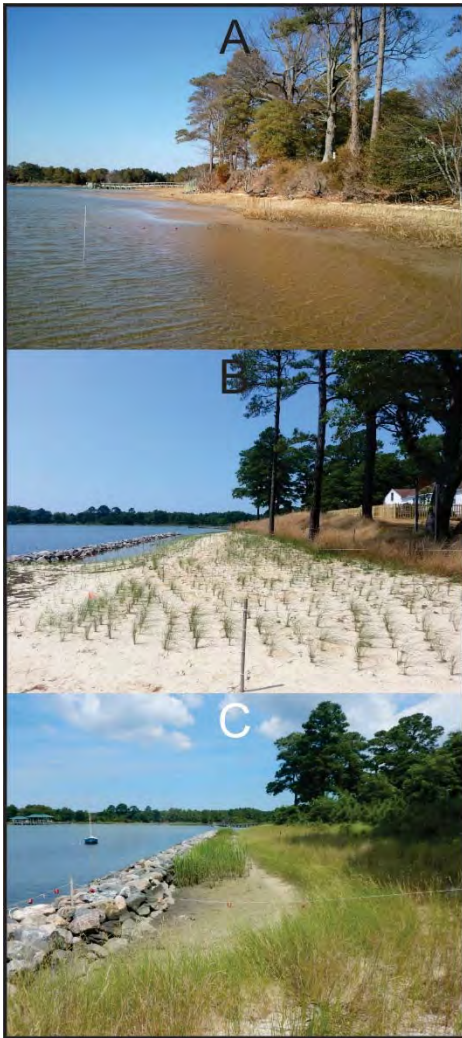
Figure 4-2-6. Photos of reach 3 at Occohannock on the Bay A), before construction (March 2013), B) after construction (March 2013), C) after planting (May 2013), C) after 5 years.

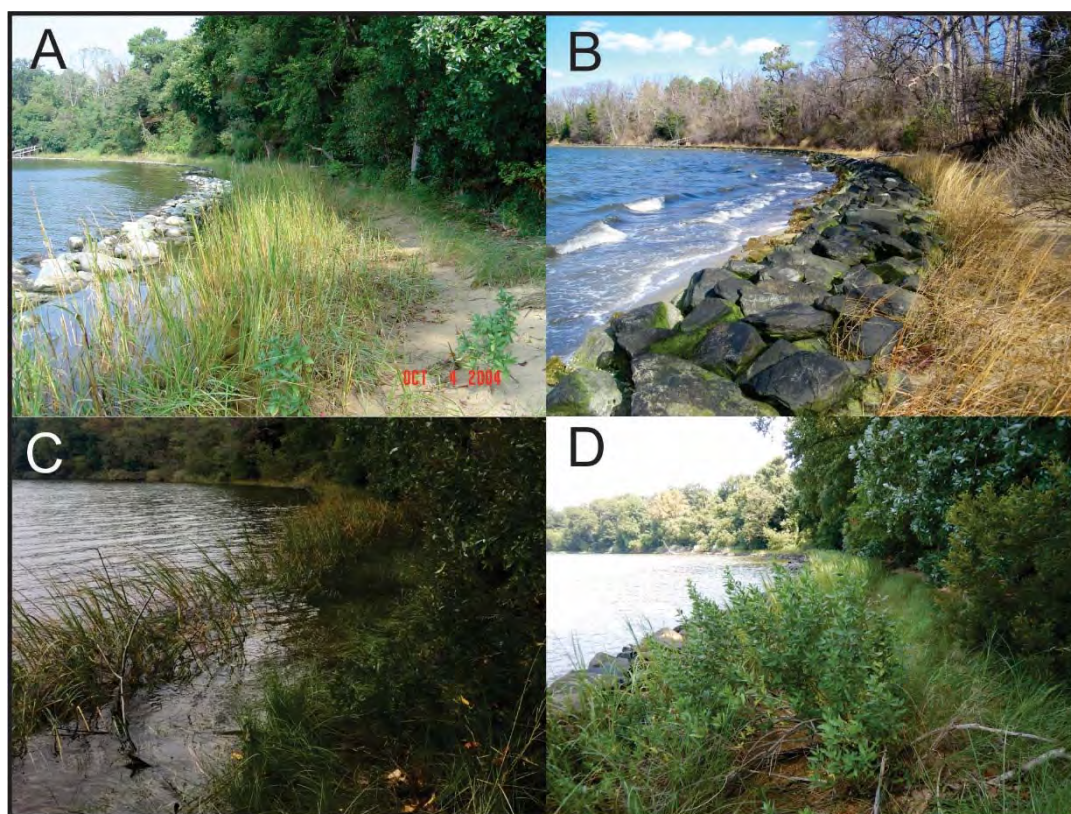
Access to the site is easiest down the hill to Sill #1. A series of photos show how that section of the project has evolved over time Figures 4-3-4A to 4-3-4D. Two years after construction, the low marsh is relatively intact. Tree limbs along the base of the bank had been cut back during construction

and began to grow back over time often shading the marsh. Elevation changes allowed salt bush and *Phragmites* to become established (Figure 4-3-4D).

Figure 4-3-4. Photos of St. Mary's A) two years after construction (4 Oct 2004), B) 11 years after construction (1 Feb 2013), C) 15 years after construction (13 Oct 2017), D) 16 years after construction (15 Aug 2018).

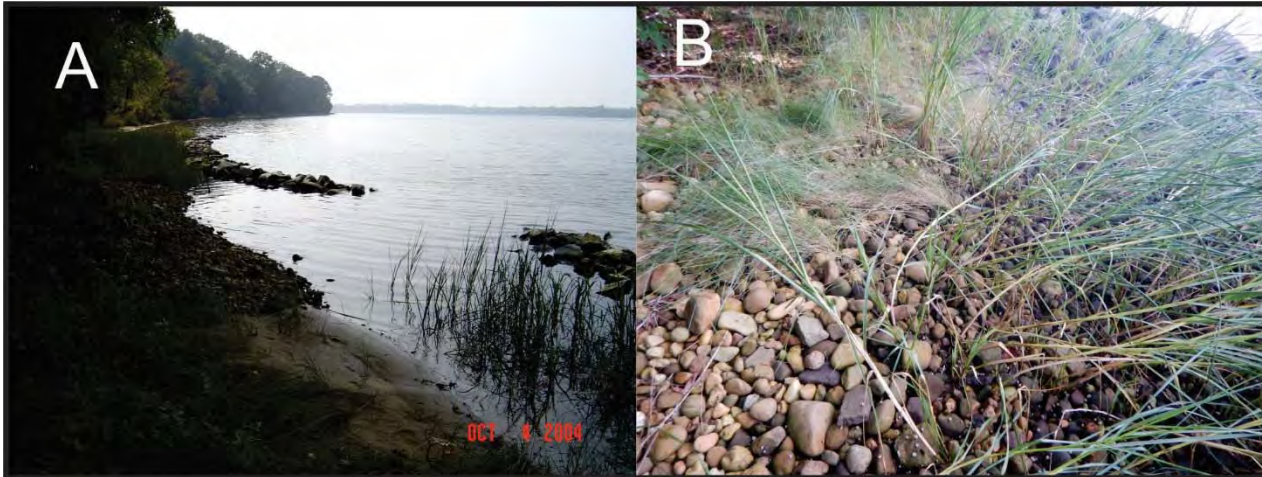
An element to the original project was experimenting with different type of sill (windows) openings in order to reduce sand attached maintain “flushing” behind the sill (Hardaway et al., 2007). In Window #1 the stable cobble substrate allowed low marsh to become established (Figure 4-3-5A and Figure 4-3-5B).

Figure 4-3-5. Gap at St. Mary's A) two years after construction, B) 16 years after construction (15 Aug 2018).

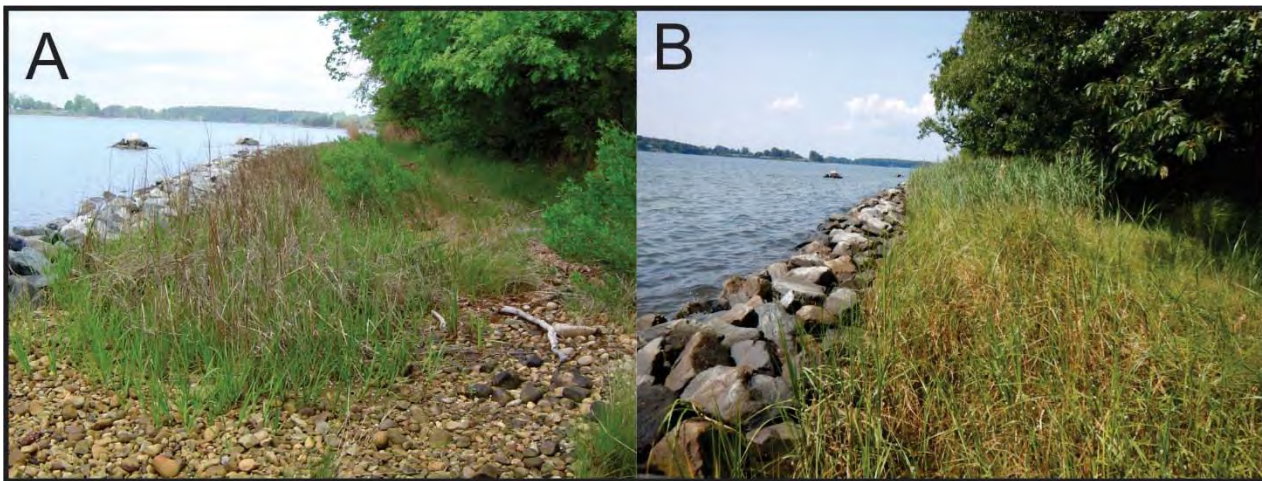
The evolution of the site vegetation over time can be seen in along Sill #7 looking north toward Window #8 with the offshore breakwater defined by two sentinel stones (Figure 4-3-6A). In 2007, the high and low marsh fringe is intact with a few salt bushes coming in and modest tree limb cover. By 2018 the low marsh in the foreground is very robust, but *Phragmites* has overcome both species farther along shore and significant limb growth occurs such that the shading inhibits any vegetation growth under that canopy.

Figure 4-3-6. Gap and sill at St. Mary's A) five years after construction (9 May 2007), B) 16 years after construction (15 Aug 2018).

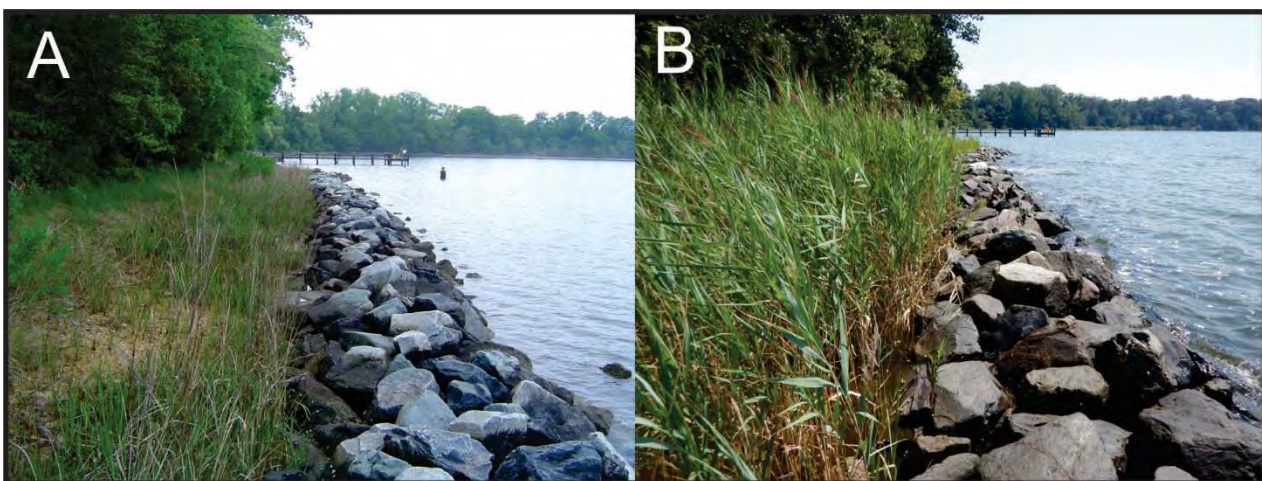
More evidence of vegetation change is seen from the same point but looking south, the same survey pier can be seen. In 2007, (Figure 4-3-7A), 5 years after construction, the marsh fringe is robust with both species intact, an occasional salt bush and a few slightly overhanging limbs. By 2018, (Figure 4-3-7B), *Phragmites* has completely taken over this section of marsh with heavy overhanging trees.

Figure 4-3-7. Sill at St. Mary's A) five years after construction (9 May 2007), B) 16 years after construction (15 Aug 2018). *Phragmites* has colonized behind the structures.

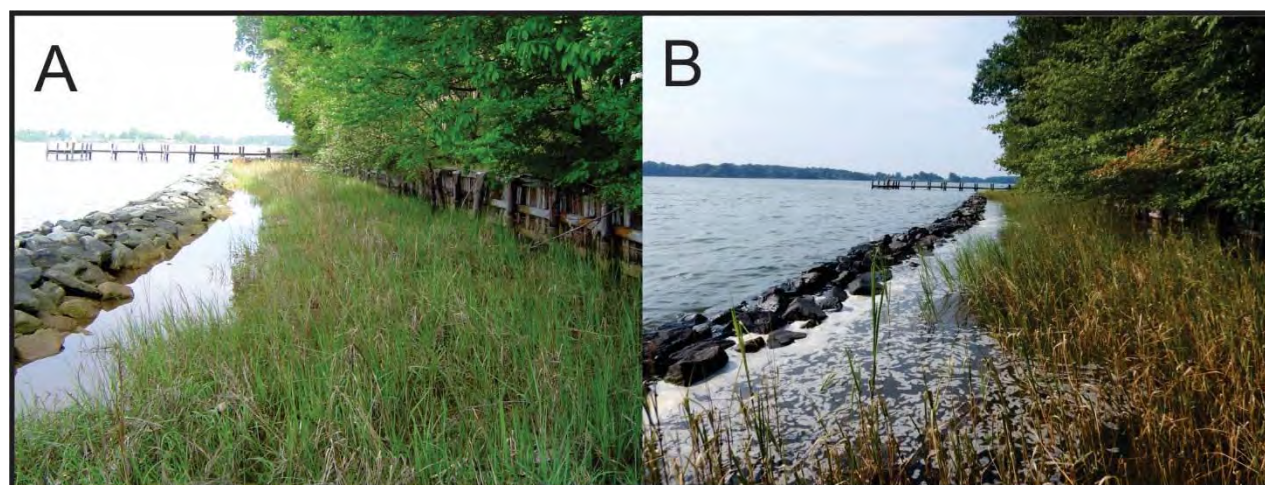
This was not the case everywhere especially in front of the one segment of existing bulkhead where on low marsh was planted in 2002, and by 2007 had become well established (Figure 4-3-8A). The fringe remained robust in 2018 with a few overhanging limbs but no *Phragmites* (Figure 4-3-8B). *Phragmites* does not tolerate regular tidal flooding in brackish water. Black needle rush is another species that has colonized St. Mary's shoreline (Figure 4-3-9A); it is often found with the intertidal snail (*Littorina littorina*). It occupies the zone where high and low marsh transition.

Figure 4-3-8. Sill backed by bulkhead at St. Mary's A) five years after construction (9 May 2007), B) 16 years after construction (15 Aug 2018). No change in the plants occurred.

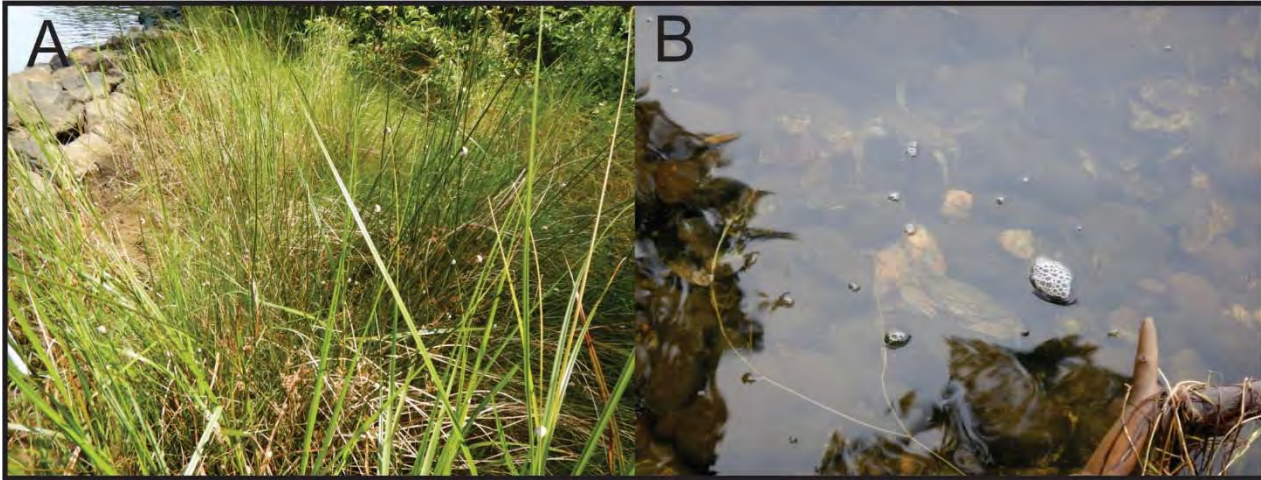
From a faunal habitat perspective, the St. Mary's City project had shown significant fish and crab usage (Hardaway et al., 2007). Qualitatively, this does appear to continue (Figure 4-3-9B). The vegetative communities may have changed slightly, but fish function appears to continue. The one stable element in the sill system is the rock sill itself. Even if it becomes submerged with SLR it will remain a fish haven.

Figure 4-3-9. Sill at St. Mary's (15 Aug 2018) A) Needlerush has colonized some sections, B) blue crabs are prevalent along the shore.

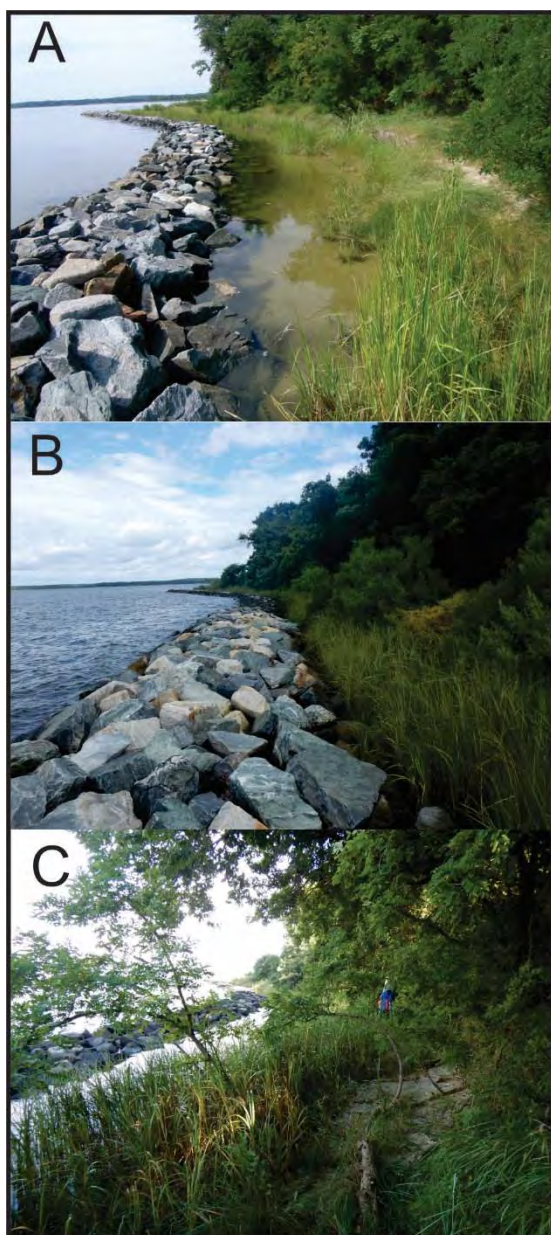
Sill #4 is shown in 2008 and 2018 (Figure 4-4-4A and Figure 4-4-4B). In 2008, 9 years after construction, the lower limit of low marsh had receded due to gradient decrease behind the lower central weir section of the sill and tree limbs were shading the backshore/base of bank area. Ten years later and 19 years old, Sill #4 still has robust low marsh along the central weir section and behind the elevated sill as seen in the foreground of Figure 4-4-4B. However evident along with very dense tree growth across the back shore that inhibits grass growth (Figure 4-4-4C) but does not really impact the overall shore protection capability.

Figure 4-4-4. Photos of Sill #4 at Jefferson Patterson on 20 Aug 2018 A) along the low weir section, B) higher section of sill, C) along the backshore.

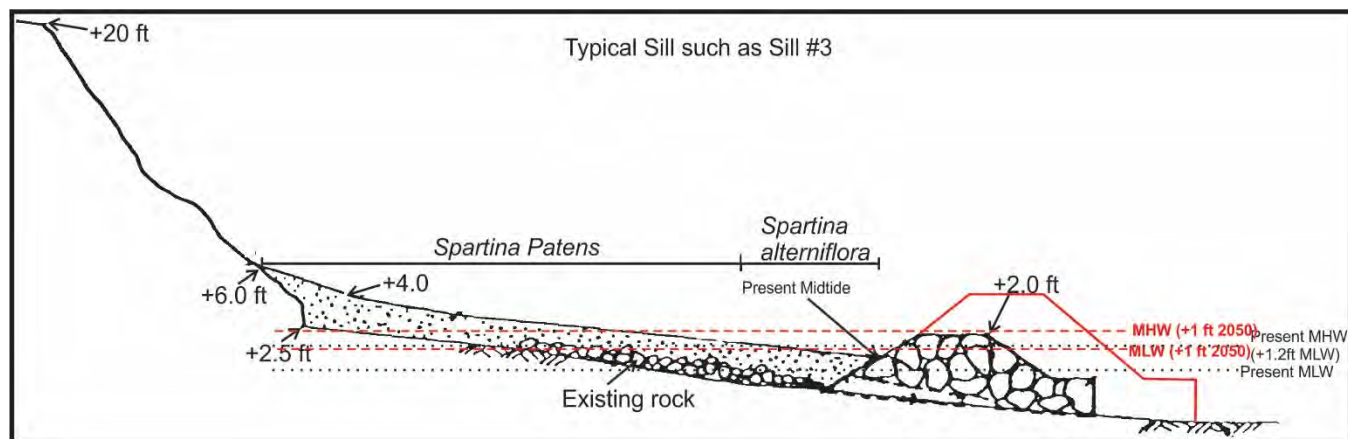
With a one-foot rise in sea level, *S. alterniflora* would migrate updrift leaving a wider non-vegetated intertidal zone. The sill would be submerged at high water (Figure 5-4-1) The extensive *Phragmites* already covers much of the sill system and would persist even with a 2-foot rise in sea level. This system would be a good candidate site for just adding rock to the sill to protect the base of bank from wave attack (Figure 5-4-2). Adding sand could be done too but at additional costs. Again these options are viable because of barge access for construction.

Figure 5-4-2. Sea-level rise scenarios modeled at Jefferson Patterson. Also shown is the adaptive management strategy coastal resiliency of the living shoreline. Rock could be added to the sill to protect the base of the bank.
