FIELD INSPECTION REPORT

Project Name:	Mountain Valley Pipeline	Inspector:	Marshall Willis
Inspection Date:	Thursday, September 9, 2021	Project Contact:	Brian Clauto, Cory Chalmers
Spread H: Montgomery County	STA 12445+86 – 12485+00 MVP-MLV-AR-28	Weather:	Rainy

FIELD INSPECTION PHOTO LOG

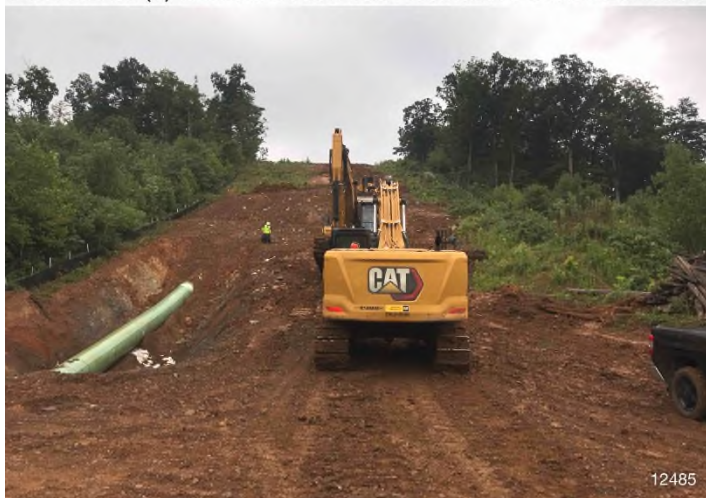
Figure 1: STA 12485+00 – Controls in place and functioning properly.

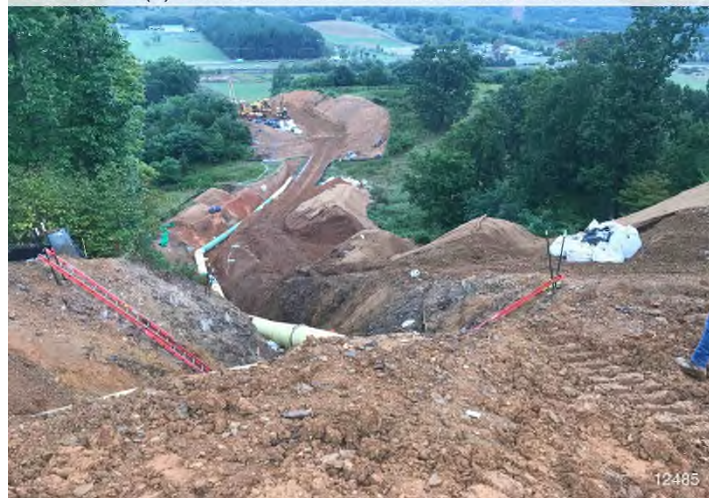
Figure 2: STA 12480+00 – Controls in place and functioning properly.

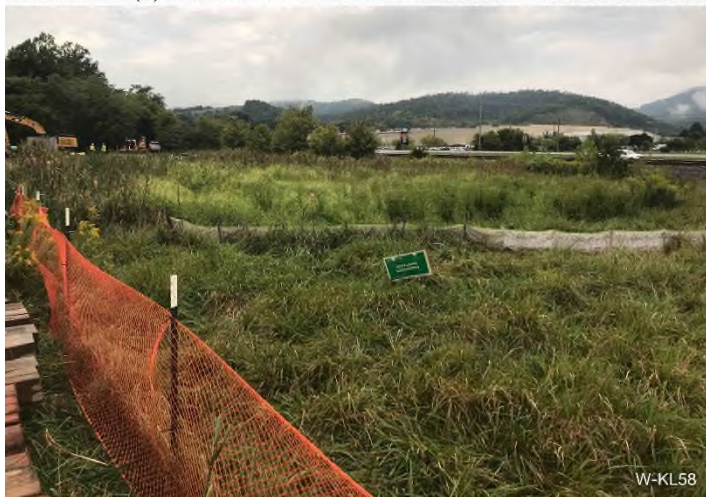
Figure 3: Wetland W-KL58– Controls in place and functioning properly around wetland W-KL58.
