FIELD INSPECTION REPORT

Project Name:	Mountain Valley Pipeline	Inspector:	Marshall Willis
Inspection Date:	Tuesday, September 7, 2021	Project Contact:	Brian Clauto, Cory Chalmers
Spread H: Franklin County Montgomery County	STA 13141+61 – 13195+79 STA 12119+17 – 12140+00 MVP-FR-292/292.01 MVP-MN-272	Weather:	Dry

FIELD INSPECTION PHOTO LOG

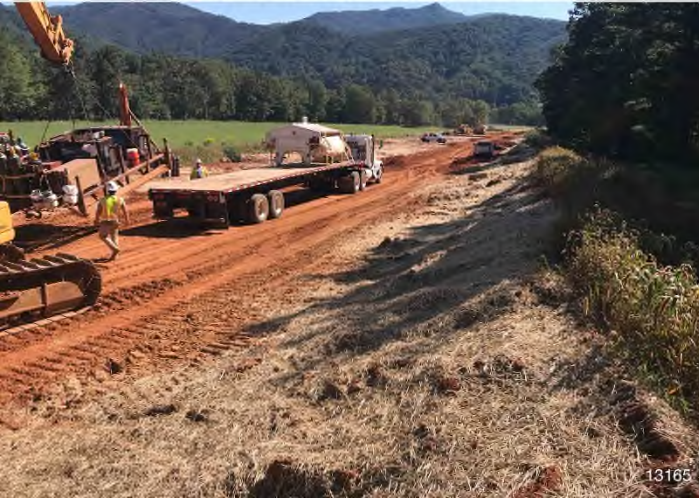
Figure 1: STA 13165+00 – Controls in place and functioning properly.

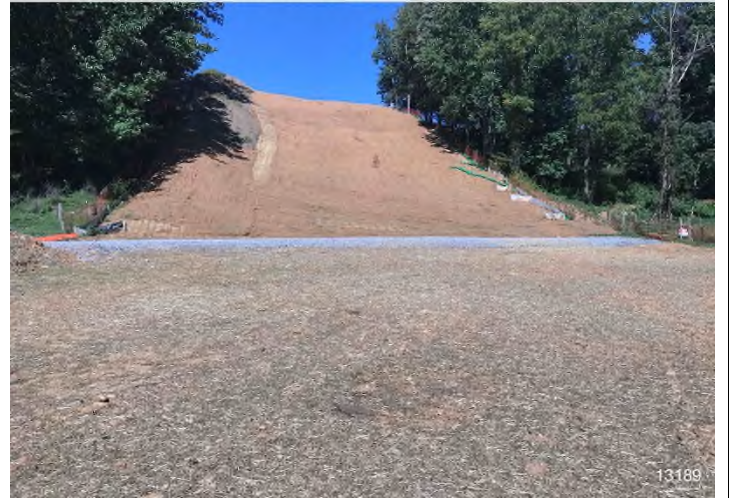
Figure 2: STA 13189+00 – Controls in place and functioning properly. Area stabilized with erosion matting.

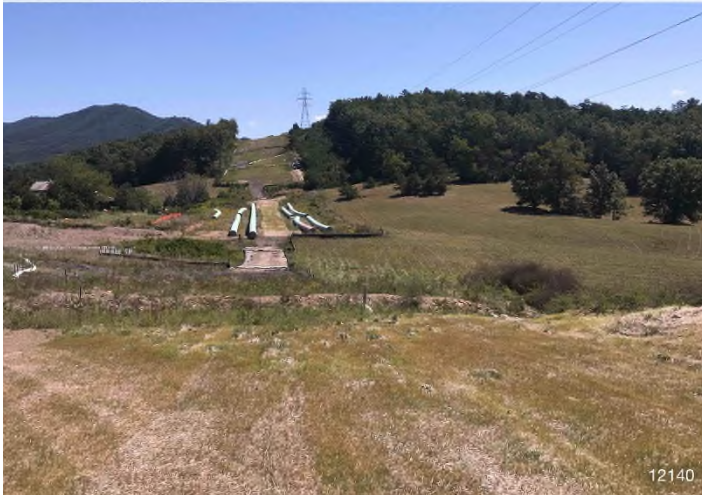
Figure 3: STA 12140+00 – Controls in place and functioning properly.

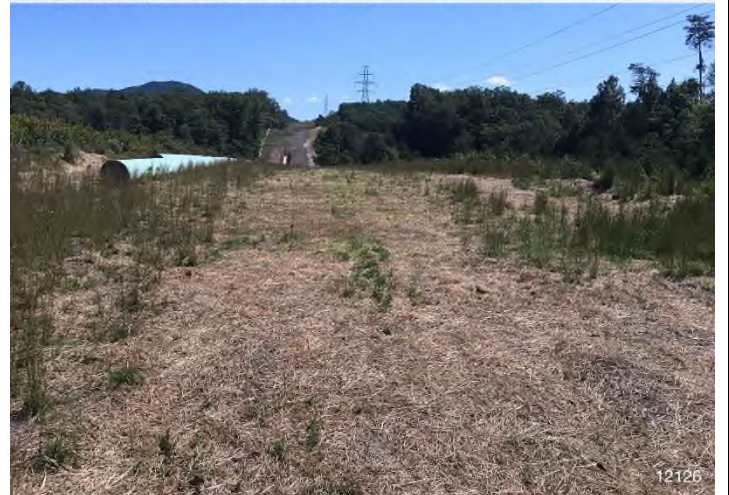
Figure 4: STA 12126+00 – Controls in place and functioning properly. Area stabilized with straw..
