## FIELD INSPECTION REPORT

Project Name:	Mountain Valley Pipeline	Inspector:	Marshall Willis
Inspection Date:	Wednesday, September 1, 2021	Project Contact:	Brian Clauto, Cory Chalmers
Spread H: Roanoke County Franklin County	STA 13145+00 – 13132+00 STA 12724+00 – 12744+00 MVP-FR-292 MVP-RO-281/281.02	Weather:	Rainy

## FIELD INSPECTION PHOTO LOG

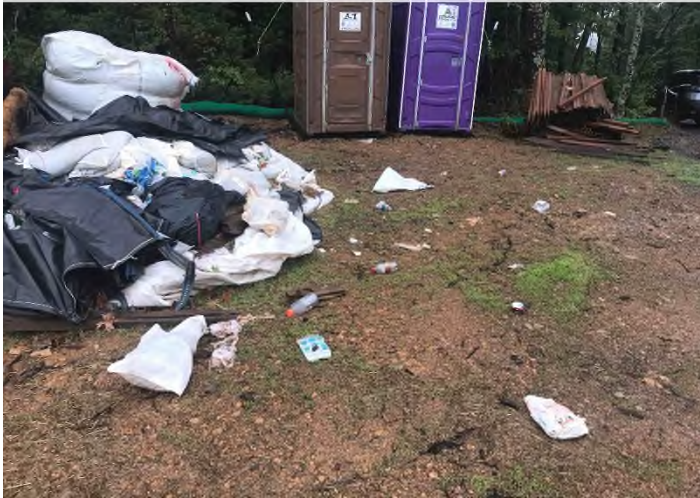
- MVP-RO-281 (ATWS 1536): Trash/debris clean up.

**Figure 1: MVP-RO-281 (ATWS 1356) – Clean up trash/debris.**

**Recommended Corrective Action:** Maintain and install all controls per the approved PSS&S.

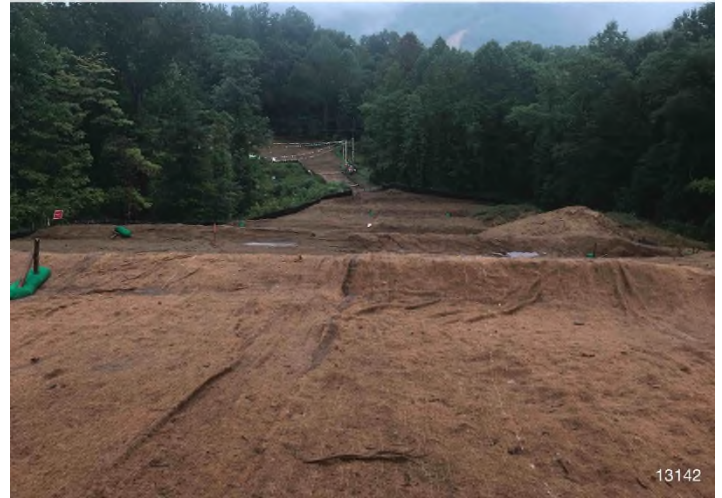
**Figure 2: STA 13142+00 – Controls in place and functioning properly. Area stabilized with erosion matting.**

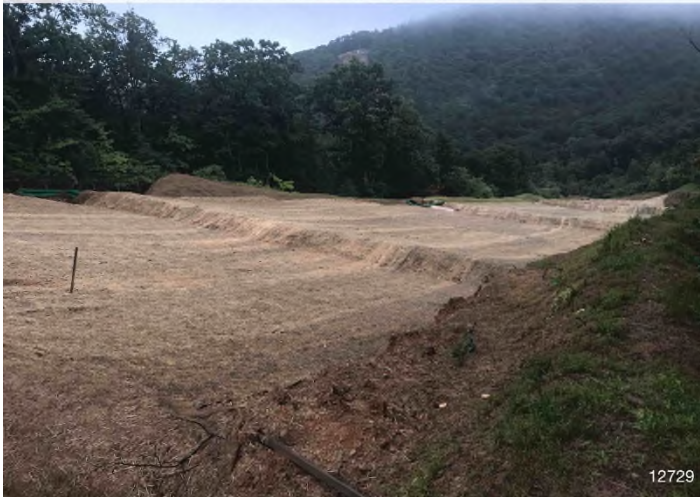
**Figure 3: STA 12729+00 – Controls in place and functioning properly. Area stabilized with erosion matting.**

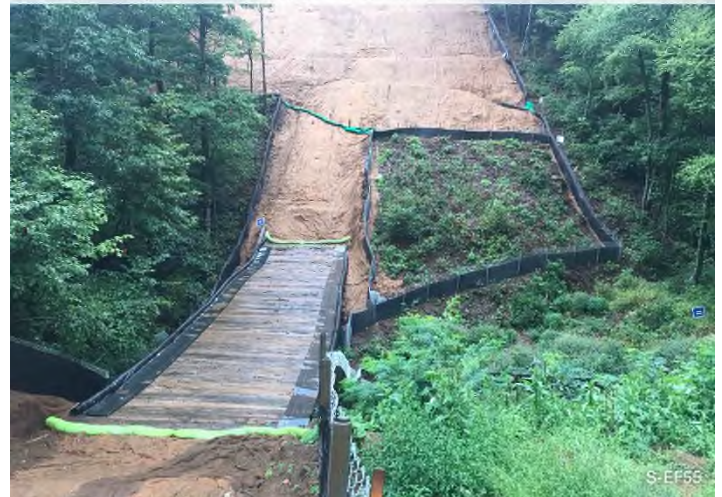
**Figure 4: Stream S-EF55 – Controls in place and functioning properly. Area stabilized with erosion matting.**
