FIELD INSPECTION REPORT

Project Name:	Mountain Valley Pipeline	Inspector:	Matthew Grant
Inspection Date:	Tuesday, August 31, 2021	Project Contact:	Brian Clauto
Spread H: Roanoke Montgomery	AR RO 282, MN275, MN274 ATWS 1225, 1224, 1375, 1446, 704A, 703 St12776+93-12796+50 St12200-12180	Weather:	Wet

FIELD INSPECTION PHOTO LOG

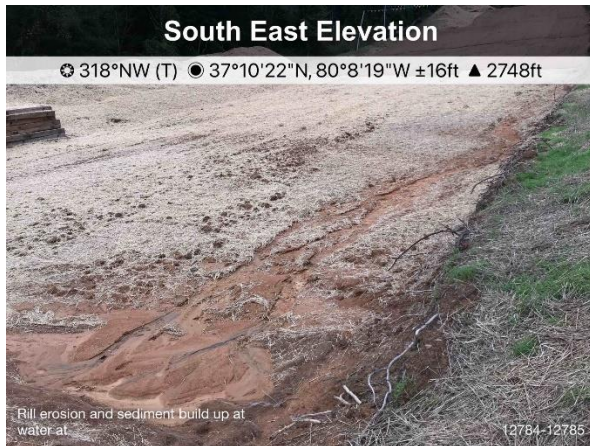
- St 12784-12785 rill erosion and sediment build up in waterbar flow path
- St12791 rill erosion
- St12789 fill slope lacks stabilization
- St 12776+80-12777+20 rill erosion
- St 12768 sump requires sediment removal

- Figure 1: St 12784-12785 sediment in flow path of waterbar and rill erosion requires repair.

Recommended Corrective Action: Maintain and install all controls per the approved PSS&S.

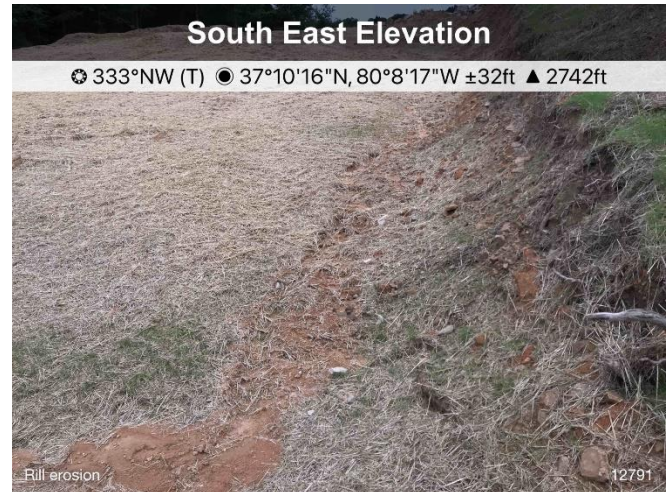
- Figure 2: St 12791 rill erosion requires repair

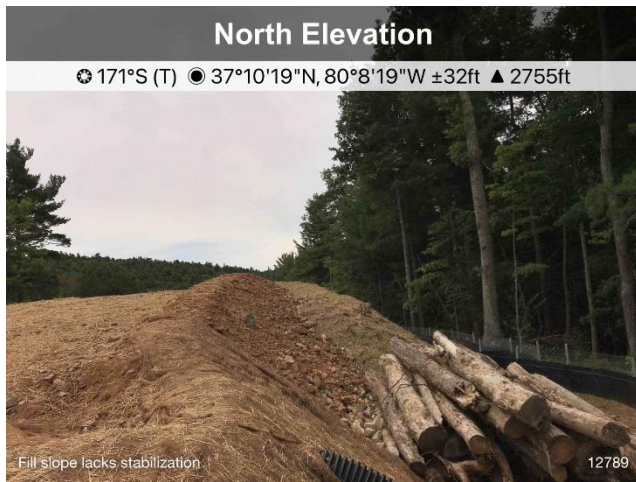
- Figure 3: St 12789 fill slope lacks stabilization

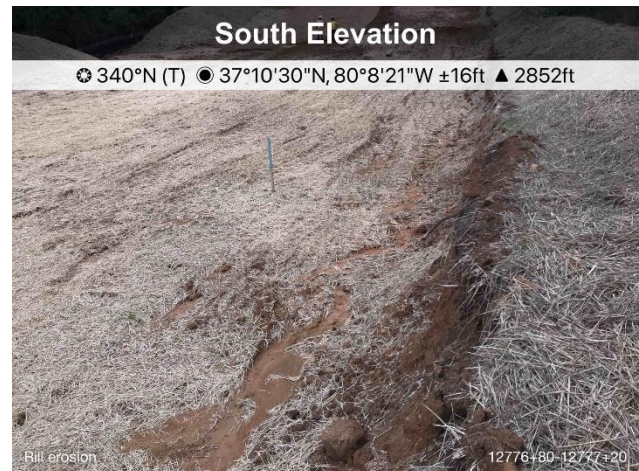
- Figure 4: St 12776+80-12777+20 rill erosion requires repair

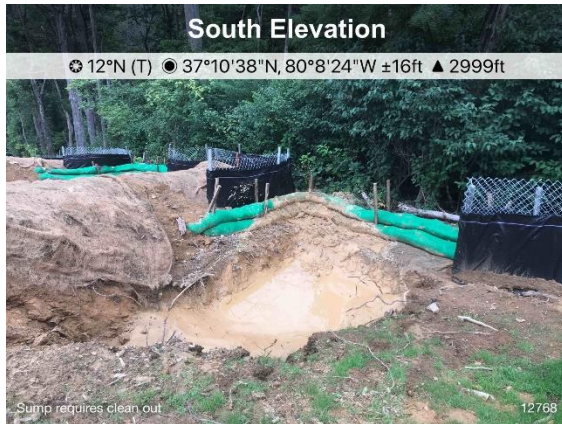
- Figure 5: St 12768 sump requires sediment removal
