## FIELD INSPECTION REPORT

| Project Name: | Mountain Valley Pipeline | Inspector: | Marshall Willis |
| Spread H:<br>Montgomery County | STA 12150+00 – 12200+00<br>MVP-MN-273/274/275 | Weather: | Dry |

## FIELD INSPECTION PHOTO LOG

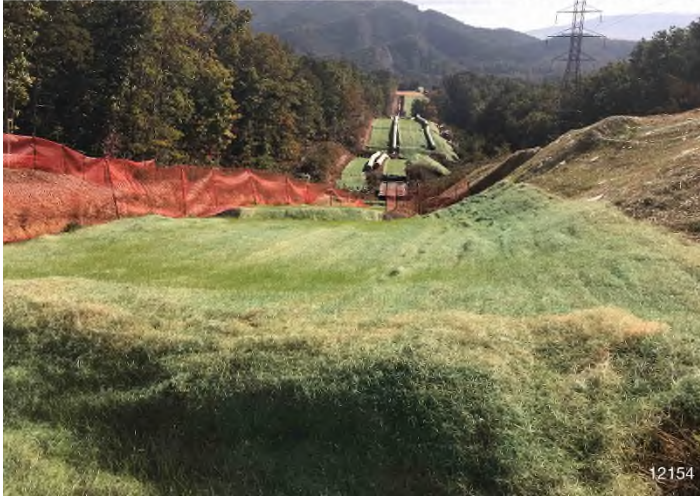
**Figure 1: STA 12154+00** – Controls in place and functioning properly. Area stabilized with erosion matting.  
BRG: 96°E (T) LAT: 37.254865 LON: -80.271101 ±32ft ALT: 1542ft

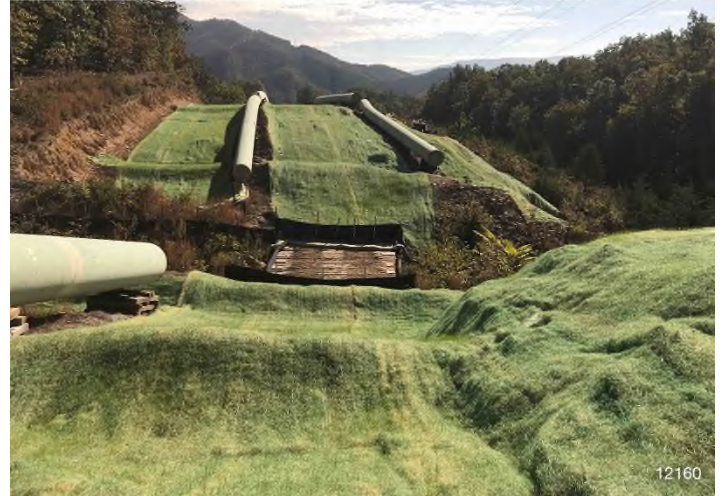
**Figure 2: STA 12160+00** – Controls in place and functioning properly. Area stabilized with erosion matting.  
BRG: 112°E (T) LAT: 37.237022 LON: -80.260660 ±6463ft ALT: 1553ft

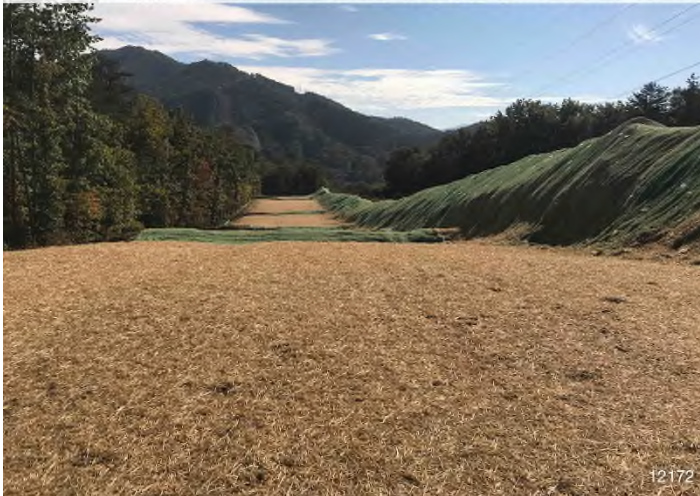
**Figure 3: STA 12172+00** – Controls in place and functioning properly. Area stabilized with straw.  
BRG: 104°E (T) LAT: 37.253976 LON: -80.265243 ±32ft ALT: 1423ft

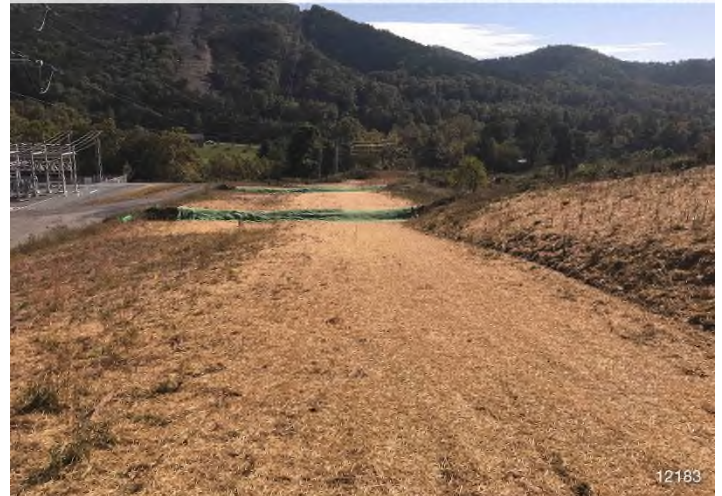
**Figure 4: STA 12183+00** – Controls in place and functioning properly. Area stabilized with straw.  
BRG: 101°E (T) LAT: 37.252721 LON: -80.261836 ±16ft ALT: 1366ft
