FIELD INSPECTION REPORT

Project Name:	Mountain Valley Pipeline	Inspector:	Marshall Willis
Inspection Date:	Thursday, October 14, 2021	Project Contact:	Brian Clauto, Cory Chalmers
Spread H: Franklin County	STA 13135+00 – 13197+50 MVP-FR-292/292.01	Weather:	Dry

FIELD INSPECTION PHOTO LOG

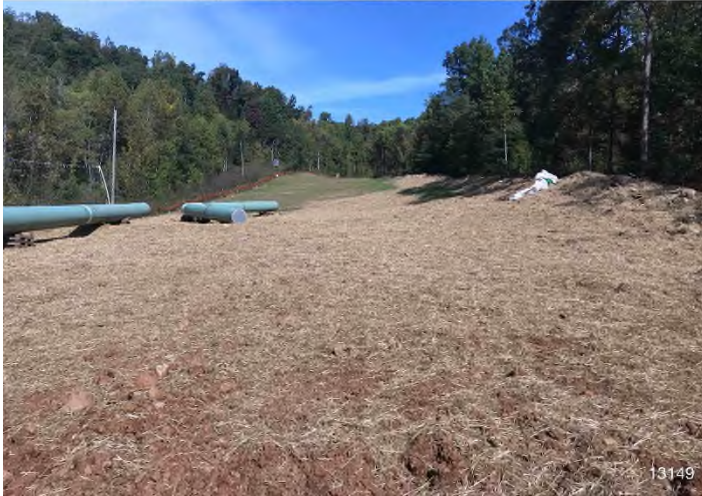
Figure 1: STA 13149+00 – Controls in place and functioning properly. Area stabilized with straw.

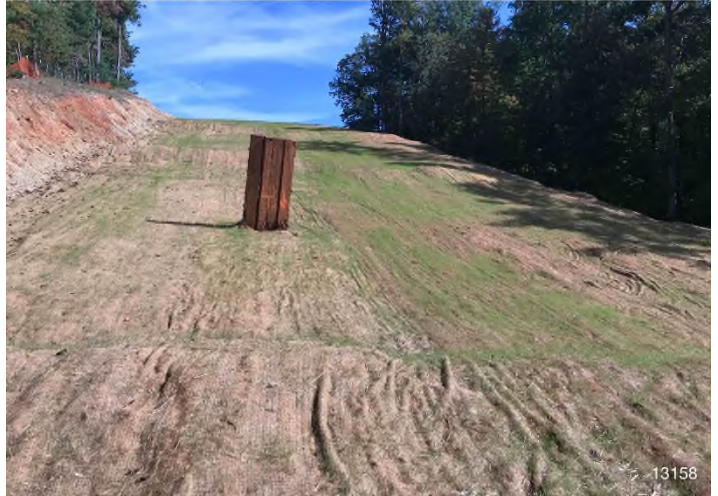
Figure 2: STA 13158+00 – Controls in place and functioning properly. Area stabilized with erosion matting.

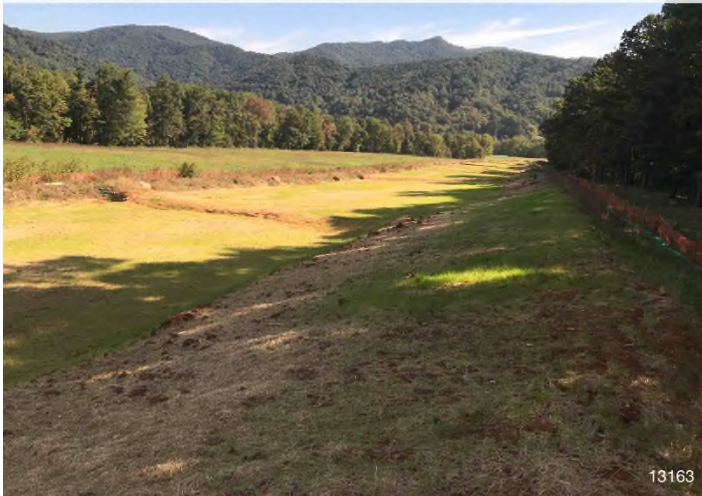
Figure 3: STA 13163+00 – Controls in place and functioning properly. Area stabilized with straw.

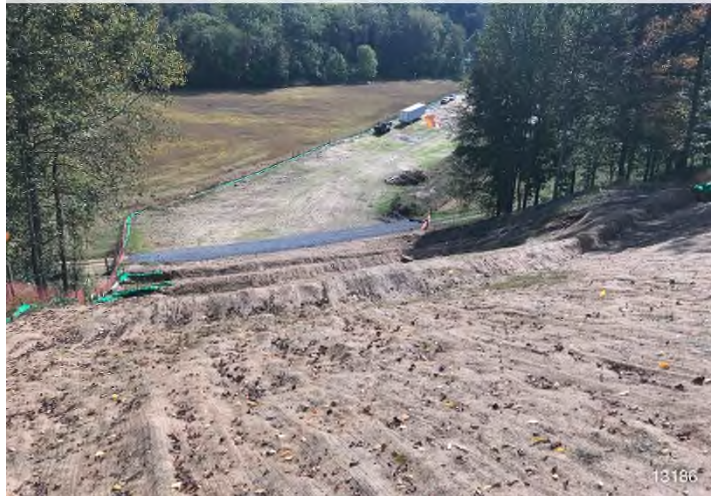
Figure 4: STA 13186+00 – Controls in place and functioning properly. Area stabilized with erosion matting.
