FIELD INSPECTION REPORT

Project Name:	Mountain Valley Pipeline	Inspector:	Marshall Willis
Inspection Date:	Tuesday, October 12, 2021	Project Contact:	Brian Clauto, Cory Chalmers
Spread H: Roanoke County	STA 12866+36 – 12915+00 MVP-RO-286	Weather:	Wet

FIELD INSPECTION PHOTO LOG

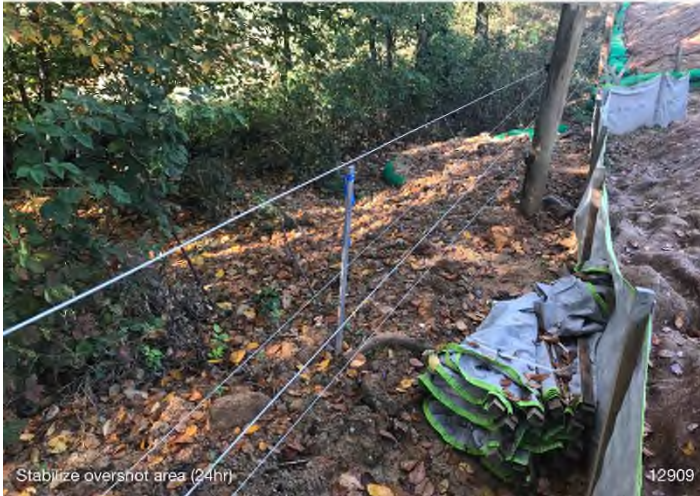
- STA 12909+00: Stabilize area of overshoot along LOD.

Figure 1: STA 12909+00 – Stabilize area of overshoot along LOD.

Recommended Corrective Action: Maintain and install all controls per the approved PSS&S.

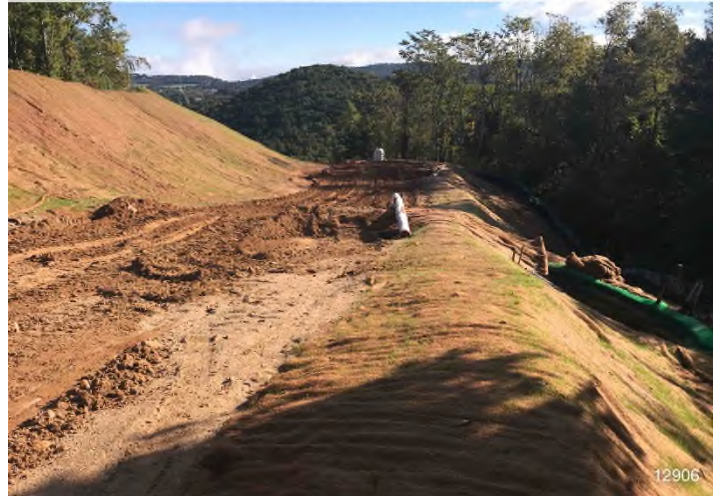
Figure 2: STA 12906+00 – Controls in place and functioning properly. Area stabilized with erosion matting.

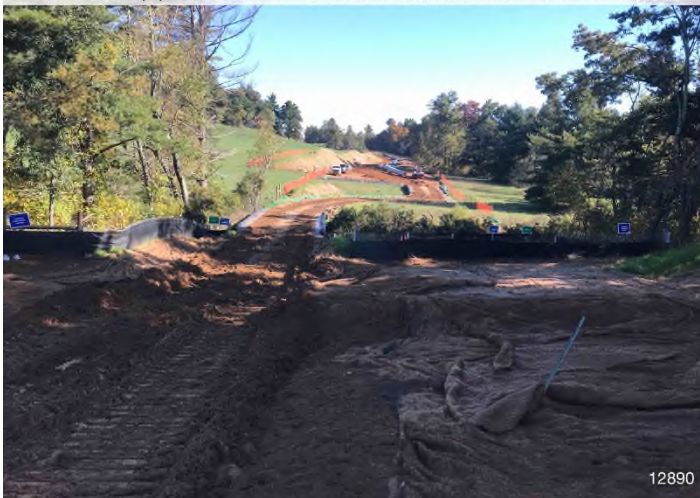
Figure 3: STA 12890+00 – Controls in place and functioning properly. Area stabilized with erosion matting.

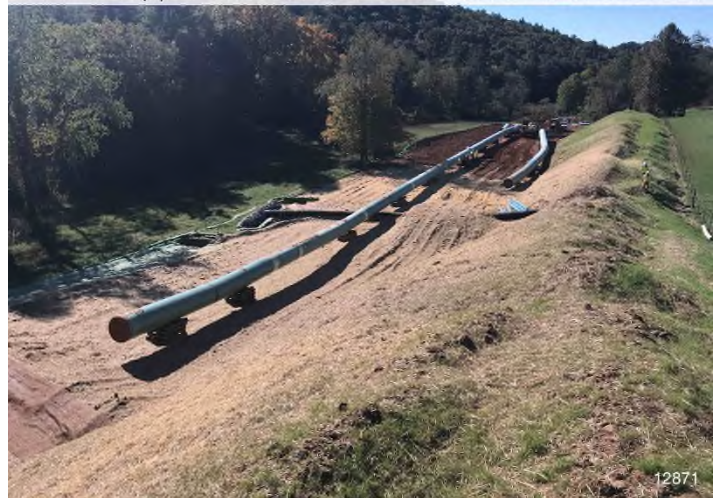
Figure 4: STA 12871+00 – Controls in place and functioning properly. Area stabilized with straw.
