## FIELD INSPECTION REPORT

| Project Name: | Mountain Valley Pipeline | Inspector: | Marshall Willis |
| Spread H:<br>Roanoke County | STA 12910+00 – 12938+00<br>MVP-RO-286 | Weather: | Rainy |

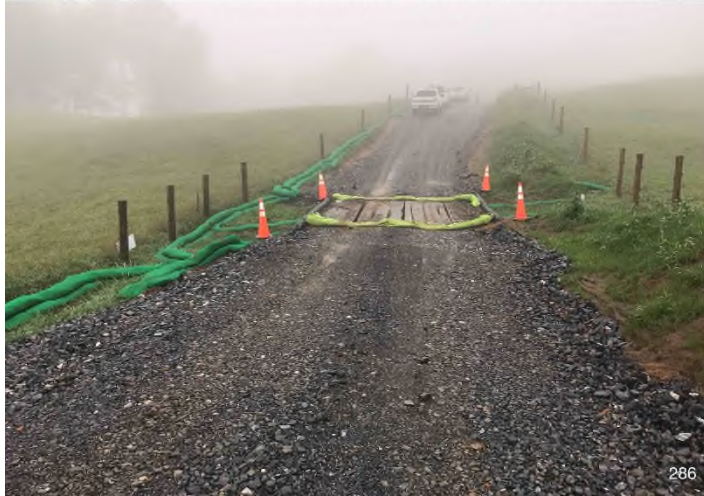
**Figure 1: MVP-RO-286** – Controls in place and functioning properly along access road.  
BRG: 267°W (T) LAT: 37.144853 LON: -80.135831 ±16ft ALT: 2697ft

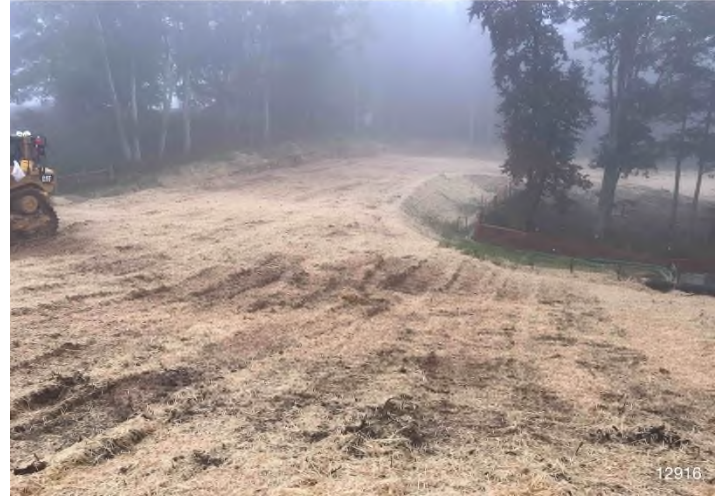
**Figure 2: STA 12916+00** – Controls in place and functioning properly. Area stabilized with straw.  
BRG: 148°SE (T) LAT: 37.144511 LON: -80.137618 ±16ft ALT: 2689ft

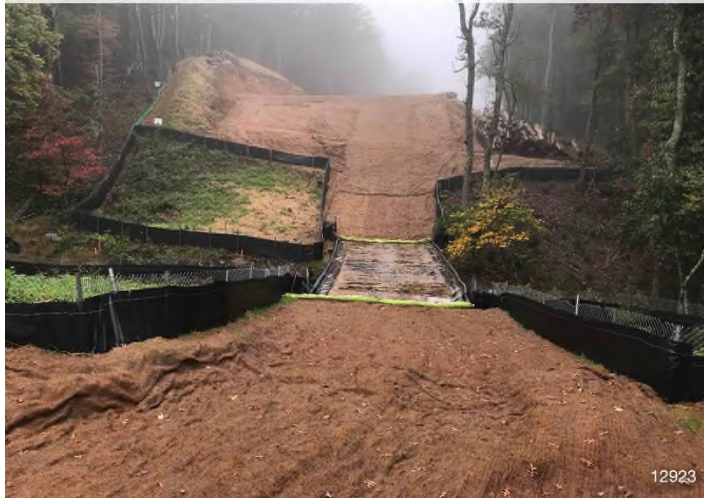
**Figure 3: STA 12923+00** – Controls in place and functioning properly. Area stabilized with erosion matting.  
BRG: 188°S (T) LAT: 37.143462 LON: -80.138072 ±3776ft ALT: 2676ft

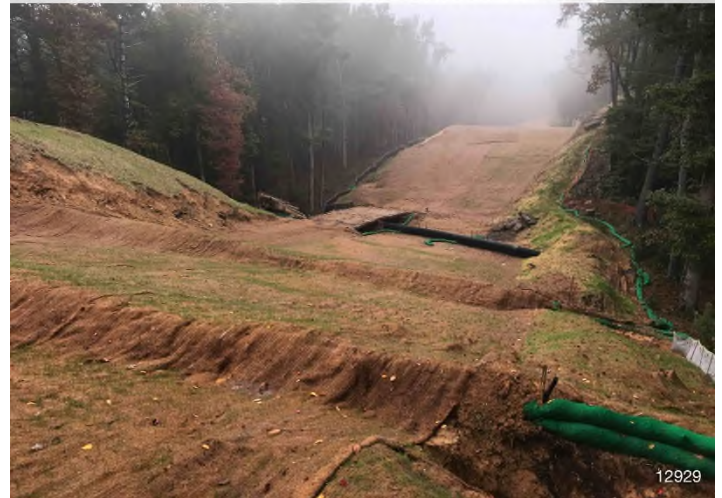
**Figure 4: STA 12929+00** – Controls in place and functioning properly. Area stabilized with erosion matting.  
BRG: 2°N (T) LAT: 37.141357 LON: -80.138884 ±32ft ALT: 2681ft
