## FIELD INSPECTION REPORT

| Project Name: | Mountain Valley Pipeline | Inspector: | Marshall Willis |
| Inspection Date: | Monday, October 4, 2021 | Project Contact: | Brian Clauto, Cory Chalmers |
| Spread H:<br>Franklin County | STA 13342+67 – 13372+00 | Weather: | Dry |

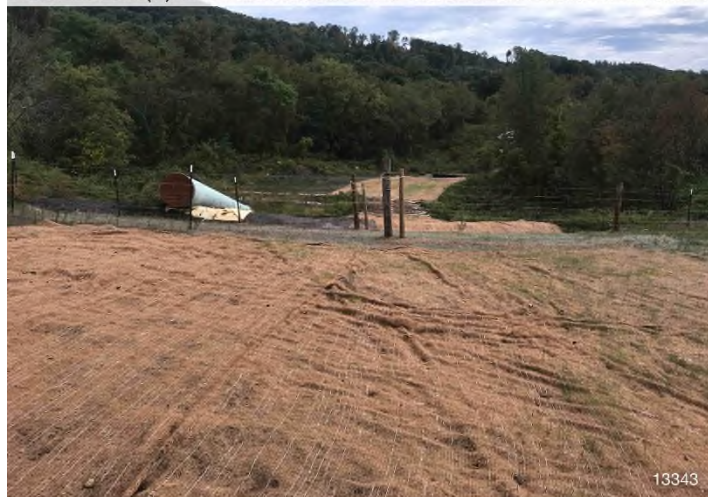
**Figure 1: STA 13343+00** – Controls in place and functioning properly. Area stabilized with erosion matting.  
BRG: 116°SE (T) LAT: 37.103922 LON: -80.043198 ±16ft ALT: 1568ft

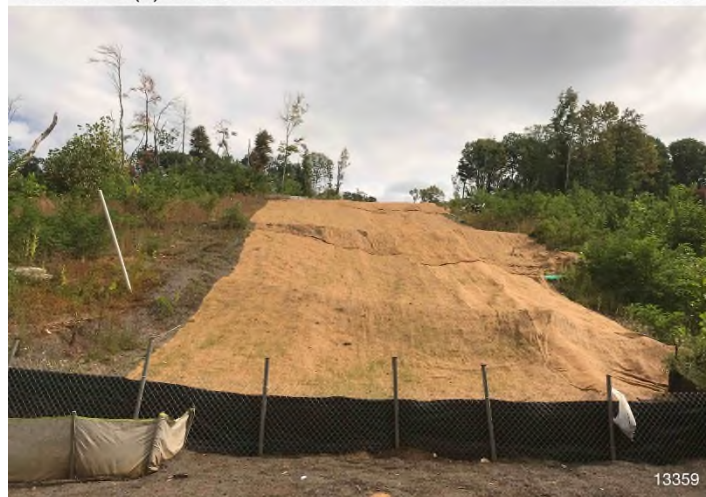
**Figure 2: STA 13359+00** – Controls in place and functioning properly. Area stabilized with erosion matting.  
BRG: 87°E (T) LAT: 37.100967 LON: -80.039578 ±16ft ALT: 1480ft

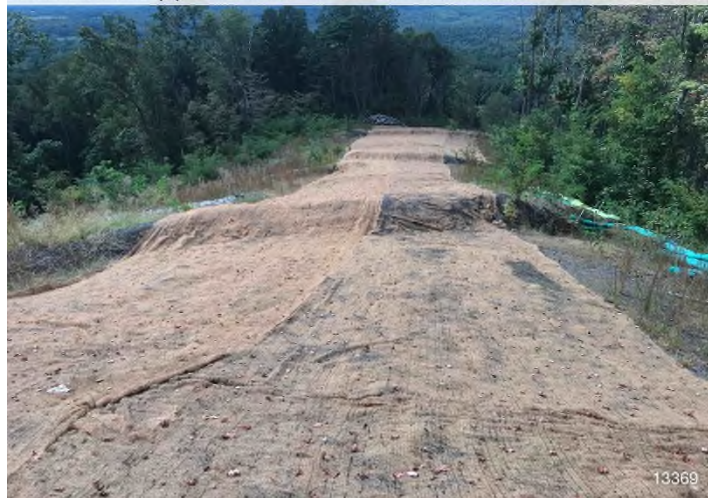
**Figure 3: STA 13369+00** – Controls in place and functioning properly. Area stabilized with erosion matting.  
BRG: 232°SW (T) LAT: 37.101381 LON: -80.036380 ±16ft ALT: 1744ft

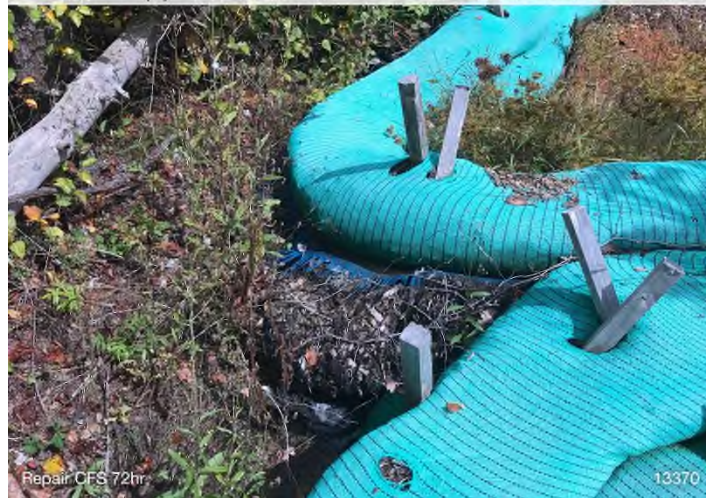
**Figure 4: STA 13360+00** – CFS maintenance needed.  
BRG: 41°NE (T) LAT: 37.101490 LON: -80.036315 ±16ft ALT: 1706ft

**Recommended Corrective Action:** Maintain and install all controls per the approved PSS&S.
