## FIELD INSPECTION REPORT

| Project Name: | Mountain Valley Pipeline | Inspector: | Marshall Willis |
| Spread H:<br>Montgomery County | STA 12150+00 – 12200+00<br>MVP-MN-273/275/274 | Weather: | Dry |

## FIELD INSPECTION PHOTO LOG

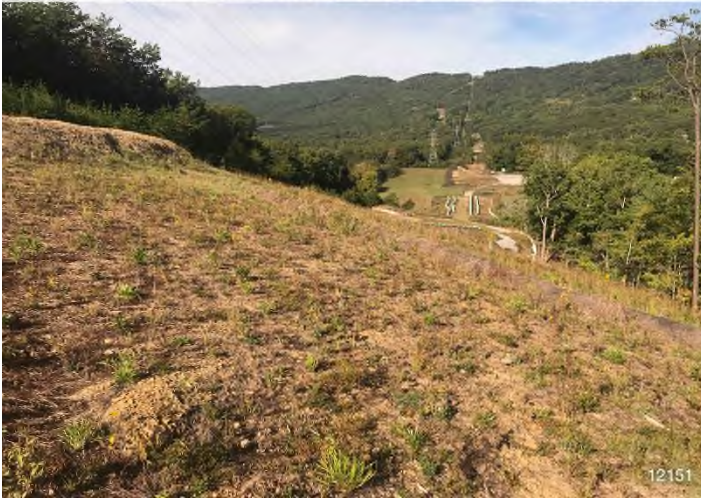
**Figure 1: STA 12151+00** – Controls in place and functioning properly.

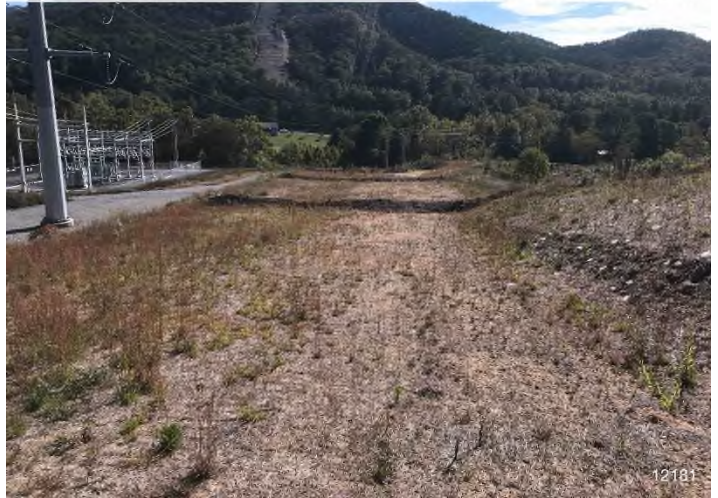
**Figure 2: STA 12181+00** – Controls in place and functioning properly.

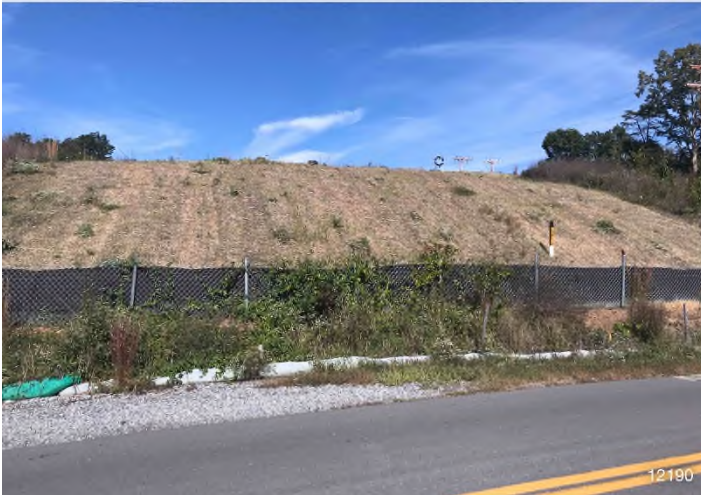
**Figure 3: STA 12190+00** – Controls in place and functioning properly at Bradshaw Road crossing.

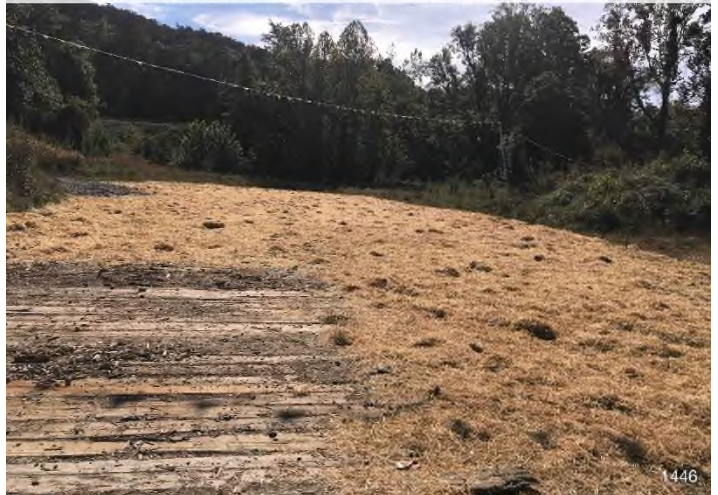
**Figure 4: ATWS 1446** – Controls in place and functioning properly. Area stabilized with straw.
