FIELD INSPECTION REPORT

Project Name:	Mountain Valley Pipeline	Inspector:	Marshall Willis
Inspection Date:	Friday, September 17, 2021	Project Contact:	Brian Clauto, Cory Chalmers
Spread H: Montgomery County Roanoke County	STA 12445+86 – 12500+00 STA 12620+00 – 12640+00 MVP-RO-279.01/.02 MVP-MLV-AR-28	Weather:	Dry

FIELD INSPECTION PHOTO LOG

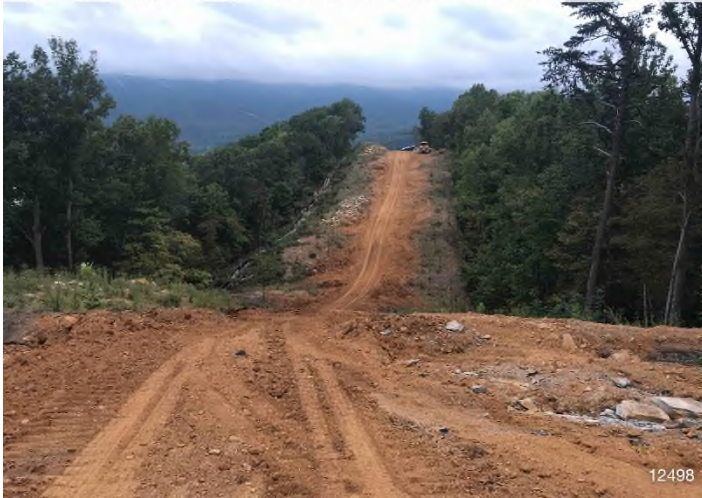
Figure 1: STA 12498+00 – Controls in place and functioning properly.

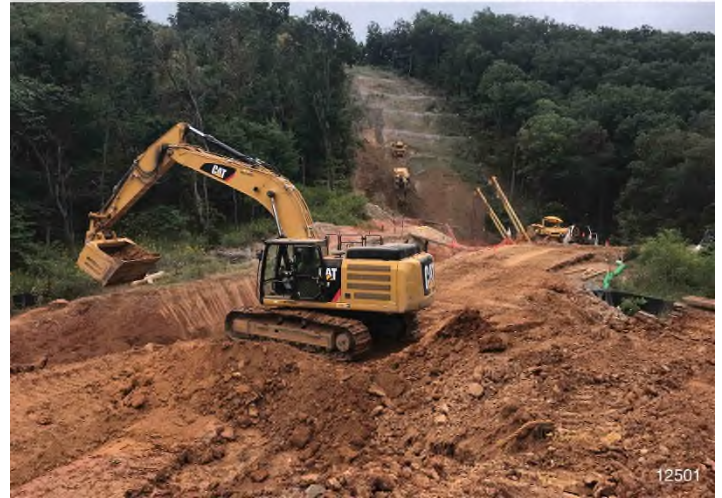
Figure 2: STA 12501+00 – Controls in place and functioning properly.

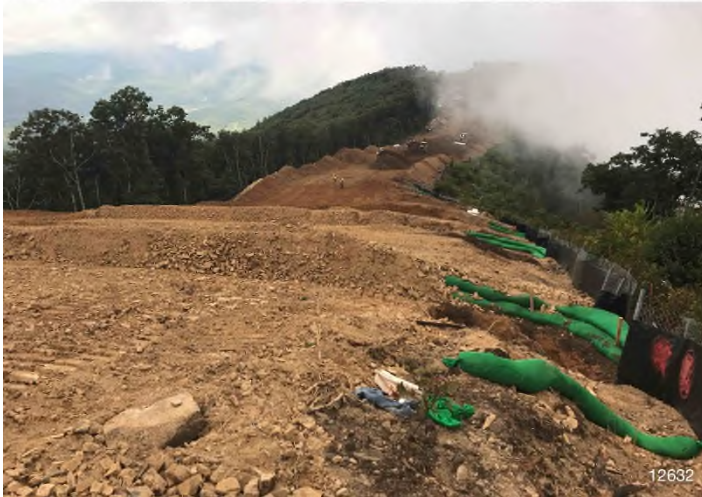
Figure 3: STA 12632+47 – Controls in place and functioning properly.

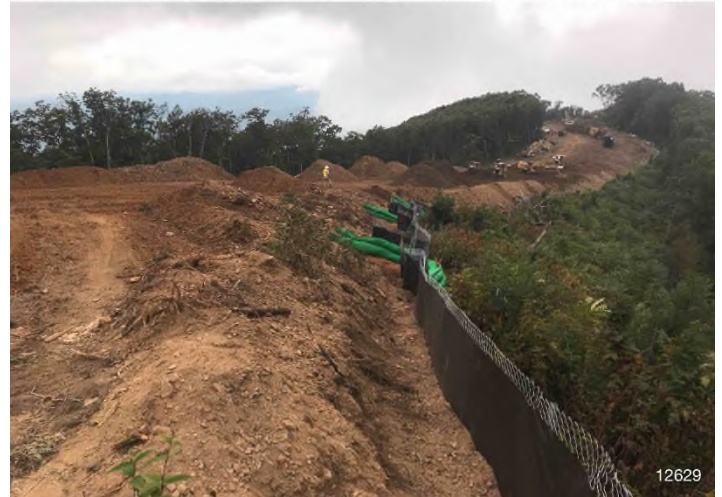
Figure 4: STA 12629+00 – Controls in place and functioning properly.
