## FIELD INSPECTION REPORT

Project Name:	Mountain Valley Pipeline	Inspector:	Marshall Willis
Inspection Date:	Wednesday, September 15, 2021	Project Contact:	Brian Clauto, Cory Chalmers
Spread H: Roanoke County	STA 12866+66 – 12935+00 MVP-RO-286	Weather:	Dry

## FIELD INSPECTION PHOTO LOG

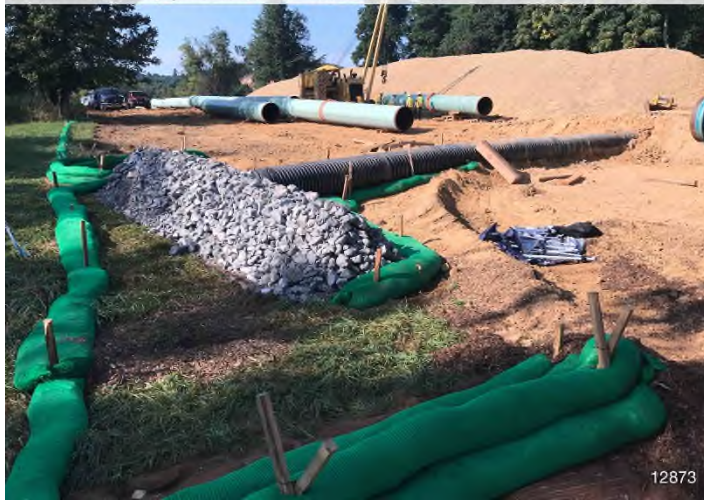
12873

**Figure 1: STA 12873+00** – Controls in place and functioning properly.

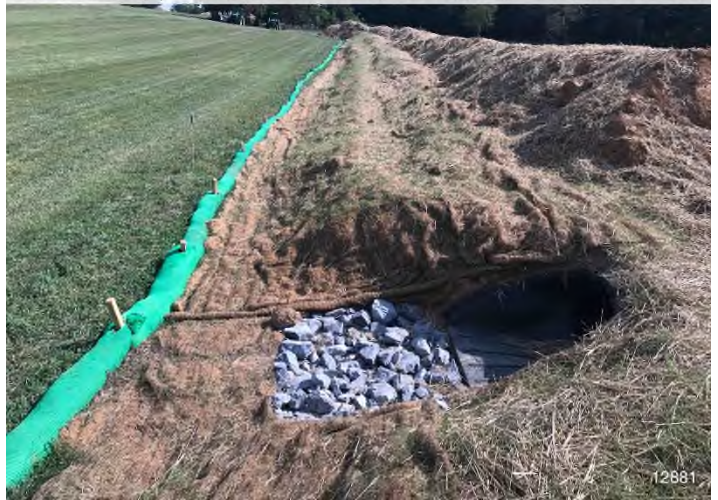
12881

**Figure 2: STA 12881+00** – Controls in place and functioning properly.

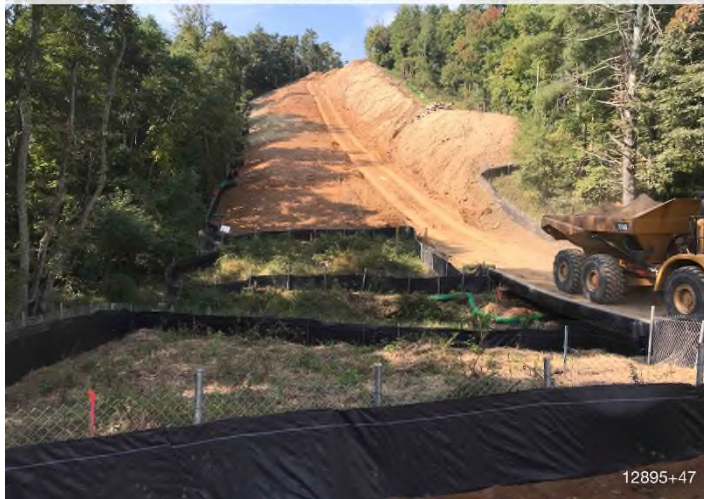
12895+47

**Figure 3: STA 12895+47** – Controls in place and functioning properly.

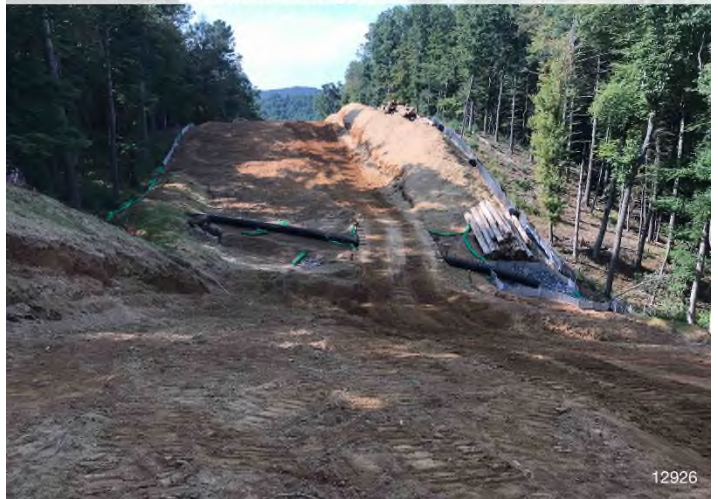
12926

**Figure 4: STA 12926+00** – Controls in place and functioning properly.
