## FIELD INSPECTION REPORT

| Project Name: | Mountain Valley Pipeline | Inspector: | Marshall Willis |
| Inspection Date: | Monday, September 13, 2021 | Project Contact: | Brian Clauto, Cory Chalmers |
| Spread H:<br>Franklin County | STA 13250+00 – 13263+45<br>STA 12994+02 – 13015+13<br>MVP-FR-293.01 | Weather: | Dry |

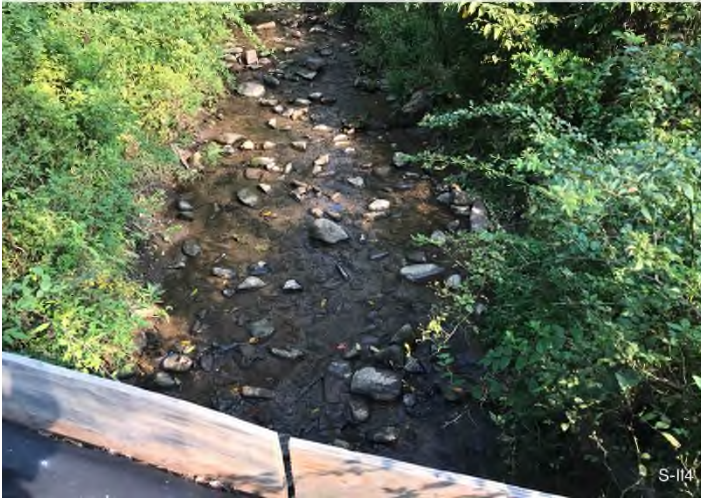
**Figure 1: Stream S-II4** – Controls in place and functioning properly along stream S-II4 crossing.

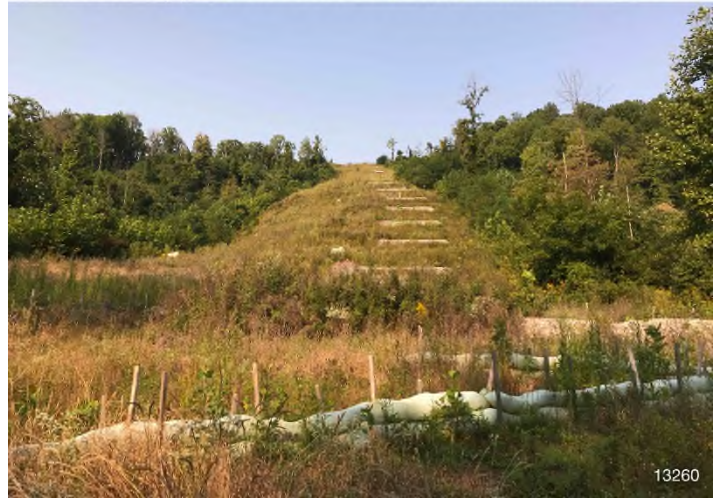
**Figure 2: STA 13260+00** – Controls in place and functioning properly.

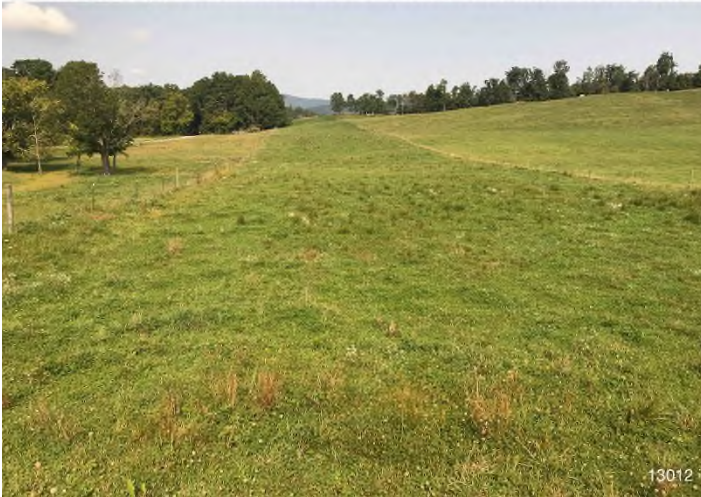
**Figure 3: STA 13012+00** – Controls in place and functioning properly.

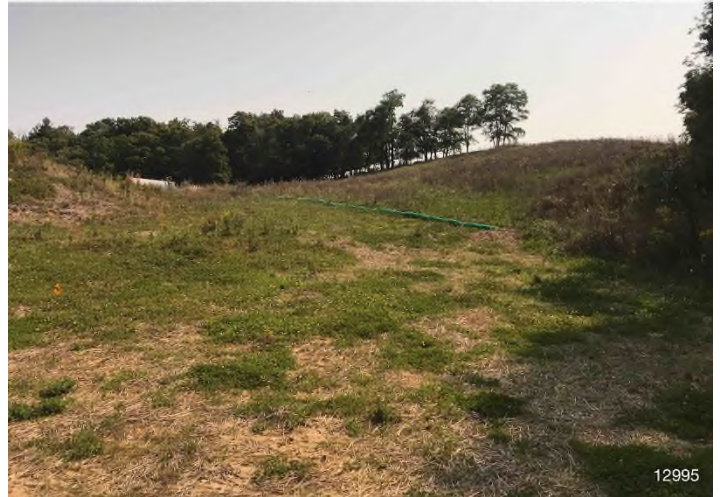
**Figure 4: STA 12995+00** – Controls in place and functioning properly.
