## FIELD INSPECTION REPORT

| <b>Project Name:</b> | Mountain Valley Pipeline | <b>Inspector:</b> | Marshall Willis |
| <b>Spread I:<br/>Franklin County</b> | STA 14062+87 – 14132+00<br>STA 14171+36 – 14210+00<br>MVP-FR-309.05<br>MVP-FR-309 | <b>Weather:</b> | Dry |

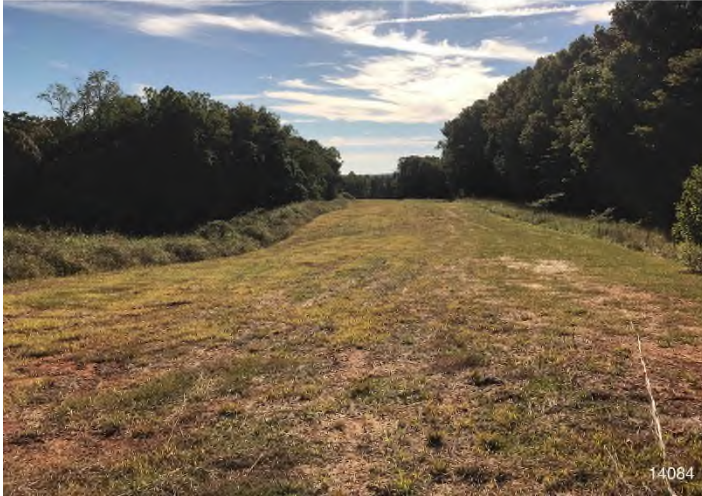
**Figure 1: STA 14084+00** – Controls in place and functioning properly.

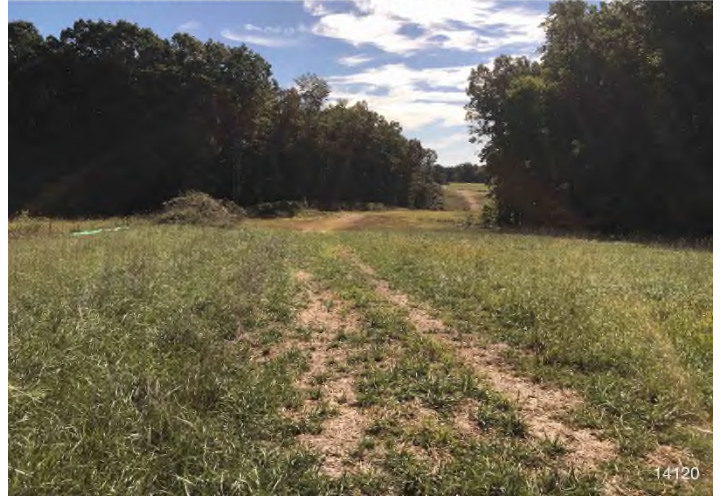
**Figure 2: STA 14120+00** – Controls in place and functioning properly.

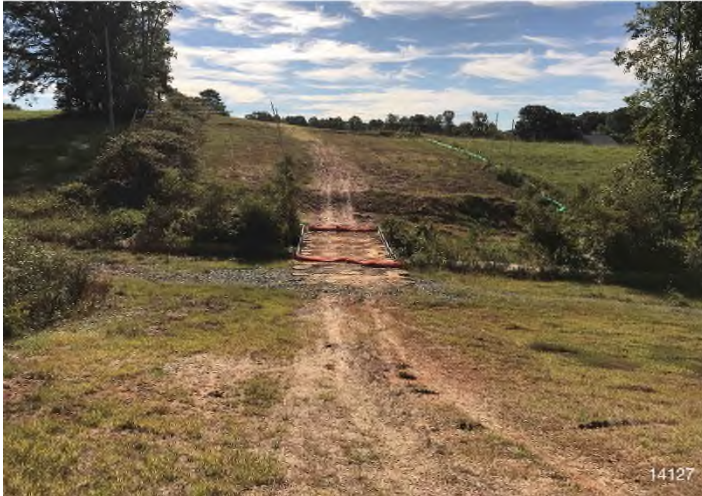
**Figure 3: STA 14127+00** – Controls in place and functioning properly.

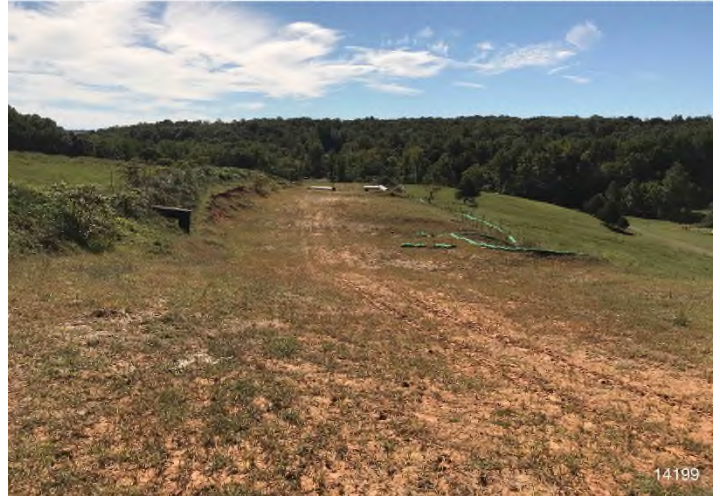
**Figure 4: STA 14199+00** – Controls in place and functioning properly.
