## FIELD INSPECTION REPORT

| <b>Project Name:</b> | Mountain Valley Pipeline | <b>Inspector:</b> | Marshall Willis |
| <b>Inspection Date:</b> | Wednesday, October 27, 2021 | <b>Project Contact:</b> | Brian Clauto, Cory Chalmers |
| <b>Spread I:<br/>Franklin County</b> | STA 13846+00 – 13865+00<br>STA 13920+00 – 13946+00<br>MVP-FR-303.01<br>MVP-FR-305 | <b>Weather:</b> | Dry |

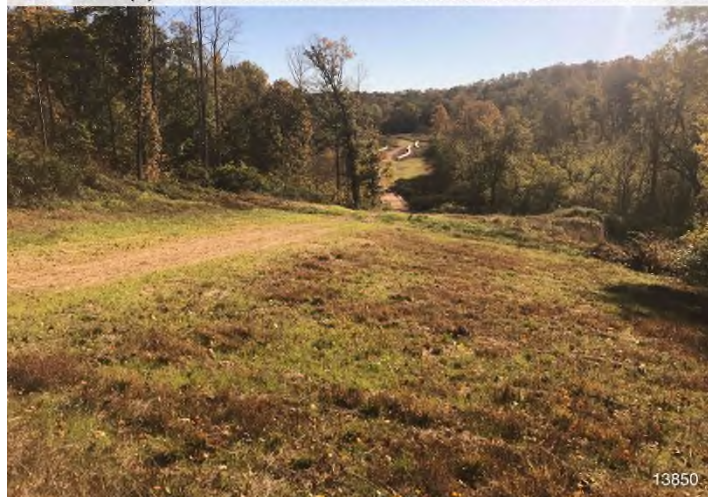
**Figure 1: STA 13855+00** – Controls in place and functioning properly.

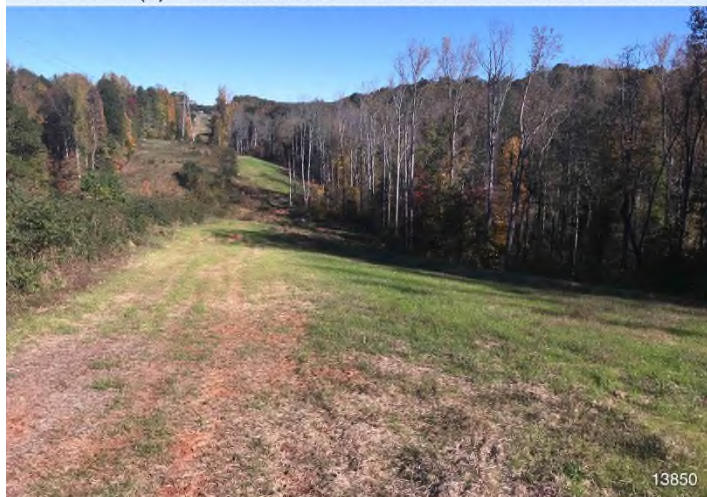
**Figure 2: STA 13850+00** – Controls in place and functioning properly.

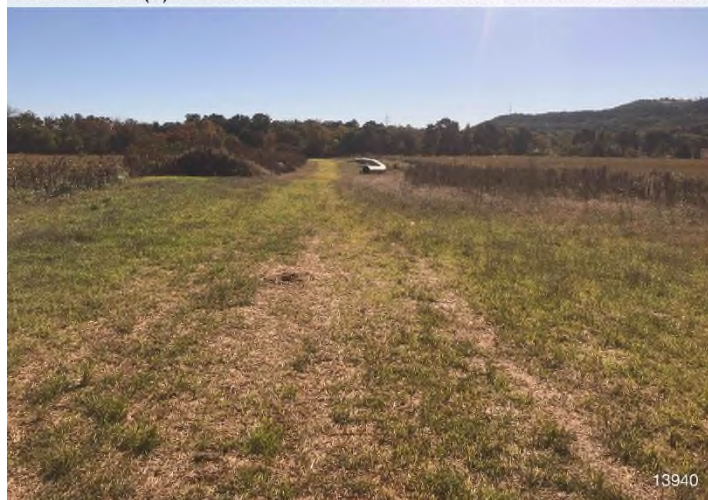
**Figure 3: STA 13940+00** – Controls in place and functioning properly.

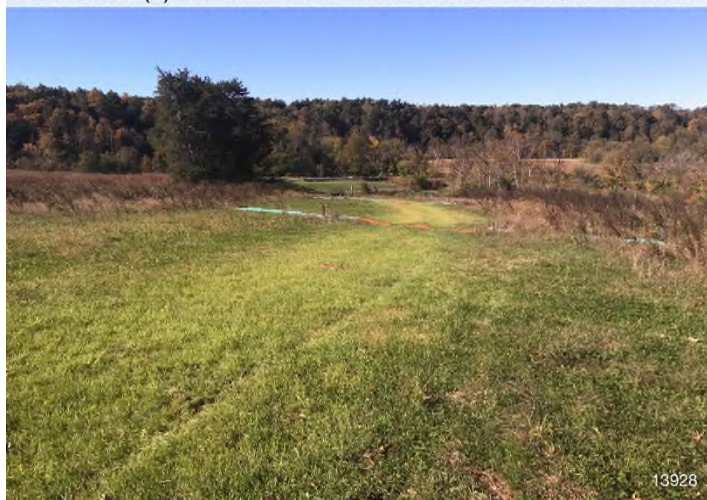
**Figure 4: STA 13928+00** – Controls in place and functioning properly.
