## FIELD INSPECTION REPORT

<b>Project Name:</b>	Mountain Valley Pipeline	<b>Inspector:</b>	Marshall Willis
<b>Inspection Date:</b>	Tuesday, October 26, 2021	<b>Project Contact:</b>	Brian Clauto, Cory Chalmers
<b>Spread I: Franklin County</b>	STA 13415+00 – 13450+00 STA 13541+00 – 13575+00 MVP-FR-293.02	<b>Weather:</b>	Dry

## FIELD INSPECTION PHOTO LOG

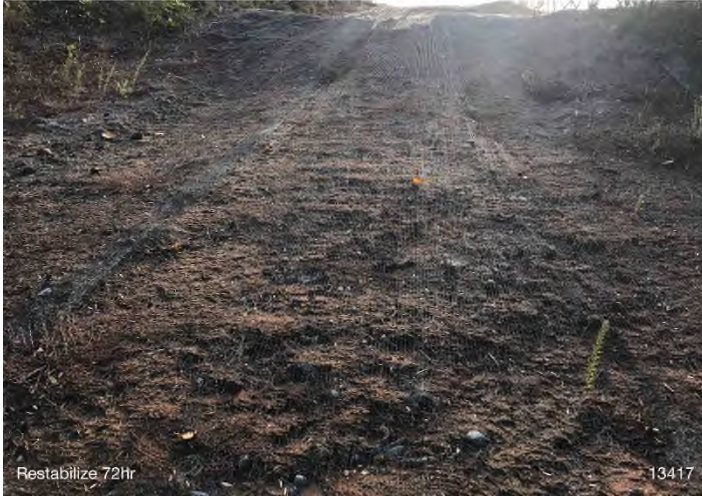
- STA 13416+00 to 13420+00: Re-stabilization needed.

**Figure 1: STA 13416+00 to 13420+00 – Re-stabilization needed.**

**Recommended Corrective Action:** Maintain and install all controls per the approved PSS&S.

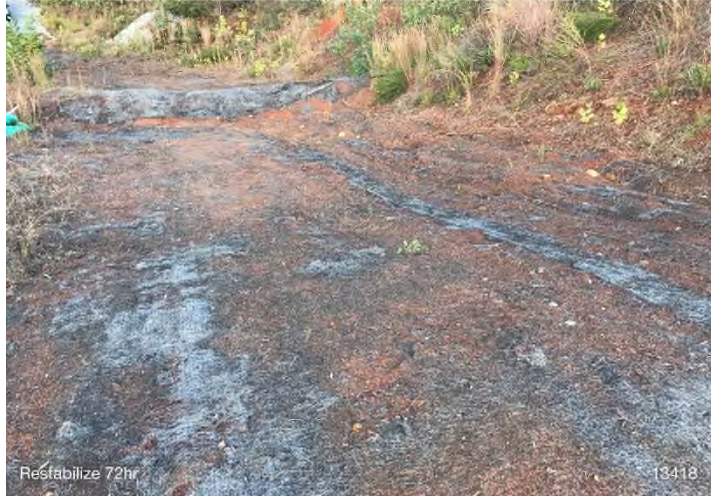
**Figure 2: STA 13416+00 to 13420+00 – Re-stabilization needed**

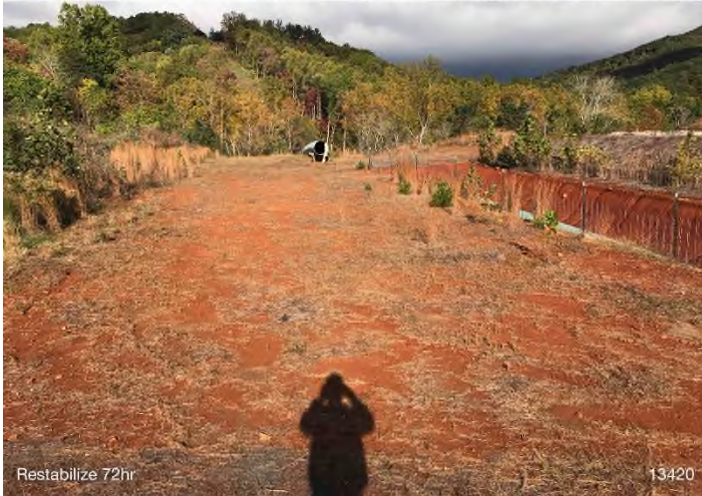
**Figure 3: STA 13416+00 to 13420+00 – Re-stabilization needed**

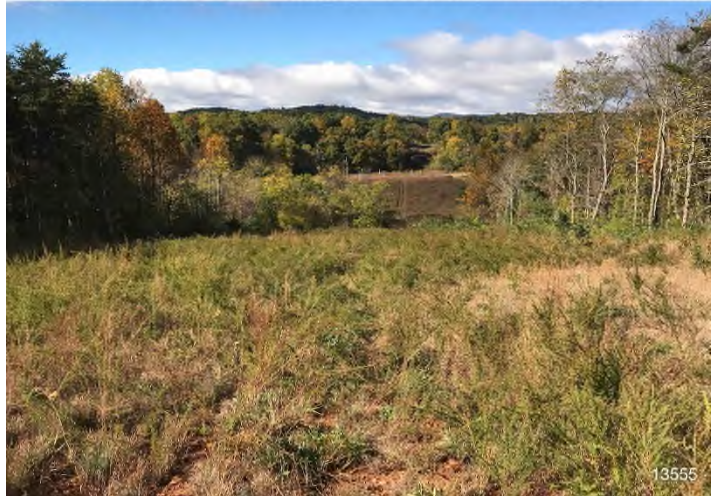
**Figure 4: STA 13555+00 – Controls in place and functioning properly.**
