## FIELD INSPECTION REPORT

| <b>Project Name:</b> | Mountain Valley Pipeline | <b>Inspector:</b> | Marshall Willis |
| <b>Spread H:<br/>Montgomery County</b> | STA 12445+00 – 12544+00<br>MVP-MN-278.01<br>MVP-MLV-AR-28 | <b>Weather:</b> | Dry |

## FIELD INSPECTION PHOTO LOG

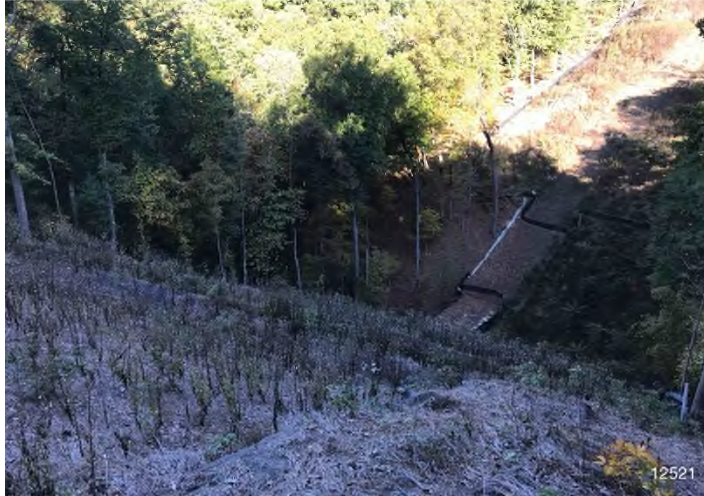
**Figure 1: STA 12521+00** – Controls in place and functioning properly.

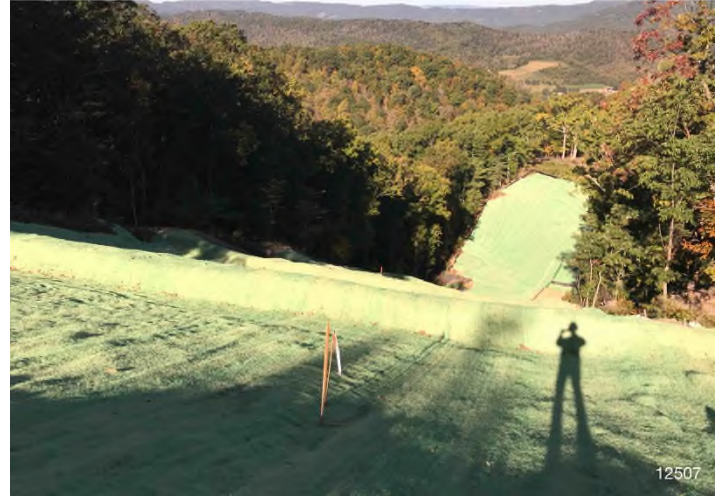
**Figure 2: STA 12507+00** – Controls in place and functioning properly. Area stabilized with erosion matting.

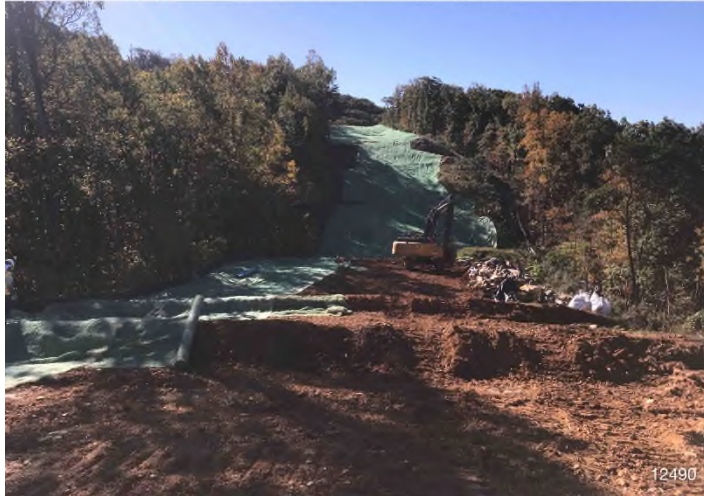
**Figure 3: STA 12490+00** – Controls in place and functioning properly. Area being re-stabilized with erosion matting.

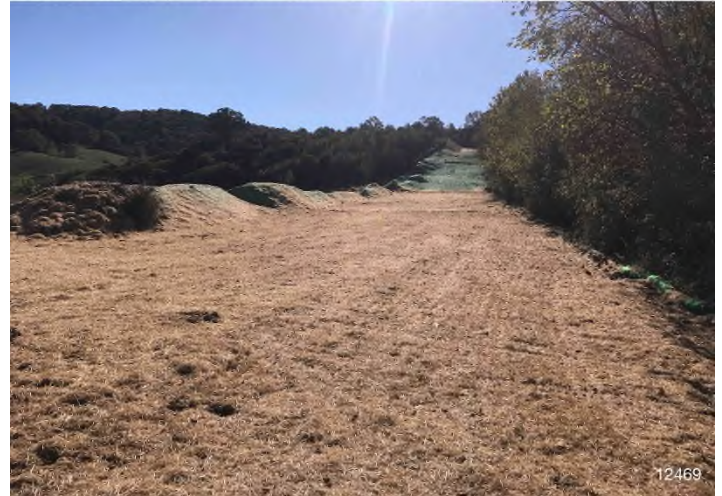
**Figure 4: STA 12469+00** – Controls in place and functioning properly. Area stabilized with erosion matting and straw.
