## FIELD INSPECTION REPORT

<b>Project Name:</b>	Mountain Valley Pipeline	<b>Inspector:</b>	Marshall Willis
<b>Inspection Date:</b>	Tuesday, October 19, 2021	<b>Project Contact:</b>	Brian Clauto, Cory Chalmers
<b>Spread H: Roanoke County</b>	STA 12591+00 – 12638+00 STA 12690+00 – 12704+00 STA 12866+00 – 12915+00	<b>Weather:</b>	Dry

## FIELD INSPECTION PHOTO LOG

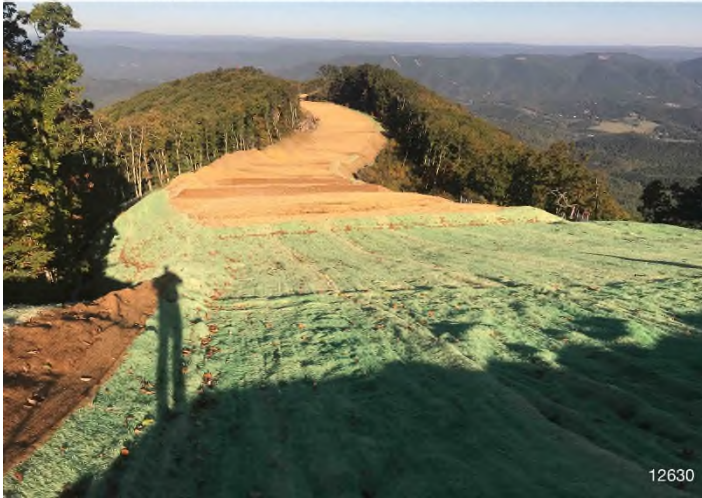
**Figure 1: STA 12630+00** – Controls in place and functioning properly. Area stabilized with erosion matting and straw.  
BRG: 323°NW (T) LAT: 37.193329 LON: -80.175997 ±164ft ALT: 3048ft

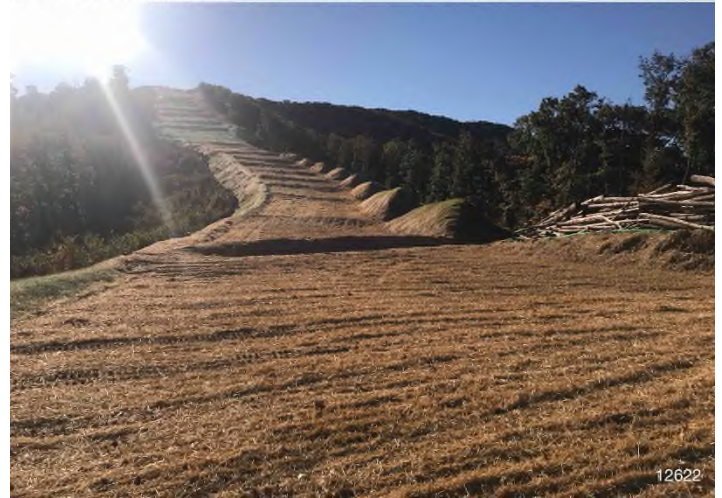
**Figure 2: STA 12622+00** – Controls in place and functioning properly. Area stabilized with straw.  
BRG: 151°SE (T) LAT: 37.195210 LON: -80.178369 ±98ft ALT: 3432ft

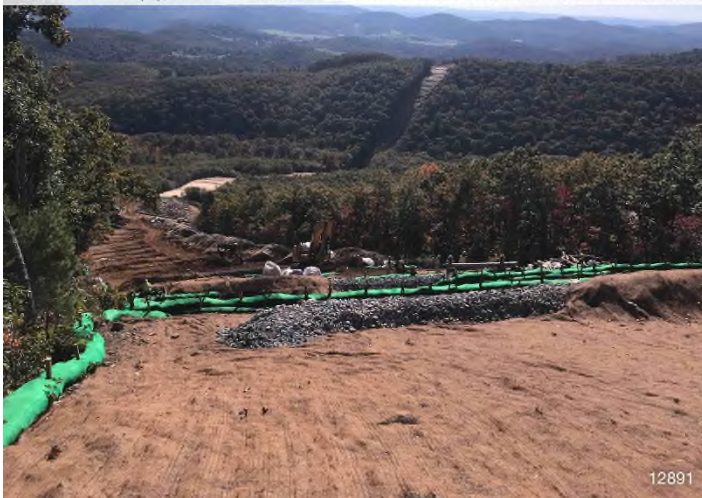
**Figure 3: STA 12691+00** – Controls in place and functioning properly.  
BRG: 132°SE (T) LAT: 37.189642 LON: -80.152830 ±7644ft ALT: 3775ft

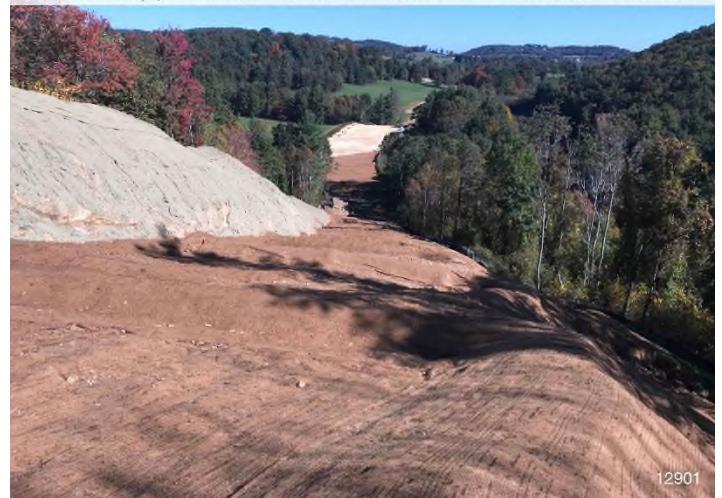
**Figure 4: STA 12901+00** – Controls in place and functioning properly. Area stabilized with erosion matting.  
BRG: 30°NE (T) LAT: 37.145966 LON: -80.137374 ±17060ft ALT: 2831ft
