## FIELD INSPECTION REPORT

| <b>Project Name:</b> | Mountain Valley Pipeline | <b>Inspector:</b> | Marshall Willis |
| <b>Spread H:<br/>Franklin County</b> | STA 13115+97 – 13195+79<br>MVP-FR-291<br>MVP-FR-292/292.01 | <b>Weather:</b> | Wet |

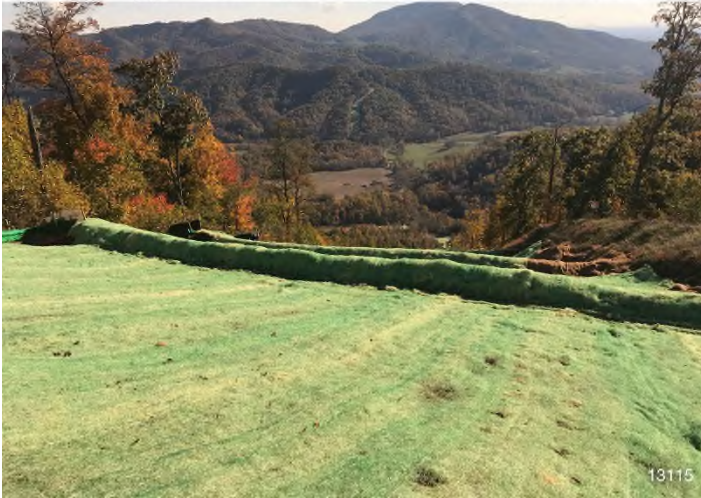
**Figure 1: STA 13115+00** – Controls in place and functioning properly. Area stabilized with erosion matting.

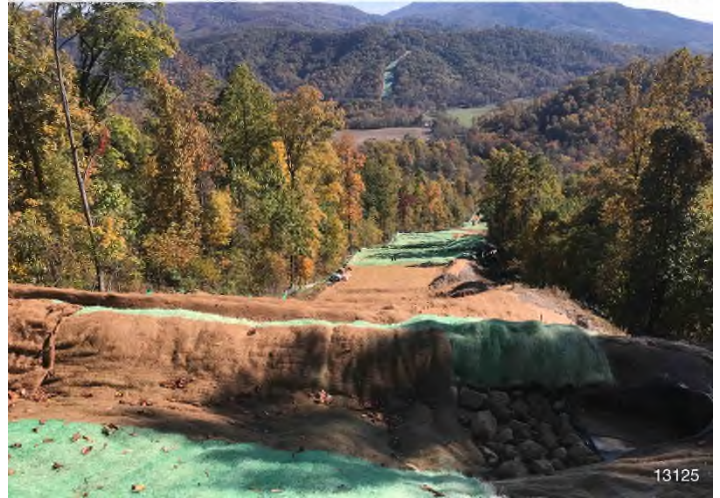
**Figure 2: STA 13125+00** – Controls in place and functioning properly. Area stabilized with erosion matting.

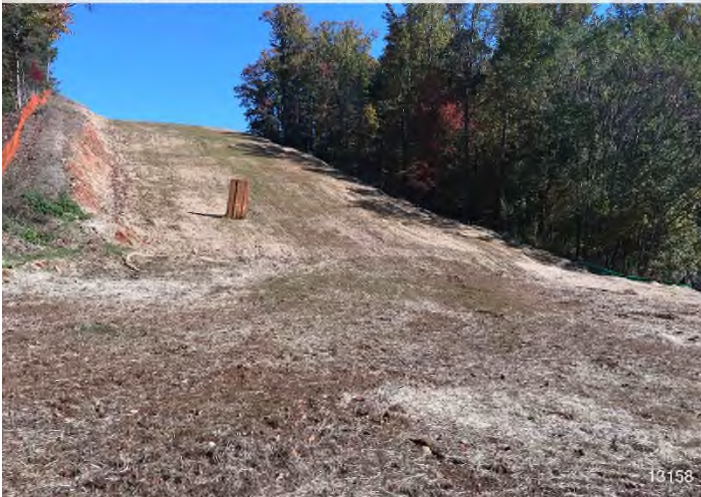
**Figure 3: STA 13158+00** – Controls in place and functioning properly. Area stabilized with straw.

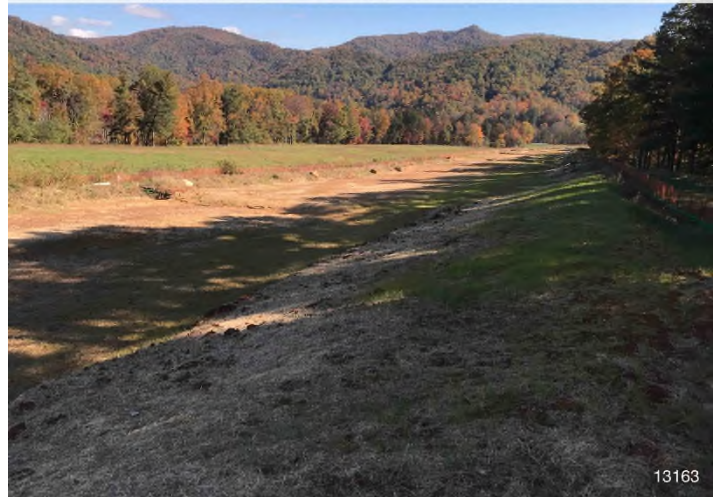
**Figure 4: STA 13163+00** – Controls in place and functioning properly. Area stabilized with straw.
