FIELD INSPECTION REPORT

Project Name:	Mountain Valley Pipeline	Inspector:	Marshall Willis
Inspection Date:	Friday, December 3, 2021	Project Contact:	Brian Clauto, Cory Chalmers
Spread I: Franklin County	STA 14861+31 – 14981+55	Weather:	Dry

FIELD INSPECTION PHOTO LOG

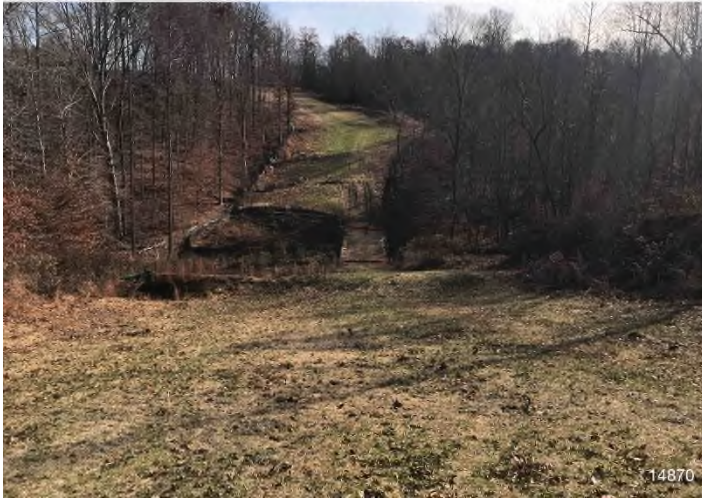
Figure 1: STA 14870+00 – Controls in place and functioning properly.

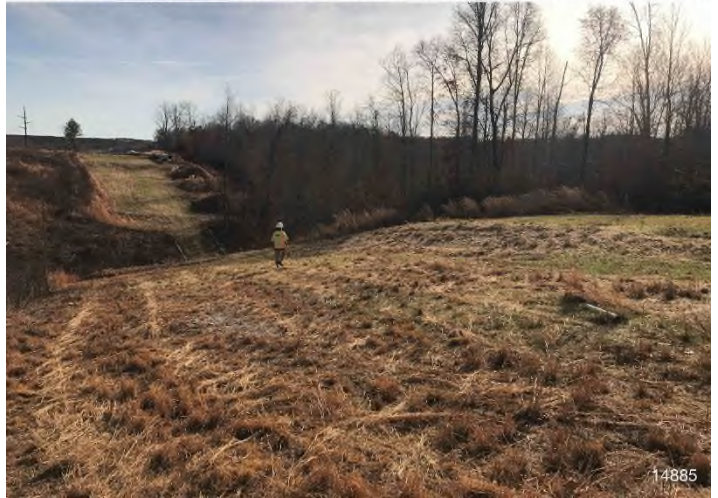
Figure 2: STA 14885+00 – Controls in place and functioning properly.

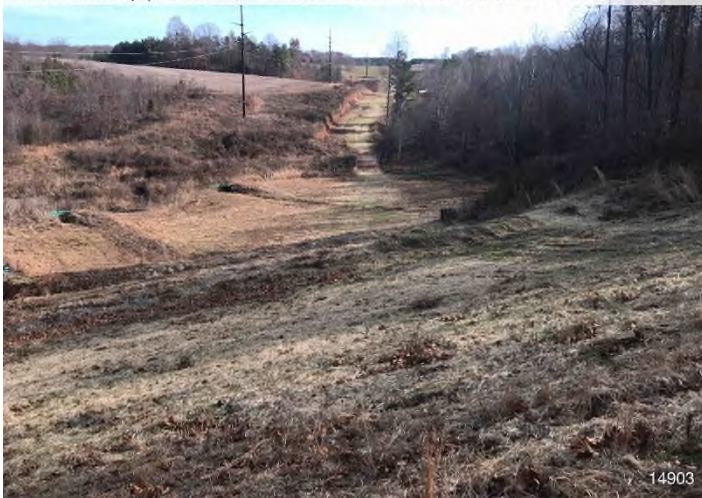
Figure 3: STA 14903+00 – Controls in place and functioning properly.

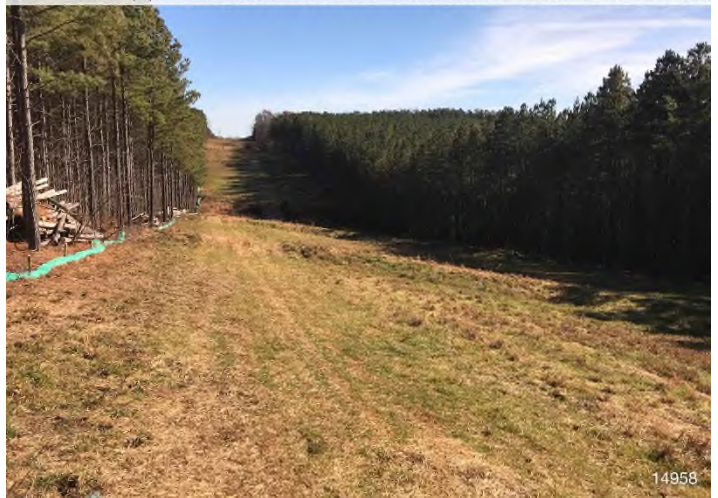
Figure 4: STA 14958+00 – Controls in place and functioning properly.
