FIELD INSPECTION REPORT

Project Name:	Mountain Valley Pipeline	Inspector:	Marshall Willis
Inspection Date:	Wednesday, December 1, 2021	Project Contact:	Brian Clauto, Cory Chalmers
Spread H: Franklin County	STA 13260+00 – 13316+13 MVP-FR-293.01	Weather:	Dry

FIELD INSPECTION PHOTO LOG

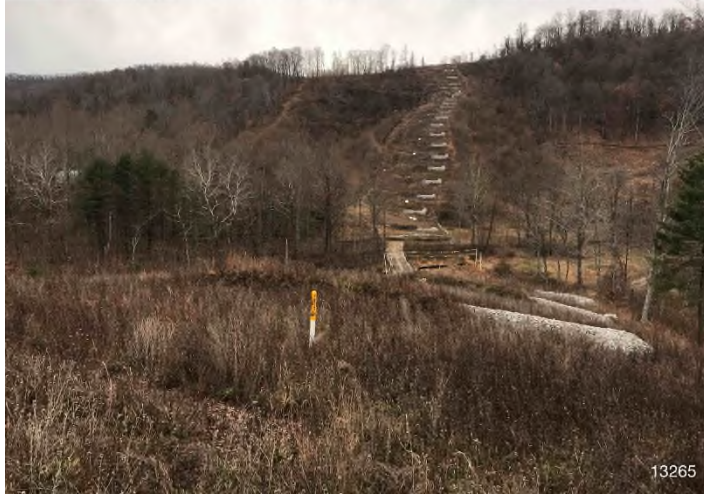
13265

Figure 1: STA 13265+00 – Controls in place and functioning properly.
 BRG: 86°E (T) LAT: 36.990646 LON: -80.064500 ±23727ft ALT: 1413ft

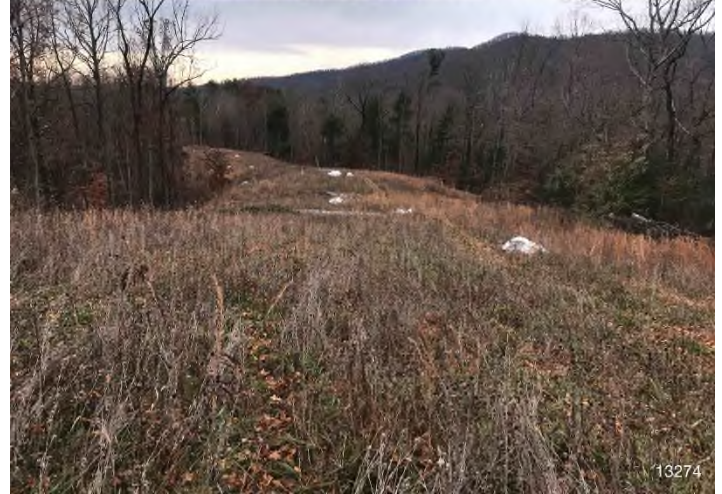
13274

Figure 2: STA 13274+00 – Controls in place and functioning properly.
 BRG: 228°SW (T) LAT: 37.114764 LON: -80.056169 ±98ft ALT: 1651ft

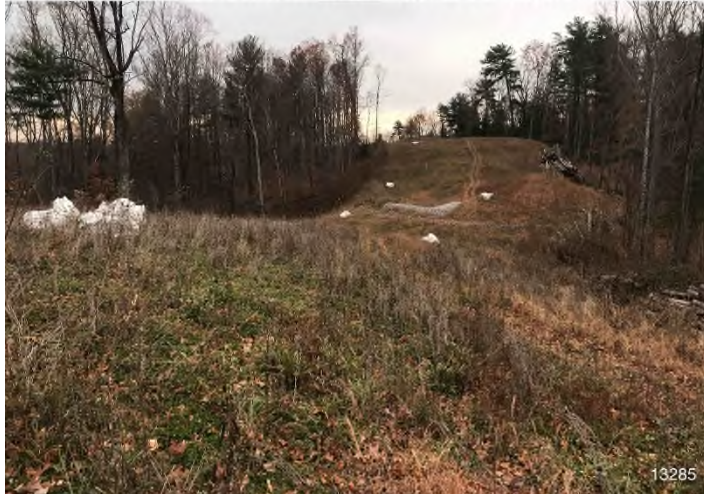
13285

Figure 3: STA 13285+00 – Controls in place and functioning properly.
 BRG: 180°S (T) LAT: 37.112478 LON: -80.055949 ±98ft ALT: 1636ft

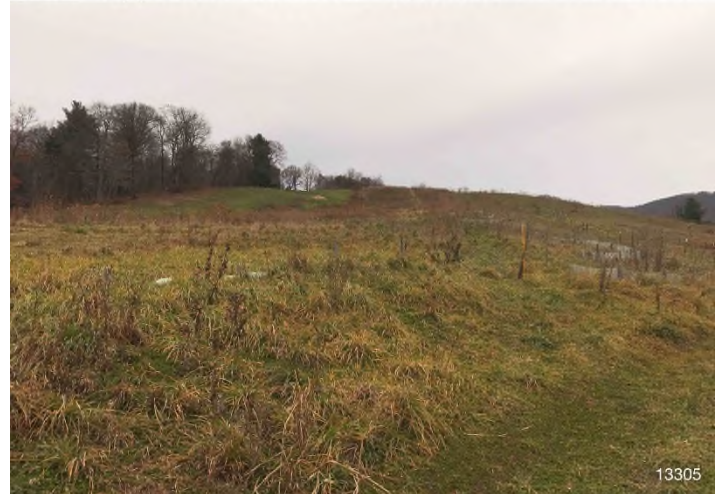
13305

Figure 4: STA 13305+00 – Controls in place and functioning properly.
 BRG: 9°N (T) LAT: 37.110509 LON: -80.055801 ±4740ft ALT: 1626ft
