## FIELD INSPECTION REPORT

<b>Project Name:</b>	Mountain Valley Pipeline	<b>Inspector:</b>	Marshall Willis
<b>Inspection Date:</b>	Tuesday, November 23, 2021	<b>Project Contact:</b>	Brian Clauto, Cory Chalmers
<b>Spread H: Montgomery County</b>	STA 12001+72 – 12015+00 MVP-MN-268/268.01	<b>Weather:</b>	Dry

## FIELD INSPECTION PHOTO LOG

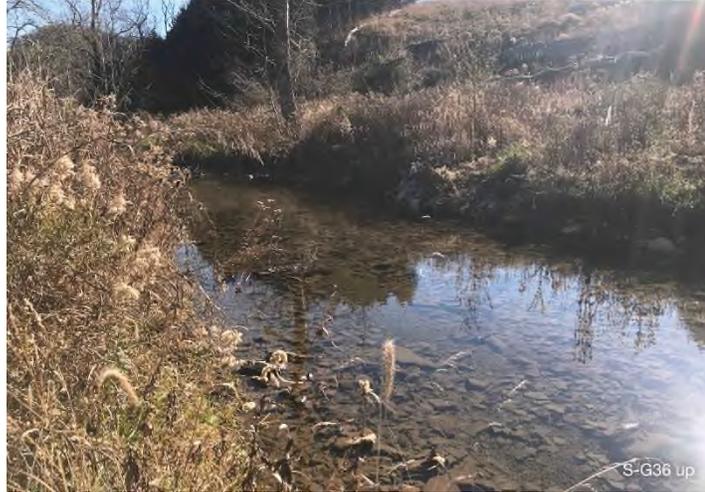
**Figure 1: Stream S-G36** – Upstream view of the North Fork Roanoke River ROW crossing.  
**BRG:** 149°SE (T) **LAT:** 37.268630 **LON:** -80.314478 ±16ft **ALT:** 1557ft

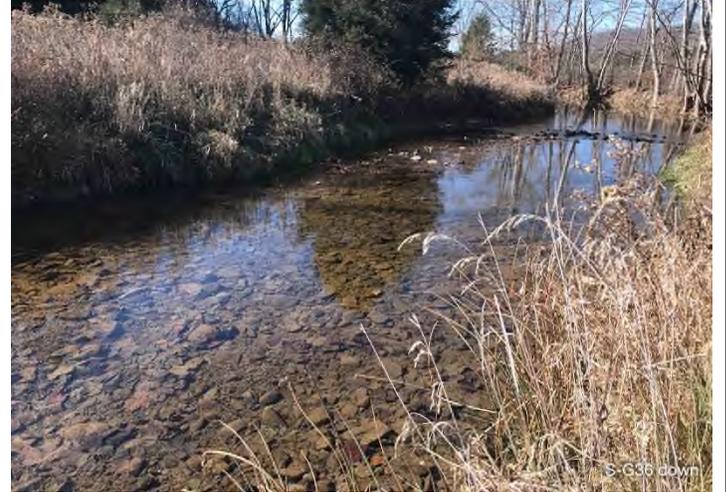
**Figure 2: Stream S-G36** – Downstream view of the North Fork Roanoke River ROW crossing.  
**BRG:** 242°SW (T) **LAT:** 37.268628 **LON:** -80.314498 ±16ft **ALT:** 1562ft

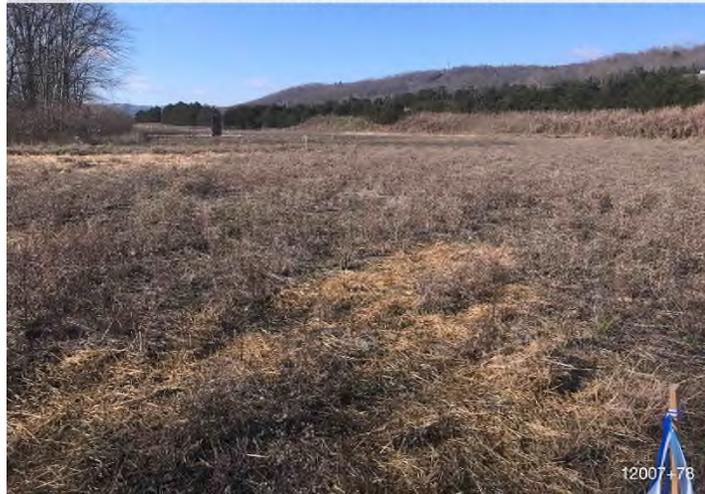
**Figure 3: STA 12007+78** – Controls in place and functioning properly. Area stabilized.  
**BRG:** 264°W (T) **LAT:** 37.268877 **LON:** -80.314359 ±16ft **ALT:** 1571ft

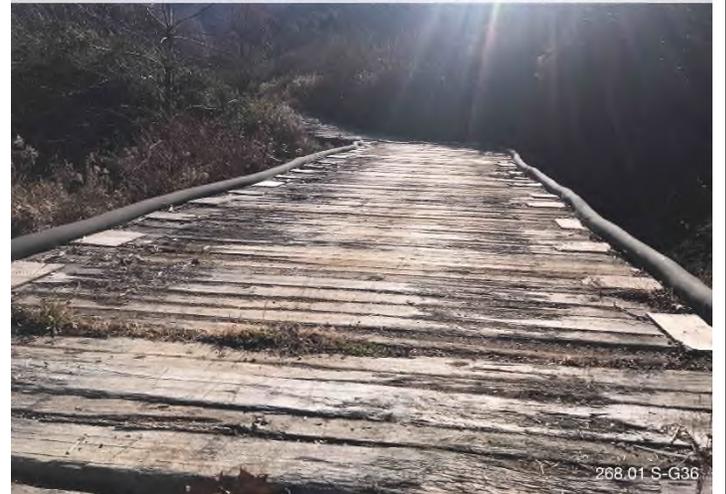
**Figure 4: MVP-MN-268.01** – Controls in place and functioning properly at S-G36 crossing.  
**BRG:** 132°SE (T) **LAT:** 37.268736 **LON:** -80.313182 ±370ft **ALT:** 1569ft
