## FIELD INSPECTION REPORT

<b>Project Name:</b>	Mountain Valley Pipeline	<b>Inspector:</b>	Marshall Willis
<b>Inspection Date:</b>	Wednesday, November 17, 2021	<b>Project Contact:</b>	Brian Clauto, Cory Chalmers
<b>Spread I: Franklin County</b>	STA 13784+00 – 13892+45 MVP-FR-300 MVP-FR-303.01	<b>Weather:</b>	Dry

## FIELD INSPECTION PHOTO LOG

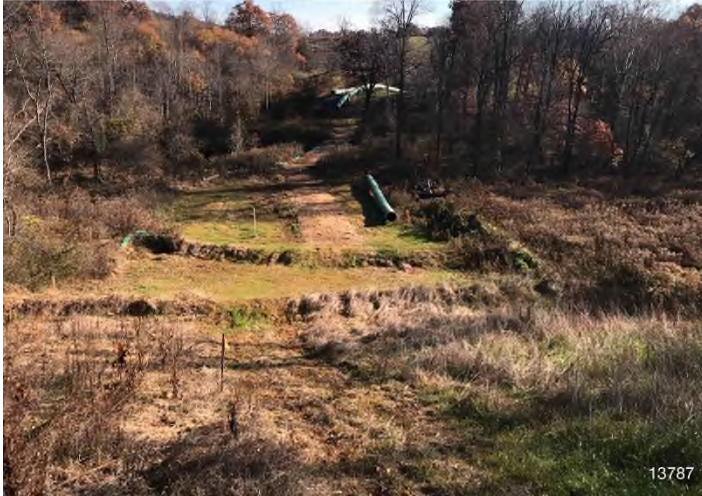
**Figure 1: STA 13787+00** – Controls in place and functioning properly.

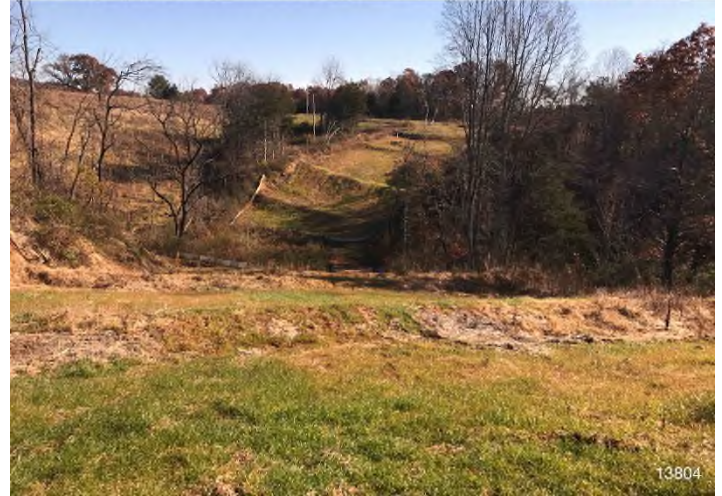
**Figure 2: STA 13804+00** – Controls in place and functioning properly.

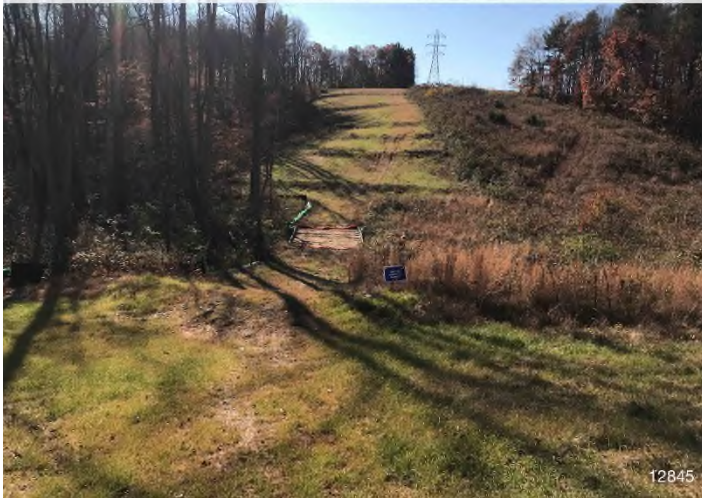
**Figure 3: STA 13845+00** – Controls in place and functioning properly.

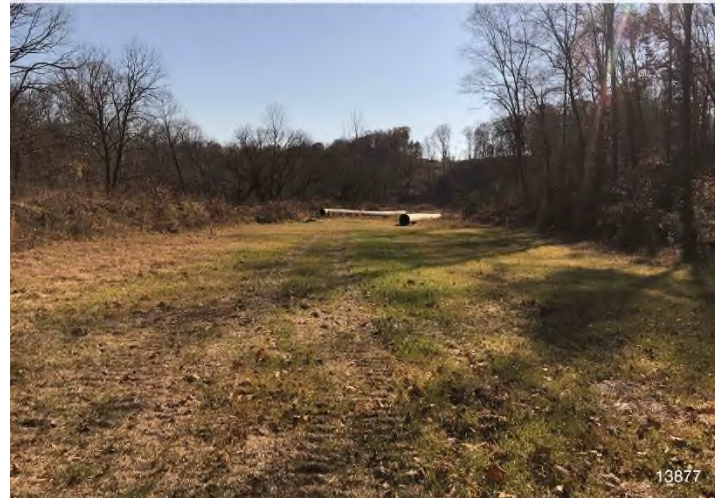
**Figure 4: STA 13877+00** – Controls in place and functioning properly.
