## FIELD INSPECTION REPORT

| <b>Project Name:</b> | Mountain Valley Pipeline | <b>Inspector:</b> | Marshall Willis |
| <b>Spread H:<br/>Roanoke County</b> | STA 12724+00 – 12776+00<br>MVP-RO-281<br>MVP-RO-282 | <b>Weather:</b> | Dry |

## FIELD INSPECTION PHOTO LOG

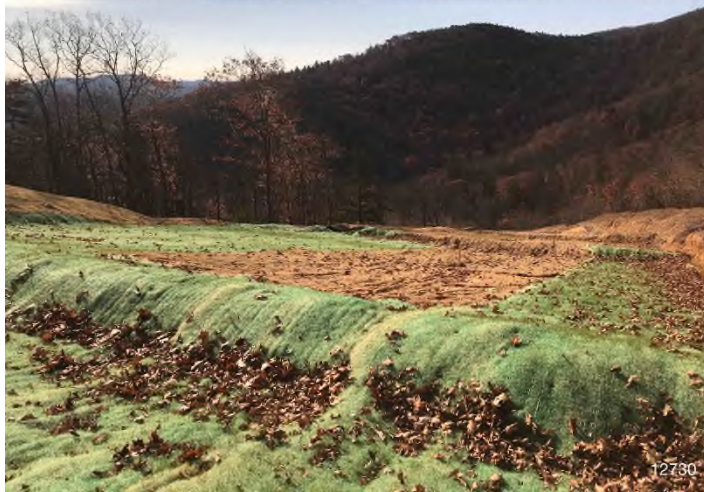
**Figure 1: STA 12730+00** – Controls in place and functioning properly. Area stabilized with erosion matting.  
BRG: 202°S (T) LAT: 37.181523 LON: -80.137169 ±9038ft ALT: 3357ft

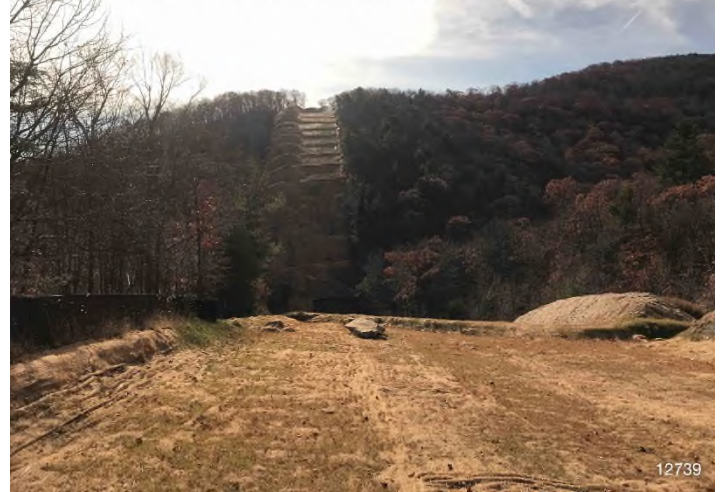
**Figure 2: STA 12739+00** – Controls in place and functioning properly. Area stabilized erosion matting.  
BRG: 169°S (T) LAT: 37.182701 LON: -80.149594 ±16ft ALT: 3095ft

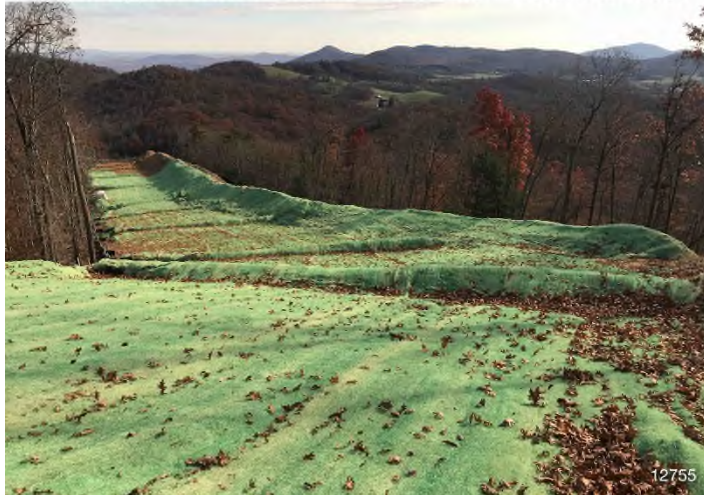
**Figure 3: STA 12755+00** – Controls in place and functioning properly. Area stabilized erosion matting.  
BRG: 93°E (T) LAT: 37.180673 LON: -80.134236 ±22913ft ALT: 3068ft

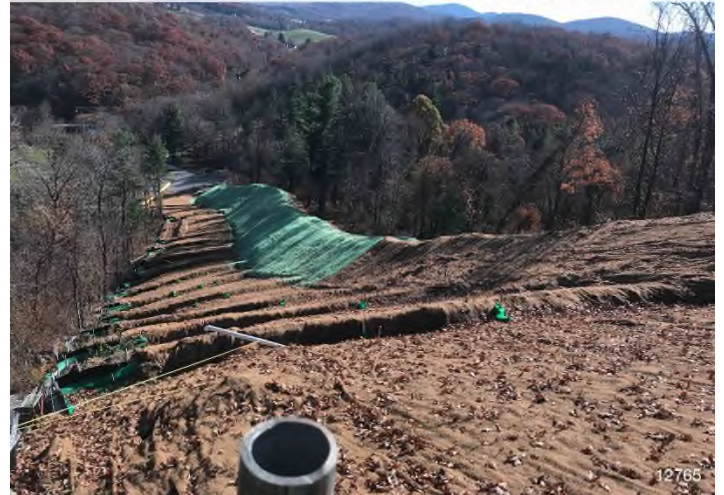
**Figure 4: STA 12765+00** – Controls in place and functioning properly. Area stabilized erosion matting.  
BRG: 73°E (T) LAT: 37.179265 LON: -80.145367 ±98ft ALT: 3091ft
