## FIELD INSPECTION REPORT

| <b>Project Name:</b> | Mountain Valley Pipeline | <b>Inspector:</b> | Marshall Willis |
| <b>Spread H:<br/>Montgomery County</b> | STA 12007+00 – 12072+00<br>MVP-MN-268/268.01<br>MVP-MN-270 | <b>Weather:</b> | Dry |

## FIELD INSPECTION PHOTO LOG

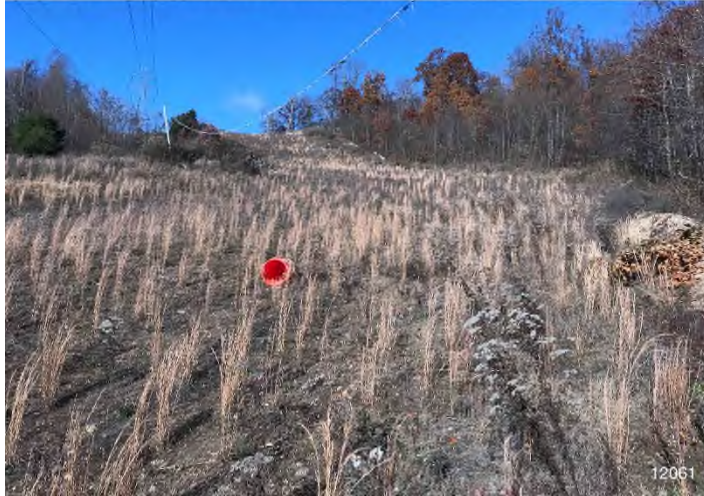
**Figure 1: STA 12061+00** – Controls in place and functioning properly. Area stabilized with erosion matting.  
BRG: 319°NW (T) LAT: 37.260993 LON: -80.299663 ±32ft ALT: 2182ft

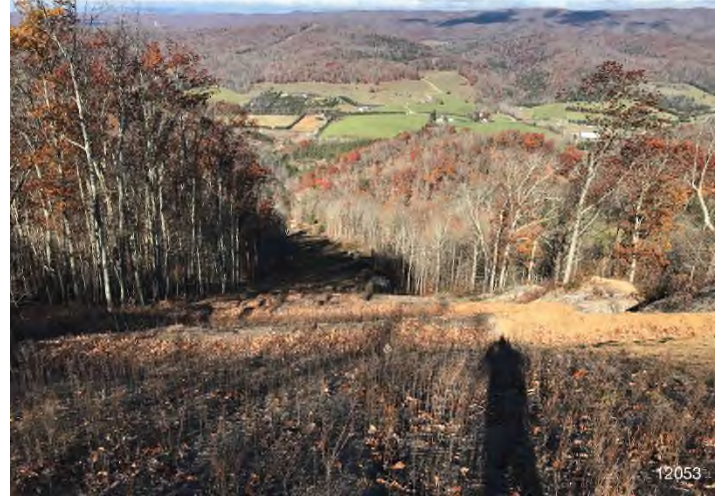
**Figure 2: STA 12053+00** – Controls in place and functioning properly. Area stabilized erosion matting.  
BRG: 336°NW (T) LAT: 37.271777 LON: -80.313685 ±921ft ALT: 1679ft

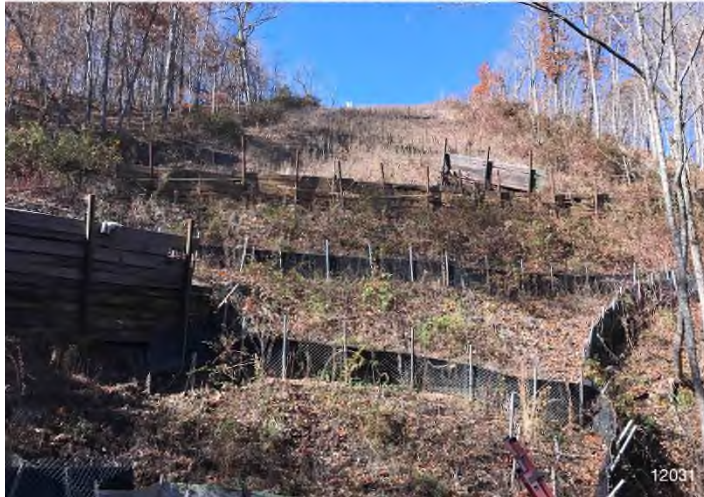
**Figure 3: STA 12031+00** – Controls in place and functioning properly. Area stabilized erosion matting.  
BRG: 292°W (T) LAT: 37.265060 LON: -80.308525 ±32ft ALT: 1735ft

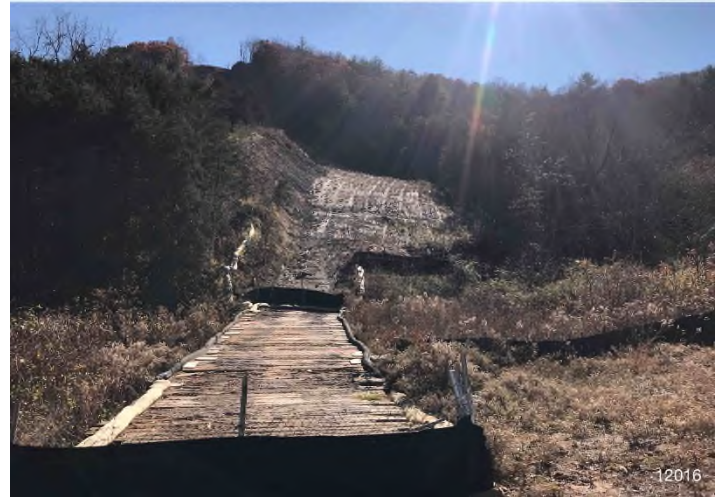
**Figure 4: STA 12016+00** – Controls in place and functioning properly. Area stabilized erosion matting.  
BRG: 148°SE (T) LAT: 37.267227 LON: -80.313112 ±16ft ALT: 1649ft
