FIELD INSPECTION REPORT

Project Name:	Mountain Valley Pipeline	Inspector:	Marshall Willis
Inspection Date:	Wednesday, November 10, 2021	Project Contact:	Brian Clauto, Cory Chalmers
Spread H: Roanoke County Franklin County	STA 13162+95 – 13185+40 STA 12915+00 – 12930+00 STA 12760+00 – 12776+00 MVP-FR-292.01 MVP-RO-282 MVP-RO-286	Weather:	Dry

FIELD INSPECTION PHOTO LOG

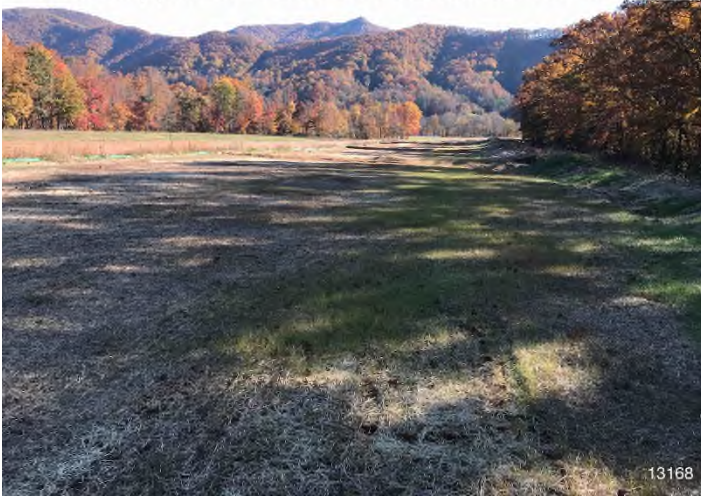
Figure 1: STA 13168+00 – Controls in place and functioning properly. Area stabilized with straw.

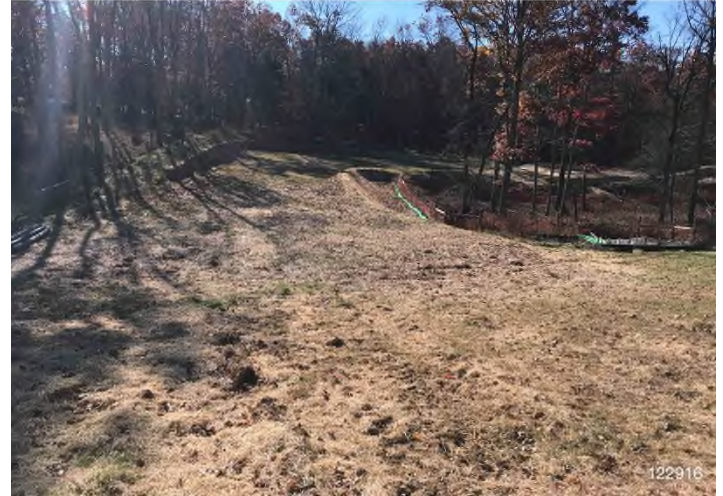
Figure 2: STA 12916+00 – Controls in place and functioning properly. Area stabilized with straw.

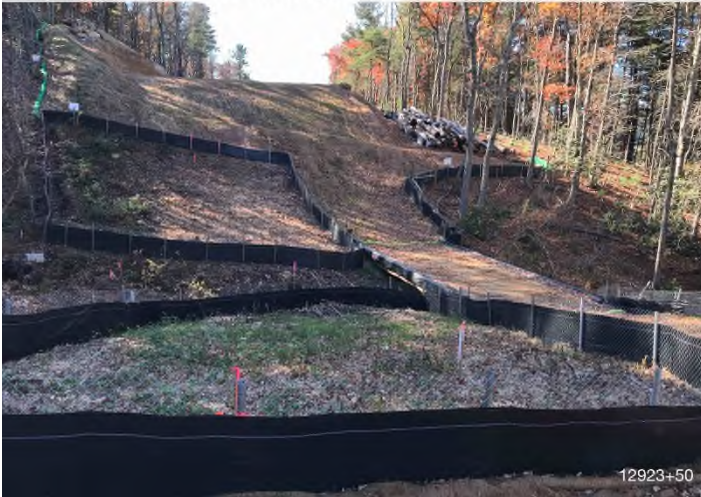
Figure 3: STA 12923+50 – Controls in place and functioning properly. Area stabilized erosion matting.

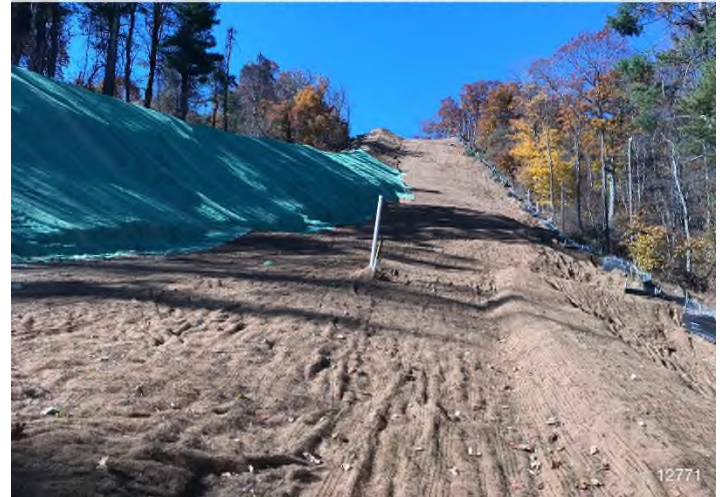
Figure 4: STA 12771+00 – Controls in place and functioning properly. Area stabilized erosion matting.
